TO: Mercedes-Benz Dealer Principals, General Managers, Sales Managers, Service Managers, Parts Managers	FROM: Gregory Gunther, Department Manager, Vehicle Compliance and Analysis, Engineering Services
RE: <b>Recall Campaign Launch Notification</b> <b>Replace Steering Control Unit Wiring Harness</b> <b>MY20 253 (GLC-Class)</b>	Date: December 04, 2020

Campaign No. 2020110012, December 2020

SUBJECT: **Model GLC-Class (253 platform)**  
**Model Year 2020**  
**Replace Steering Control Unit Wiring Harness Insulation**

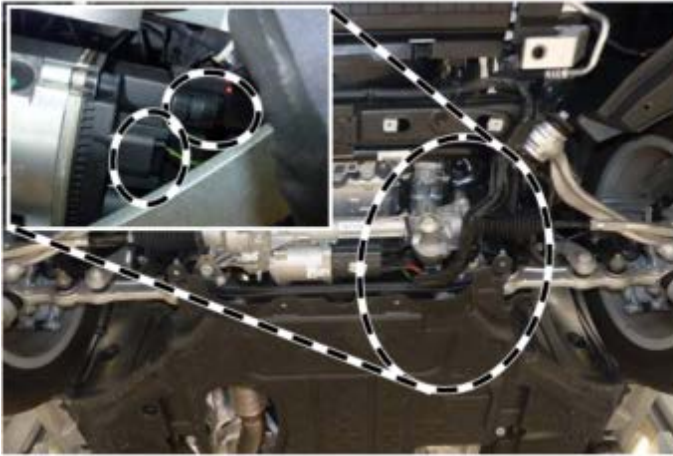
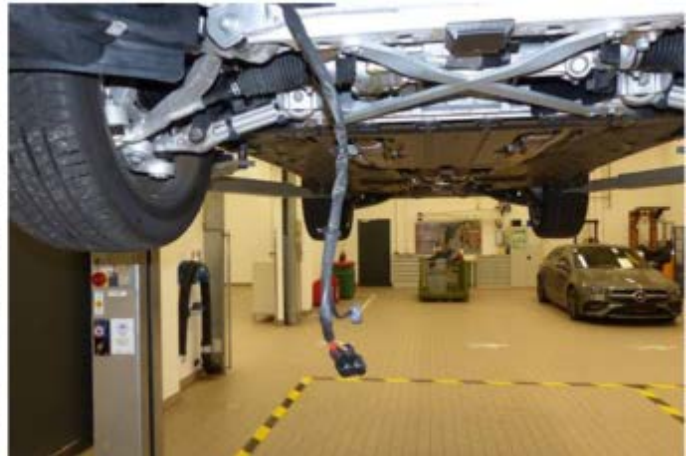
**Figure 1** (Routing in cable duct)

1. Switch off ignition and store vehicle key at least 2 meters away from vehicle.
2. Remove lower engine compartment lining.  
For basic data for model 253, see **AR61.20-P-1105LW**;
3. Release and remove both connectors at steering control unit (**figure 1**).
4. Check connector of **red** power supply cable and **brown** ground cable for moisture.  
**i** In the case of moisture, make detailed photos, create the steering (N68) control unit log and clarify the further repair procedure via **PTSS case**.
5. Expose wiring harness up to a length of 300 mm from the connector. This can be achieved by sliding back the protective hose.  
**i** There are two different cable routings (**figure 1**).

1. Release cable duct.
2. Mark position of cable ties so that these are located at same position during the installation.
3. Release cable ties (from the connector, the first four) and remove lines from cable duct.
4. Slide back the protective hose for check purposes.

1. Mark position of cable ties so that these are located at same position during the installation.
2. Release cable ties (starting from the connector, the first two) and slide back the protective hose.

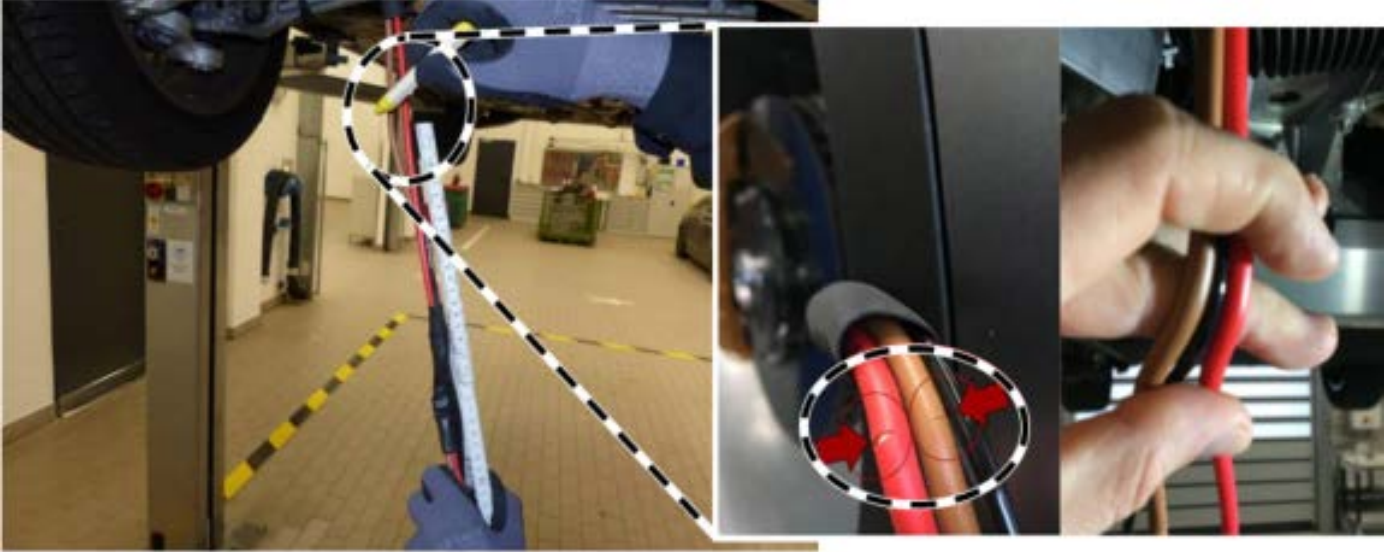
**Figure 2 (NOT OK)**

6. Check the **red** power supply cable and **brown** ground cable 300 mm up to 320 mm after the connector for cuts in the insulation (**figure 2**). Move the **red** power supply cable and **brown** ground cable in all directions for check purposes.

**i** The **red** power supply cable and **brown** ground cable may **not** be damaged.

**i** The following damage may be present.

- a. Brown ground cable **damaged**: Perform **work procedure A**.
- b. Red power supply cable or both cables **damaged**: Perform **work procedure B**.
- c. Red power supply cable and brown ground cable **not damaged**: **End measure**.

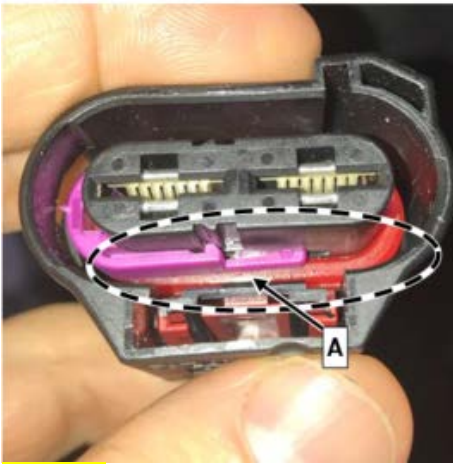
**Figure 3**

**i** The red seal may appear a bit "wet" (in **Figure 3 (A)**). This is residual oil from manufacturing and is normal. If this is the only area that looks "wet" **No PTSS case** needs to be created in this case.

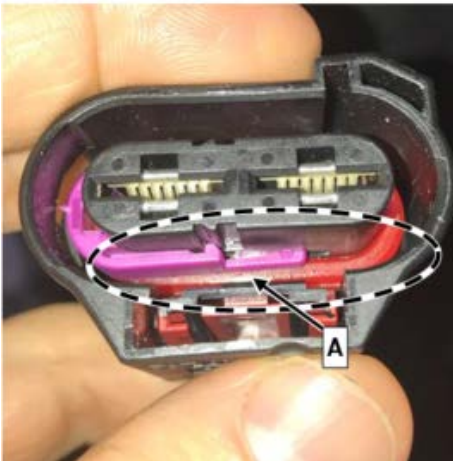
**Figure 7**

**i** The red seal may appear a bit "wet" (in **Figure 7 (A)**). This is residual oil from manufacturing and is normal. If this is the only area that looks "wet" **No PTSS case** needs to be created in this case.
