TO: Mercedes-Benz Dealer Principals, General Managers, Sales Managers, Service Managers, Parts Managers	FROM: Gregory Gunther, Department Manager, Vehicle Compliance and Analysis, Engineering Services
RE: Recall Campaign Launch Notification Replace Steering Control Unit Wiring Harness MY20 253 (GLC-Class)	Date: December 08, 2020

Campaign No. :	NHTSA ID	Campaign Desc. :	Replace Steering Control Unit Wiring Harness
2020110012	20V651	20P5491022

Campaign No. 2020110012, December 2020

SUBJECT: **Model GLC-Class (253 platform)**
Model Year 2020
Replace Steering Control Unit Wiring Harness Insulation

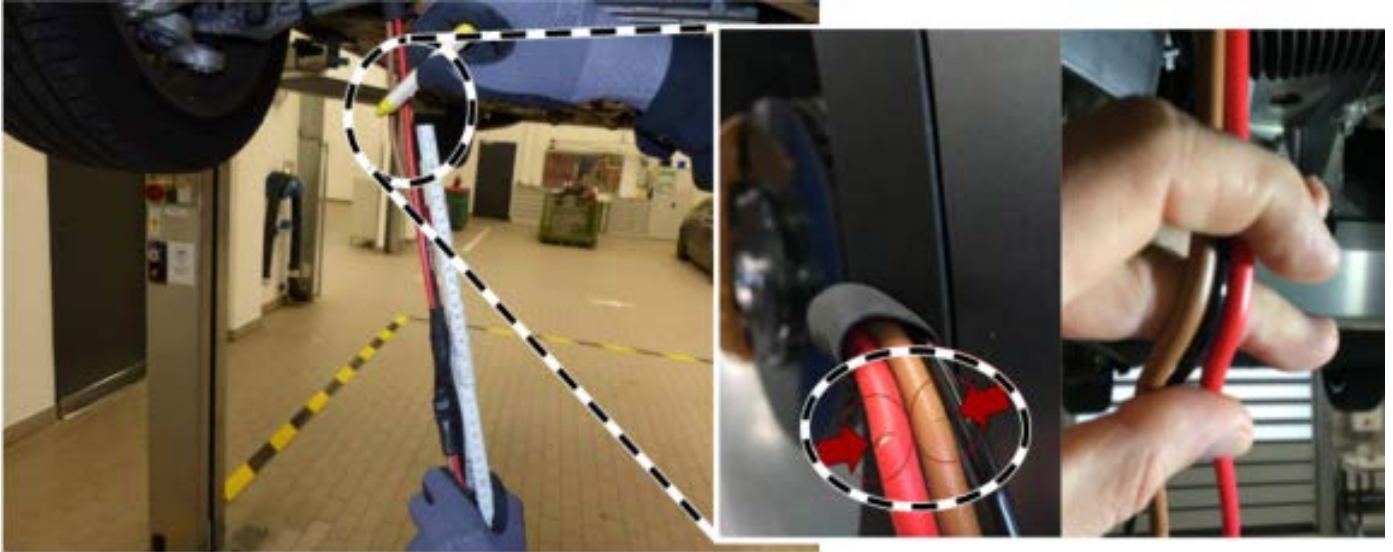
Figure 2 (NOT OK)

6. Check the **red** power supply cable and **brown** ground cable 300 mm up to 320 mm after the connector for cuts in the insulation (**figure 2**). Move the **red** power supply cable and **brown** ground cable in all directions for check purposes.

i The **red** power supply cable and **brown** ground cable may **not** be damaged.

i The following damage may be present.

- a. Brown ground cable **damaged**: Perform **work procedure A**.
- b. Red power supply cable or both cables **damaged**: Perform **work procedure B**.
- c. Red power supply cable and brown ground cable **not damaged**: **End measure**.
