TO: Mercedes-Benz Dealer Principals, General Managers, Sales Managers, Service Managers, Parts Managers	FROM: Gregory Gunther, Department Manager, Vehicle Compliance and Analysis, Engineering Services
RE: Recall Campaign Launch Notification Replace Steering Control Unit Wiring Harness MY20 253 (GLC-Class)	Date: December 08, 2020

Campaign No. :	NHTSA ID	Campaign Desc. :	Replace Steering Control Unit Wiring Harness
2020110012	20V651	20P5491022

SUBJECT: **Model GLC-Class (253 platform)**
Model Year 2020
Replace Steering Control Unit Wiring Harness Insulation

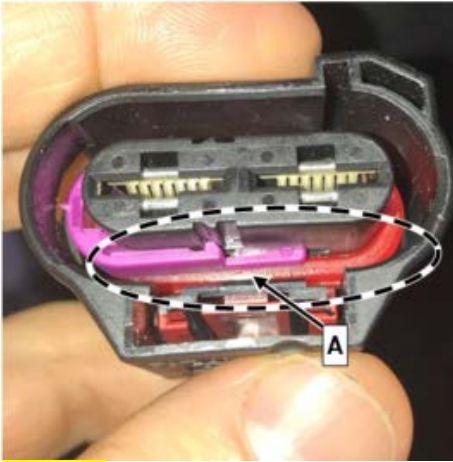
Figure 3

i The red seal may appear a bit "wet" (in **Figure 3 (A)**). This is residual oil from manufacturing and is normal. If this is the only area that looks "wet" **No PTSS case** needs to be created in this case.
