Mercedes-Benz

Campaign No. 2020110012, December 2020

SUBJECT: **Model GLC-Class (253 platform)**
Model Year 2020
Replace Steering Control Unit Wiring Harness Insulation

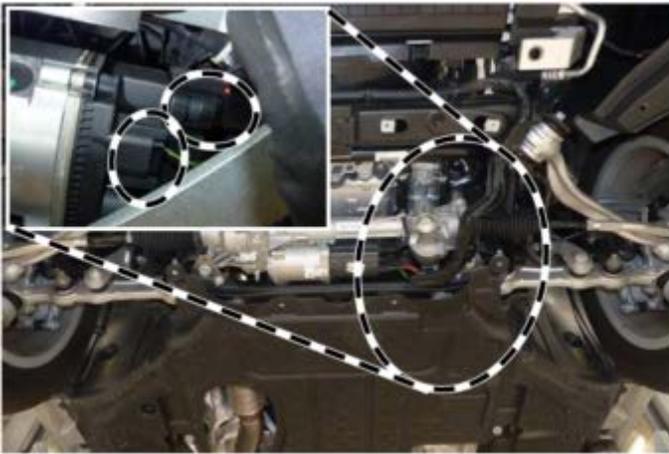
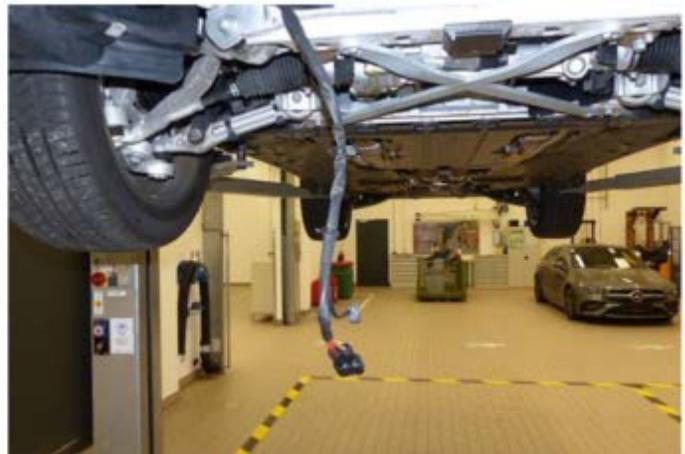
Figure 1 (Routing in cable duct)

1. Switch off ignition and store vehicle key at least 2 meters away from vehicle.
2. Remove lower engine compartment lining.
For basic data for model 253, see **AR61.20-P-1105LW**;
3. Release and remove both connectors at steering control unit (**figure 1**).
4. Check connector of **red** power supply cable and **brown** ground cable for moisture.
i In the case of moisture, make detailed photos, create the steering (N68) control unit log and clarify the further repair procedure via **PTSS case**.
5. Expose wiring harness up to a length of 300 mm from the connector. This can be achieved by sliding back the protective hose.
i There are two different cable routings (**figure 1**).

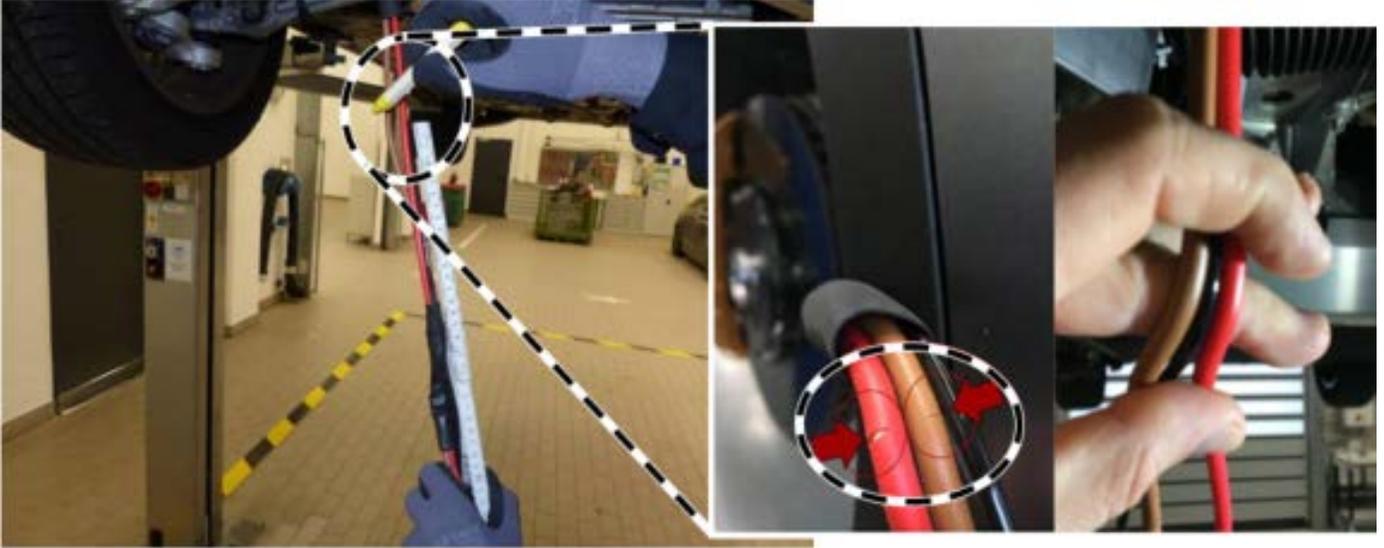
Figure 2 (NOT OK)

6. Check the **red** power supply cable and **brown** ground cable 300 mm up to 320 mm after the connector for cuts in the insulation (**figure 2**). Move the **red** power supply cable and **brown** ground cable in all directions for check purposes.

i The **red** power supply cable and **brown** ground cable may **not** be damaged.

i The following damage may be present.

- a. Brown ground cable **damaged**: Perform **work procedure A**.
- b. Red power supply cable or both cables **damaged**: Perform **work procedure B**.
- c. Red power supply cable and brown ground cable **not damaged**: **End measure**.
