Mercedes-Benz

Campaign No. 2020110012, December 2020

SUBJECT: **Model GLC-Class (253 platform)**
Model Year 2020
Replace Steering Control Unit Wiring Harness Insulation

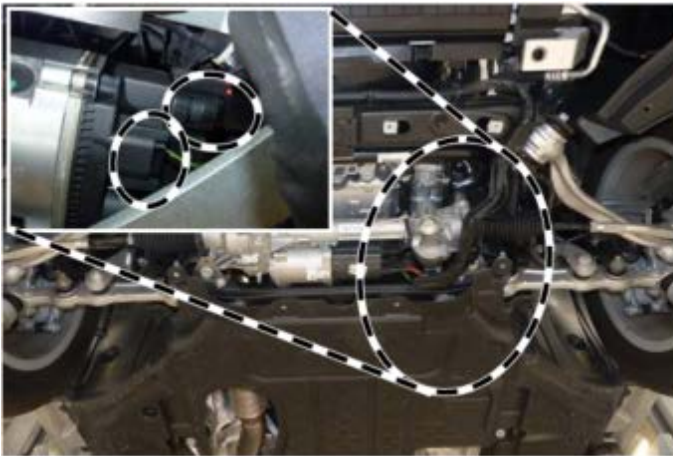
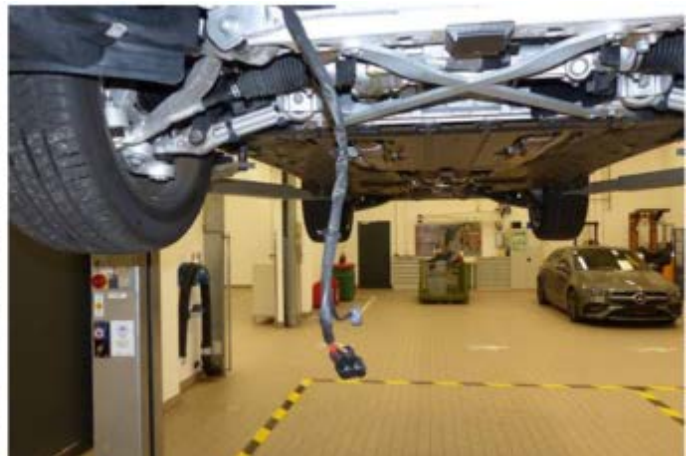
Figure 1 (Routing in cable duct)

1. Switch off ignition and store vehicle key at least 2 meters away from vehicle.
2. Remove lower engine compartment lining.
For basic data for model 253, see **AR61.20-P-1105LW**;
3. Release and remove both connectors at steering control unit (**figure 1**).
4. Check connector of **red** power supply cable and **brown** ground cable for moisture.
i In the case of moisture, make detailed photos, create the steering (N68) control unit log and clarify the further repair procedure via **PTSS case**.
5. Expose wiring harness up to a length of 300 mm from the connector. This can be achieved by sliding back the protective hose.
i There are two different cable routings (**figure 1**).

1. Release cable duct.
2. Mark position of cable ties so that these are located at same position during the installation.
3. Release cable ties (from the connector, the first four) and remove lines from cable duct.
4. Slide back the protective hose for check purposes.

1. Mark position of cable ties so that these are located at same position during the installation.
2. Release cable ties (starting from the connector, the first two) and slide back the protective hose.
