December 2020  
FL866A  
NHTSA #20V-660  
Transport Canada #2020-513

## Subject: Steer Axle Spindle Nut Snap Rings

**Models Affected: Specific Model Year 2020-2021 Freightliner 108SD, 114SD, Business Class M2, Cascadia; and Western Star 4700, 4900, and 5700 model vehicles manufactured June 1, 2020, through September 9, 2020.**

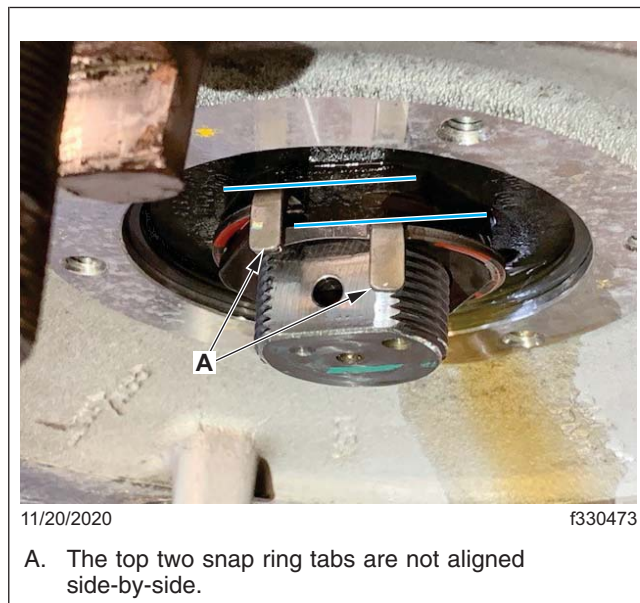
The top two snap ring tabs should be in line and close together. The lower tab should be fully installed in the locking hole in the spindle nut.

**Fig. 1, Top Snap Ring Tab Incorrectly Installed**

7. Confirm the snap ring is properly seated in the spindle nut groove. If the snap ring looks like [Fig. 1](#) or [Fig. 3](#), ref. A, install the snap ring correctly in the grooves.
8. Confirm the locking tab is fully installed in the spindle nut locking hole.  
If the snap ring looks like [Fig. 4](#), go to step 9.  
If the snap ring looks like [Fig. 5](#), go to step 10.

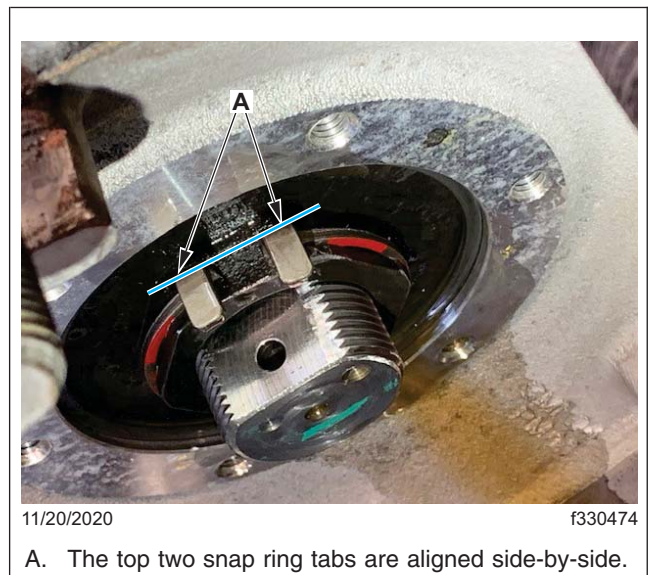
**Fig. 2, Top Snap Ring Tabs Correctly Installed**

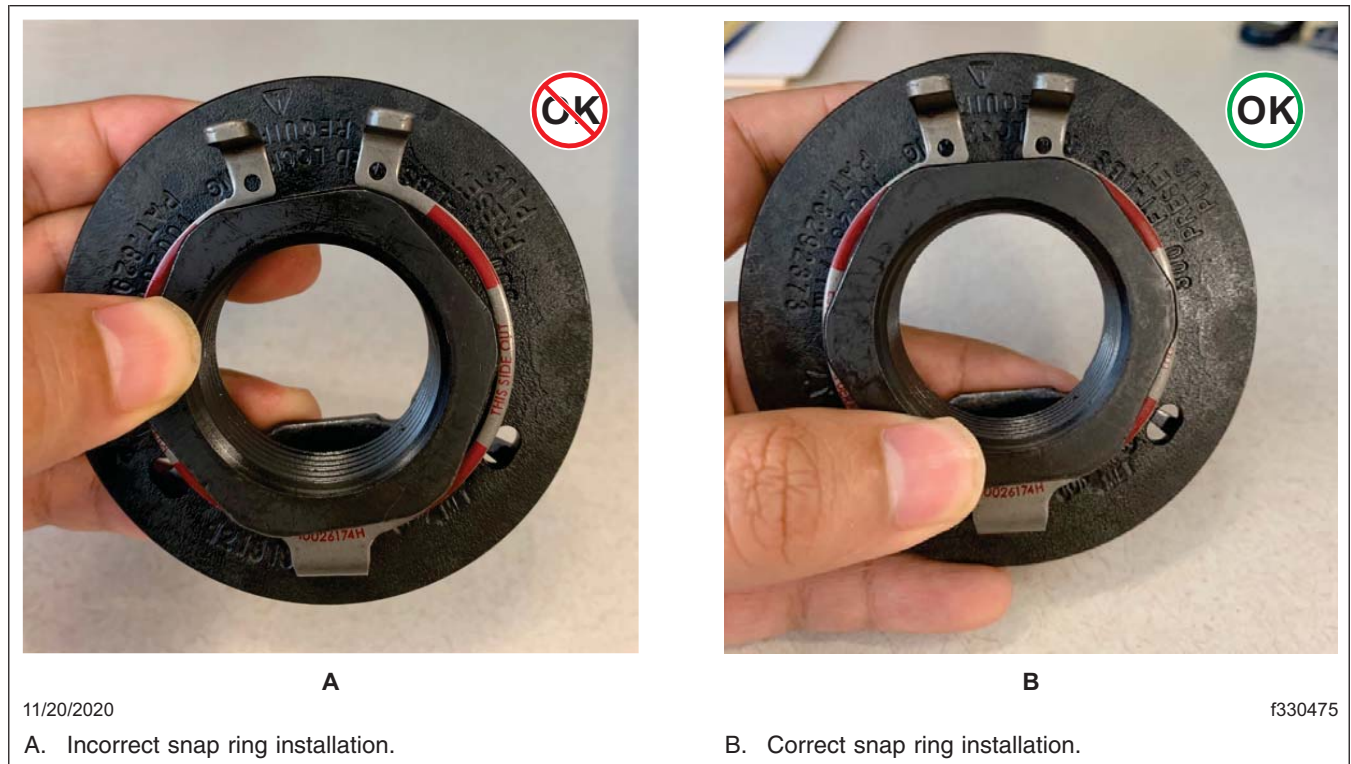
**Fig. 3, Incorrect and Correct Snap Ring Installation Examples**

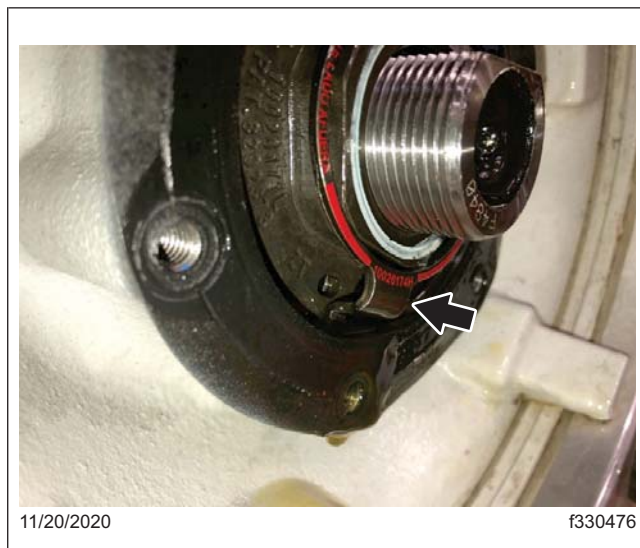
**Fig. 4, Lower Snap Ring Tab is not Fully Installed in the Spindle Nut Locking Hole**

9. Completely remove the snap ring and tighten the hub spindle nut 300 lbf·ft (407 N·m). If the hub spindle nut moves at all, remove the hub and check for damage; replace the hub if it is damaged. For replacement instructions, see Group 33 of the applicable workshop manual.

If the hub spindle nut does not move, install the snap ring.

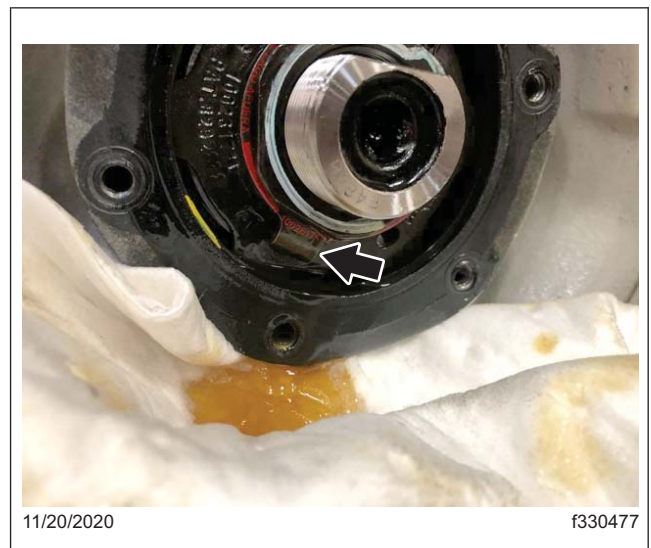
**Fig. 5, Lower Snap Ring Tab is Fully Installed in the Spindle Nut Locking Hole**

10. Clean the area where the hub cap gasket will be installed.
11. Install a new hub cap gasket and the existing hub cap. In a star pattern, tighten the capscrews 15 lbf·ft (20 N·m).
12. Remove fill plug and fill hub with oil, then install the fill plug.
13. Repeat steps 3 through 12 on the other steer axle wheel.
14. Clean a spot on the base label (Form WAR259). Write the campaign number, FL866, on a blank red completion sticker (Form WAR260) to indicate the work has been completed, and attach it to the base label.
