Bedlift System- Defective Motor

Bulletin Type:	Safety Recall	Publication Date:	November 18, 2020
Bulletin #(s):	20V-662 US Units 2020-548 CN Units	Make(s):	Jayco Entegra
Job Code:	9903525	Model(s):	Alante, Precept, Precept Prestige Emblem, Vision, Vision XL
Flat Rate:	.8 hour	Model Year:	2021

EUROLOFT™ BED LIFT MOTOR REPLACEMENT

TSB Number:	20E-074
Product:	EuroLoft™ Bed Lift Motor
Date:	10/21/2020

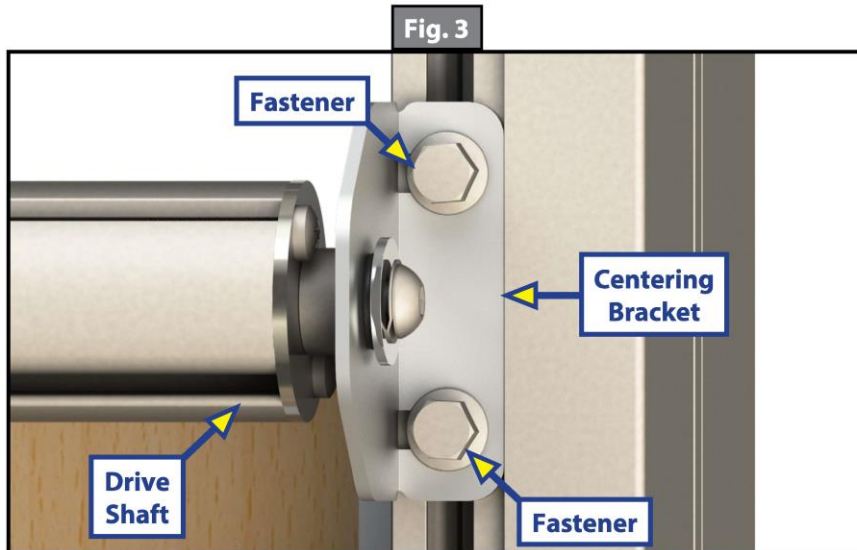
Incident:	Motor in the LCI P2K Bedlift System may fail due to internal gear failure, causing the bed to extend from a stowed position.
Affected Units:	<p>2021 Alante M1<u>AS</u>4066-4087 <u>AU</u>4074-4093</p> <p>2021 Precept M1<u>UG</u>4069-4074, 4077-4090. 4092 <u>UL</u>4052-4055, 4057-4059,4061,4063, 4065-4066, 4070-4071,4073-4075 <u>UV</u>4051-4056, 4058</p> <p>2021 Emblem M1<u>DH</u>8051-8063 <u>DU</u>8051-8061, 8065</p> <p>2021 Vision M1<u>AF</u>8066 <u>AS</u>8066-8085 <u>AU</u>8051-8075</p> <p>2021 Vision XL M1<u>UG</u>8064, 8066-8067, 8070-8072, 8074-8080</p>
Parts Kit:	<p>Parts Kit #: 20V-662</p> <p>Parts Kit Contents: 1 motor</p>

1. Support the bed frame at all lift strap locations, or so that all four corners cannot drop while working underneath the bed frame.
2. Remove the mattress from the bed frame.
3. Disconnect the main wire harness from the motor.
4. Locate the drive shaft centering bracket (Fig.3) that is attached to the drive shaft, located on the opposite side of the motor support bracket (Fig.4). Mark the position of the centering bracket with a non-permanent method of marking.
5. Remove the two fasteners (Fig.3) that hold the centering bracket (Fig.3) in place.

NOTE: Do not allow the bed support belts to unspool. If this happens, re-wrap the belts the same amount of rotations on the drive shaft.
