Product Safety Recall

N202313440 Transmission Accumulator Bolts Missing

Release Date: October 2020

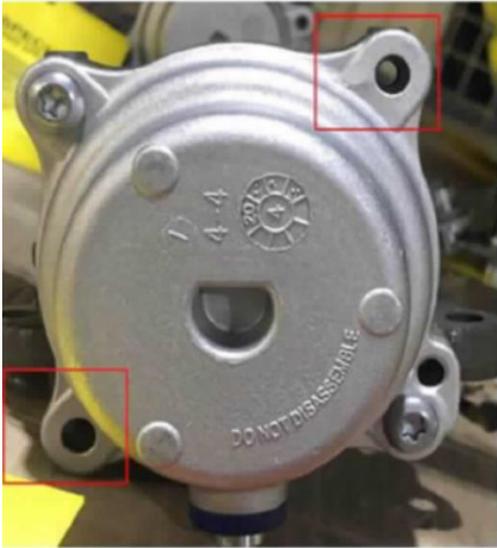
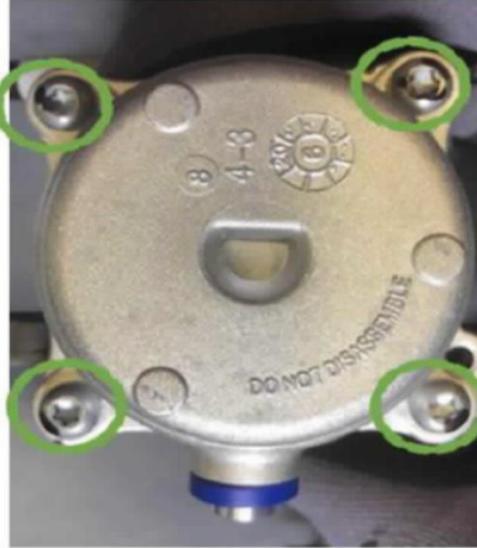
5666156

Condition	General Motors has decided that a defect which relates to motor vehicle safety exists in the affected vehicles identified above. These vehicles are equipped with a start-stop accumulator that may have missing bolts. Missing bolts on the start-stop accumulator endcap could result in a transmission oil leak and may progress to a loss of propulsion, which could increase the risk of a crash. A transmission oil leak in the presence of an ignition source may increase the risk of fire.
Correction	Dealers will inspect the start-stop transmission accumulator and replace it if any bolts are missing.

Note: The purpose of this service procedure is to inspect for the presence of missing bolts in the Transmission Auxiliary Fluid Accumulator Cover, an example of which is shown above.

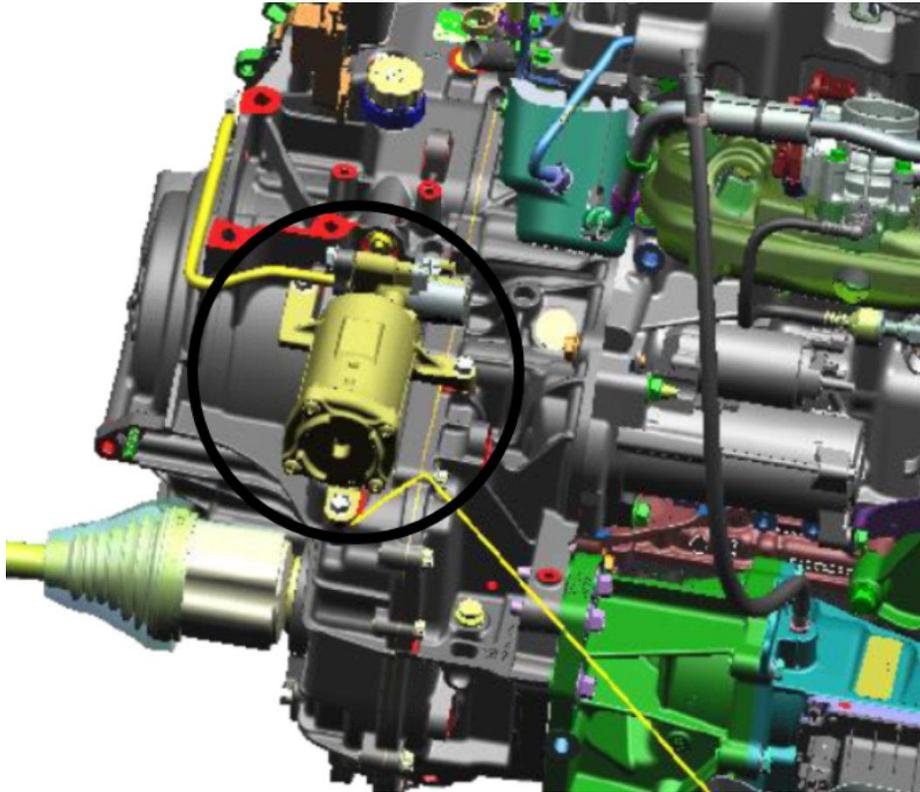
5666157

2. Looking straight up around the rear of the transmission, identify the transmission auxiliary fluid accumulator.

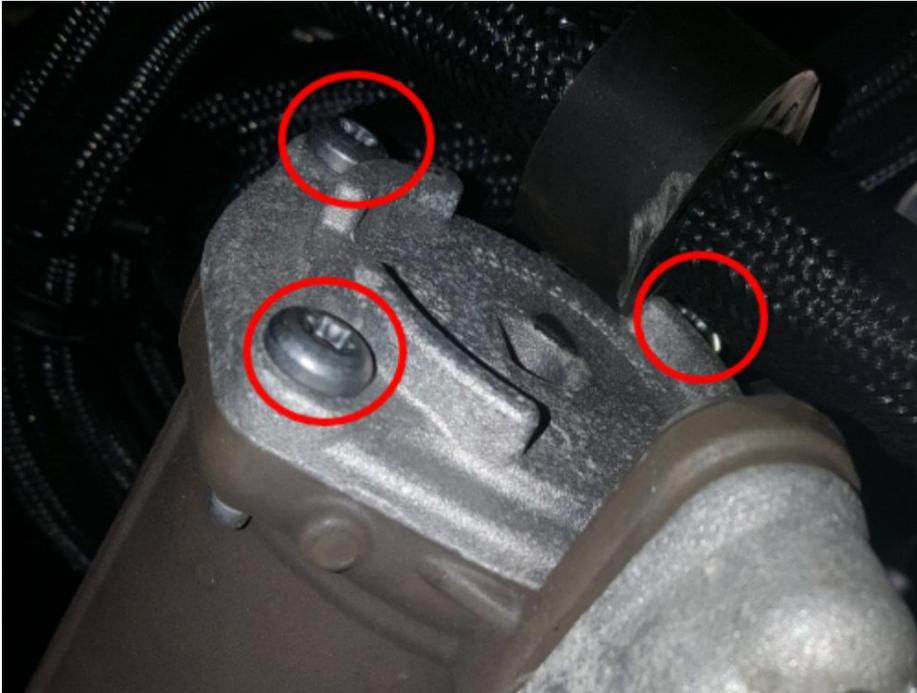
5666158

3. Visually inspect for the presence of the three bolts shown above.
4. Using your hand, feel for the presence of the bottom right bolt in the cover.
 - If NONE of the four cover bolts are missing, no further action is required.
 - If ANY of the four cover bolts are missing, replace the Transmission Auxiliary Fluid Accumulator. Refer to *Auxiliary Fluid Accumulator Replacement* in SI.
5. Lower the vehicle. Refer to *Lifting and Jacking the Vehicle* in SI.

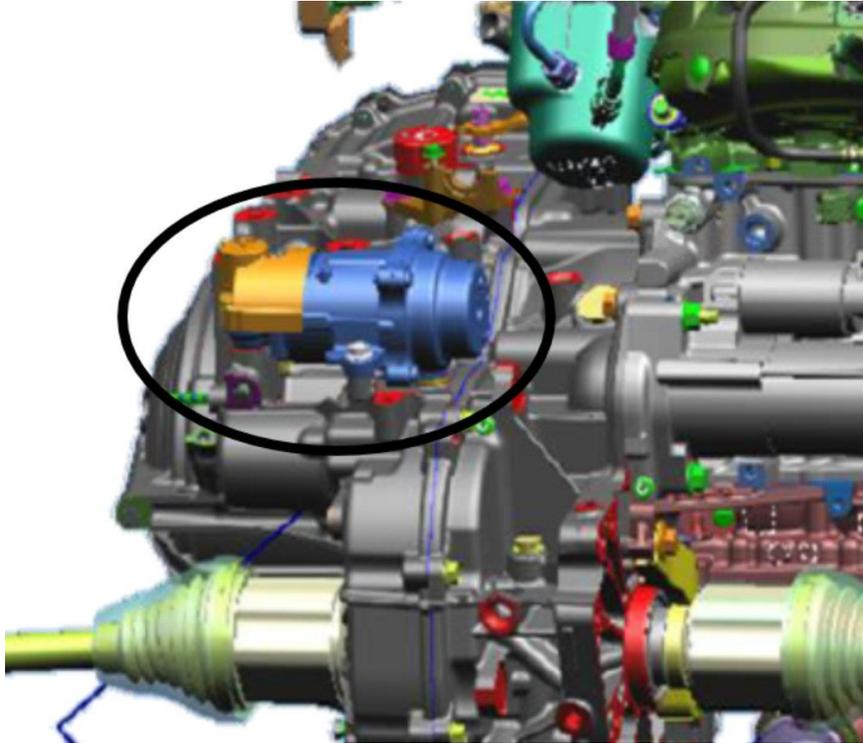
5666159

2. Looking up above the driver's side wheel drive shaft, locate the transmission auxiliary fluid accumulator.

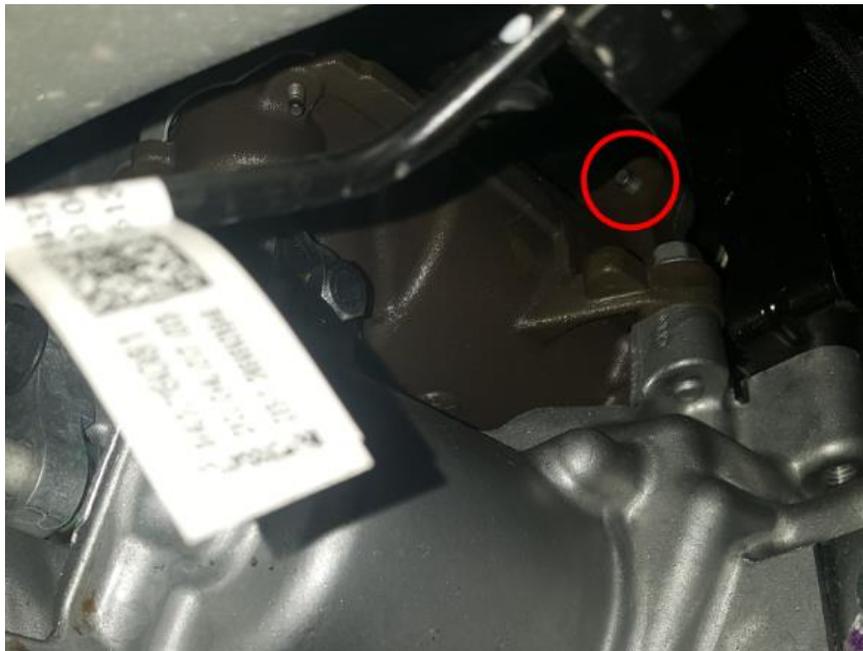
5666160

3. Visually verify the first bolt (circled above) is installed. You will be looking for the threads protruding from the transmission fluid accumulator housing for these vehicles to verify the bolt is installed.
4. Using a borescope, visually verify the next three bolts are installed.

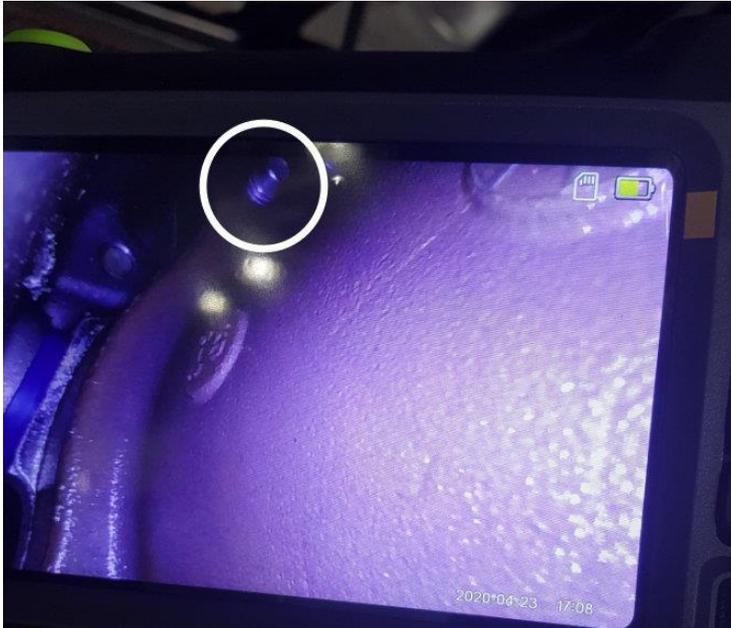
5666161

5. Top left.

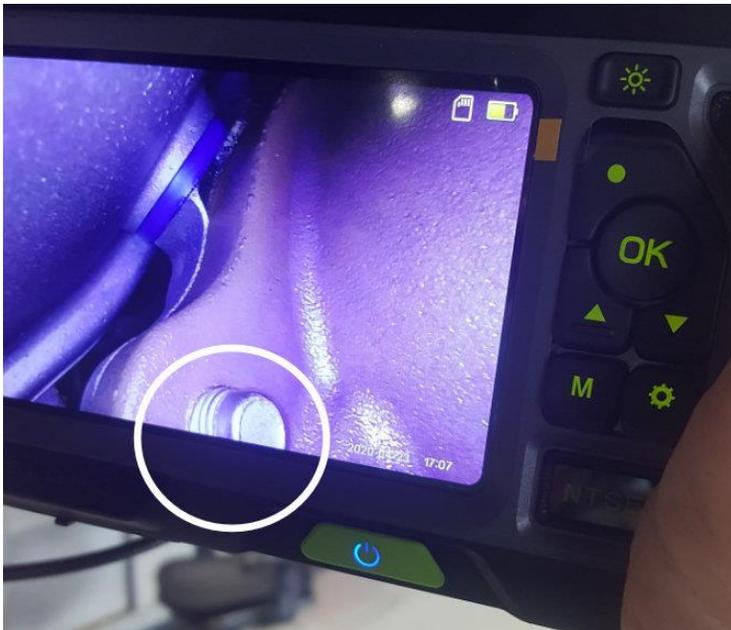
5666162

6. Bottom left.

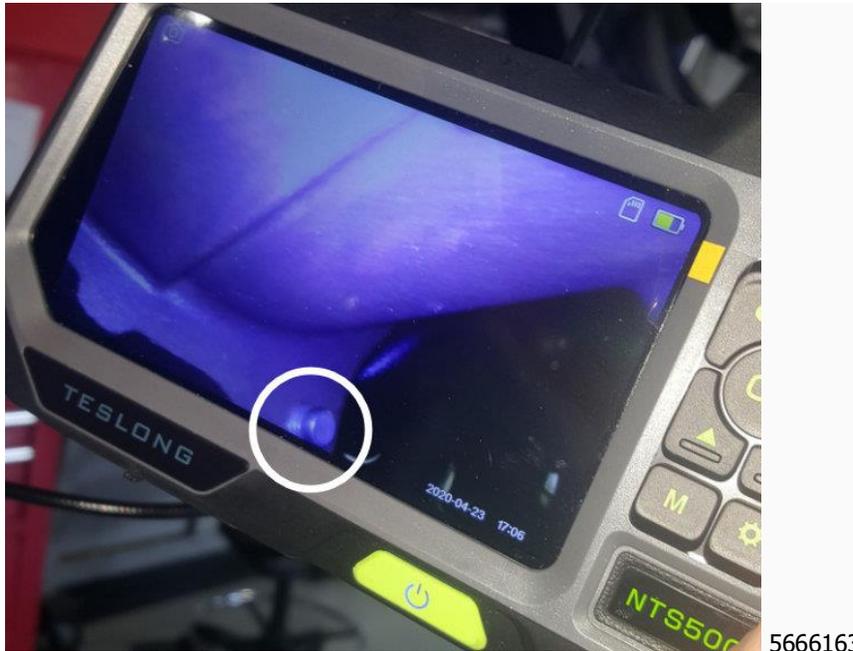
5666163

7. Bottom right.
 - If NONE of the four cover bolts are missing, no further action is required.
 - If ANY of the four cover bolts are missing, replace the Transmission Auxiliary Fluid Accumulator. Refer to *Auxiliary Fluid Accumulator Replacement* in SI.
8. Lower the vehicle. Refer to *Lifting and Jacking the Vehicle* in SI.
