TO: Mercedes-Benz Dealer Principals, General Managers, Sales Managers, Service Managers, Parts Managers	FROM: Gregory Gunther, Department Manager, Vehicle Compliance and Analysis, Engineering Services
RE: Recall Campaign Launch Notification Adjust Second Row Bench Middle Double Buckle MY20-21 167 (GLE-Class)	DATE: December 11, 2020

Campaign No. 2020110005, December 2020

SUBJECT: **Model GLE-Class (167 platform)**
Model Year 2020-2021
Adjust Second Row bench Middle Double Buckle

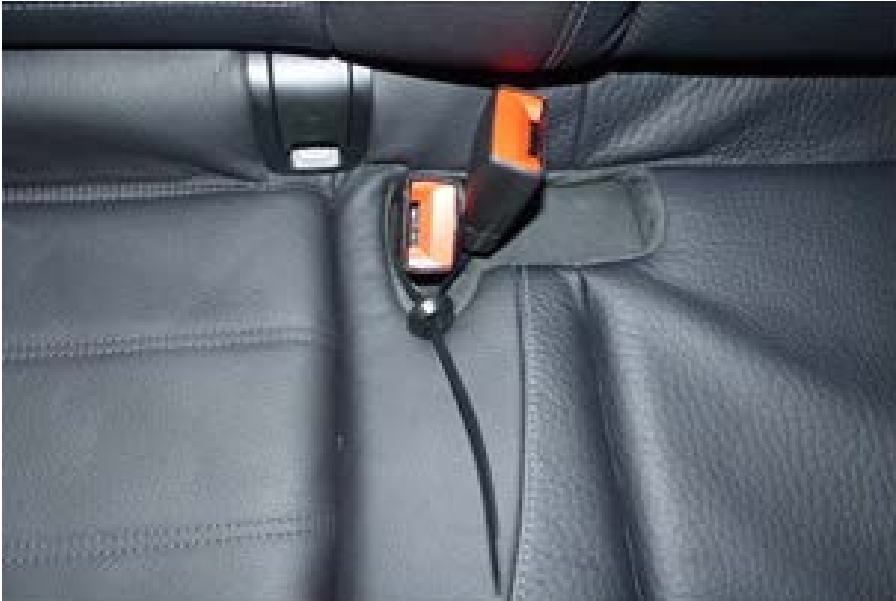
Figure 1

Mercedes-Benz AG (“MBAG”), the manufacturer of Mercedes-Benz vehicles, has determined that on certain Model Year (“MY”) 2020 - 2021 GLE-Class (167 platform) vehicles with 5 passenger seating, in certain circumstances while buckling the seatbelt, the middle seatbelt buckle could be pushed down below the seat cushion. If the passenger is not able to retrieve the buckle, the affected seat would not be available for an occupant to properly fasten the seatbelt. If a passenger does not fasten the seatbelt according to the Operator’s Manual, the risk of injury in a crash could increase. An authorized Mercedes-Benz dealer will additionally secure of the middle seatbelt buckle on the affected vehicles to prevent it from being pushed below the seat cushion.

1. Pull center seat belt buckle upward.
2. Guide cable tie over right seat belt buckle **and** over center seat belt buckle.
3. Position cable tie **beneath** right seat belt buckle (**Figure 1**).
