Mercedes-Benz

Campaign No. 2020110005, December 2020
Revision A 12/02/2021

SUBJECT: **Model GLE-Class (167 platform)**
Model Year 2020-2021
Adjust Second Row bench Middle Double Buckle

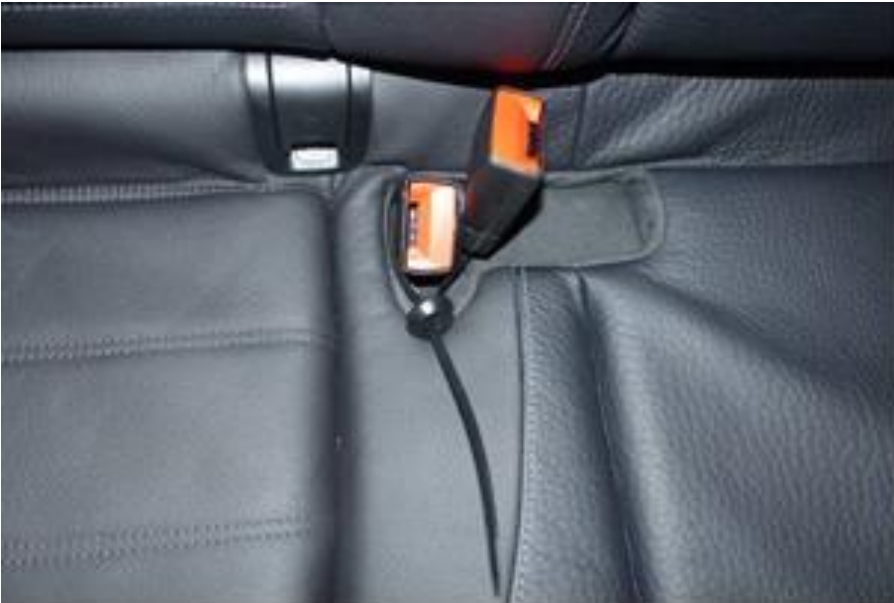
Figure 1

Mercedes-Benz AG (“MBAG”), the manufacturer of Mercedes-Benz vehicles, has determined that on certain Model Year (“MY”) 2020 - 2021 GLE-Class (167 platform) vehicles with 5 passenger seating, in certain circumstances while buckling the seatbelt, the middle seatbelt buckle could be pushed down below the seat cushion. If the passenger is not able to retrieve the buckle, the affected seat would not be available for an occupant to properly fasten the seatbelt. If a passenger does not fasten the seatbelt according to the Operator’s Manual, the risk of injury in a crash could increase. An authorized Mercedes-Benz dealer will additionally secure of the middle seatbelt buckle on the affected vehicles to prevent it from being pushed below the seat cushion.

1. Pull center seat belt buckle upward.
2. Guide cable tie over right seat belt buckle **and** over center seat belt buckle.
3. Position cable tie **beneath** right seat belt buckle (**Figure 1**).
