Mercedes-Benz

Campaign No. 2020110007, December 2020

SUBJECT: **Model GLA-Class (156 platform)**
Model Year 2019
Check Mounting of Engine Fuse Box

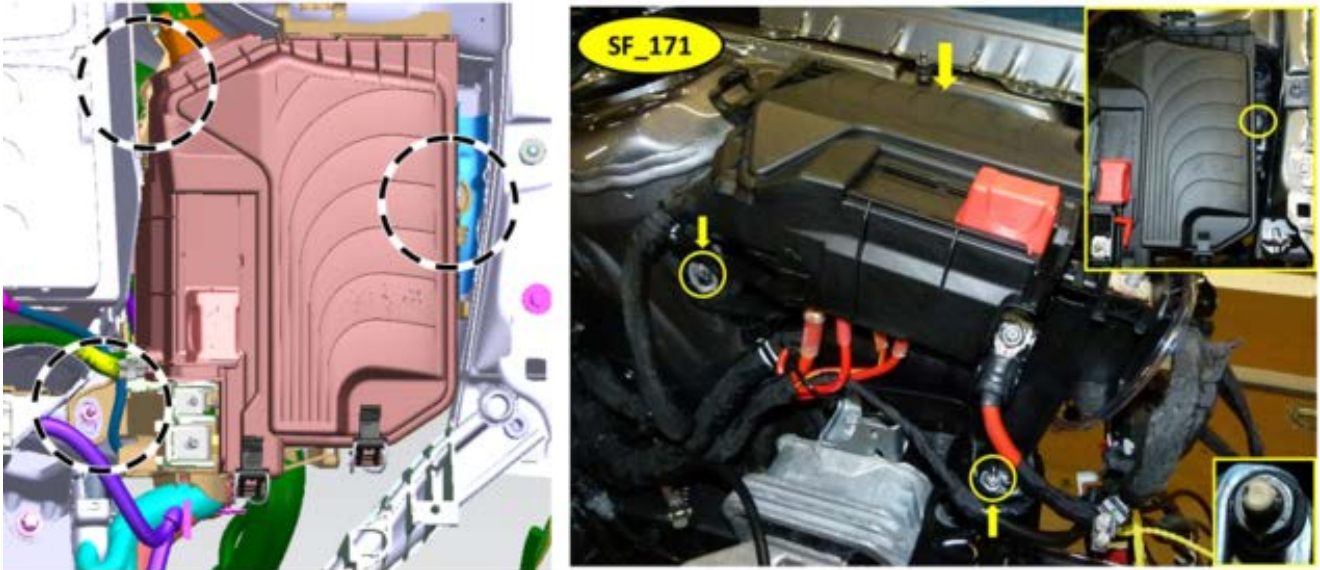
Figure 1

Mercedes-Benz AG ("MBAG"), the manufacturer of Mercedes-Benz vehicles, has determined that on certain MY 2019 GLA-Class (156 platform) vehicles, the mounting of the engine compartment fuse box housing might not meet current production specifications. If the screw connection securing the engine compartment fuse box housing does not meet current production specifications, it could loosen over time and be subjected to vibrations. The vibrations could lead to excessive mechanical stress and damage to the fuses in the fuse box housing, causing contact interruption and preventing the availability of certain vehicle functions including engine operation, power steering assist, ESP system, and Active Brake Assist, which could increase the risk of a crash. An authorized Mercedes-Benz dealer, will check the mounting of the engine compartment fuse box on the affected vehicles and correct it, if necessary.

1. Open hood.
2. Check all three threaded connections (**Figure 1**) for correct seating of the nuts and retighten with 6 **Nm** of torque.
