SUBJECT: **Safety Recall 20S62 – Supplement #1**
 Certain 2013 through 2017 Model Year Explorer and Police Interceptor Utility Vehicles that are Registered or Sold in High Corrosion States/Provinces
 Rear Toe Link Ball Joint Inspection

Ref: **Safety Recall 20S62**
 Dated November 20, 2020

CERTAIN 2013-2017 MODEL YEAR EXPLORER VEHICLES — REAR SUSPENSION TOE LINK TO WHEEL KNUCKLE BALL JOINT

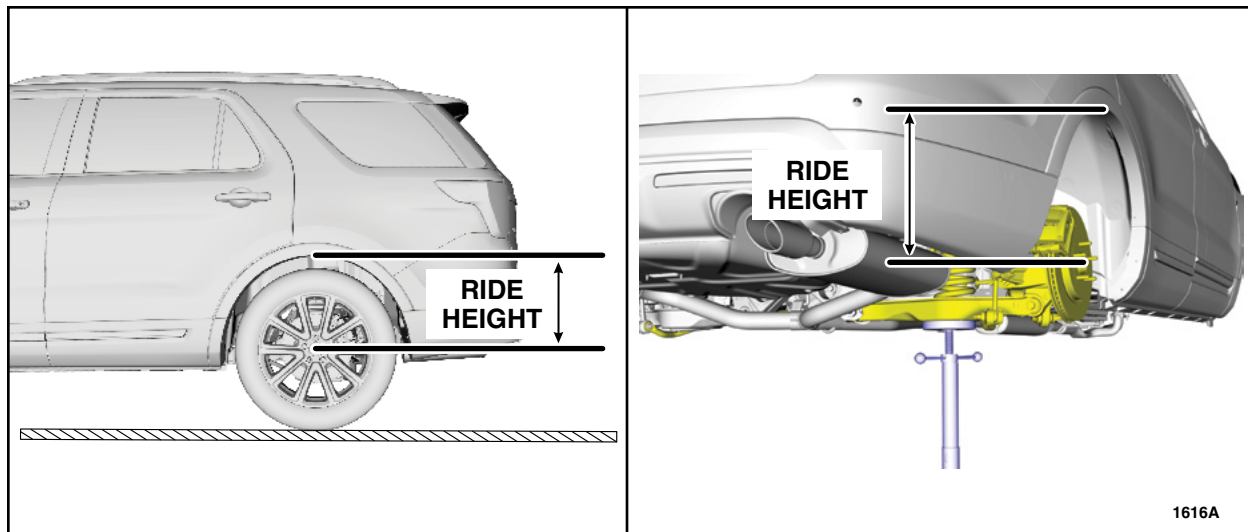
FIGURE 1

1. Measure the distance from the center of the wheel hub to the lip of the fender with the vehicle in a level, static ground position (ride height) before disassembly. See Figure 1.

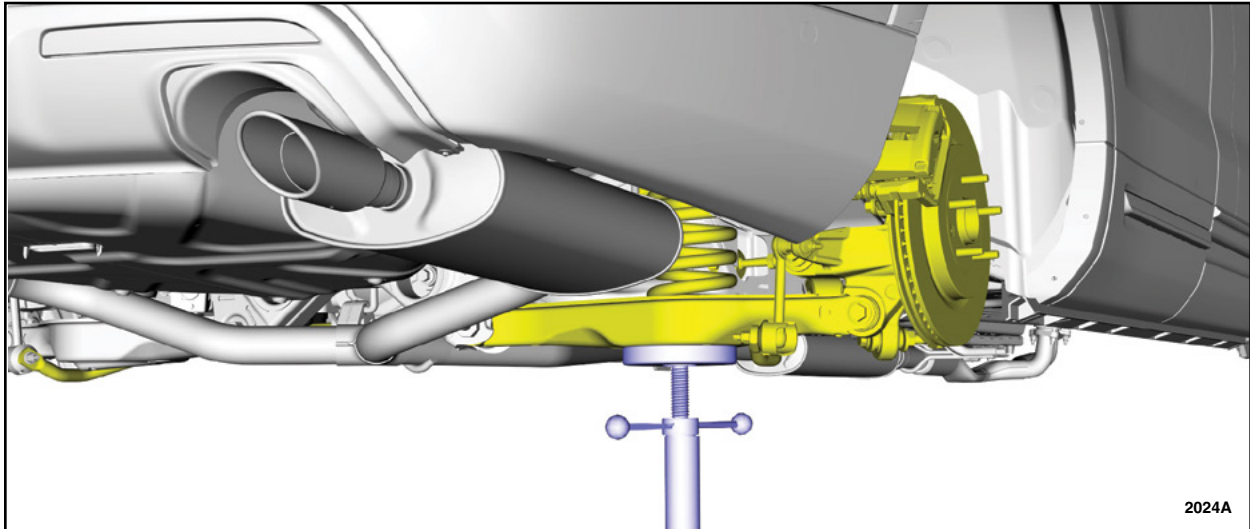
FIGURE 2

2. Position the vehicle on a hoist. Please follow the WSM procedures in Section 100-02.
3. Remove both rear tires. Please follow the WSM procedures in Section 204-04A.
4. Using a jack stand, support the rear suspension to ride height. See Figure 2.

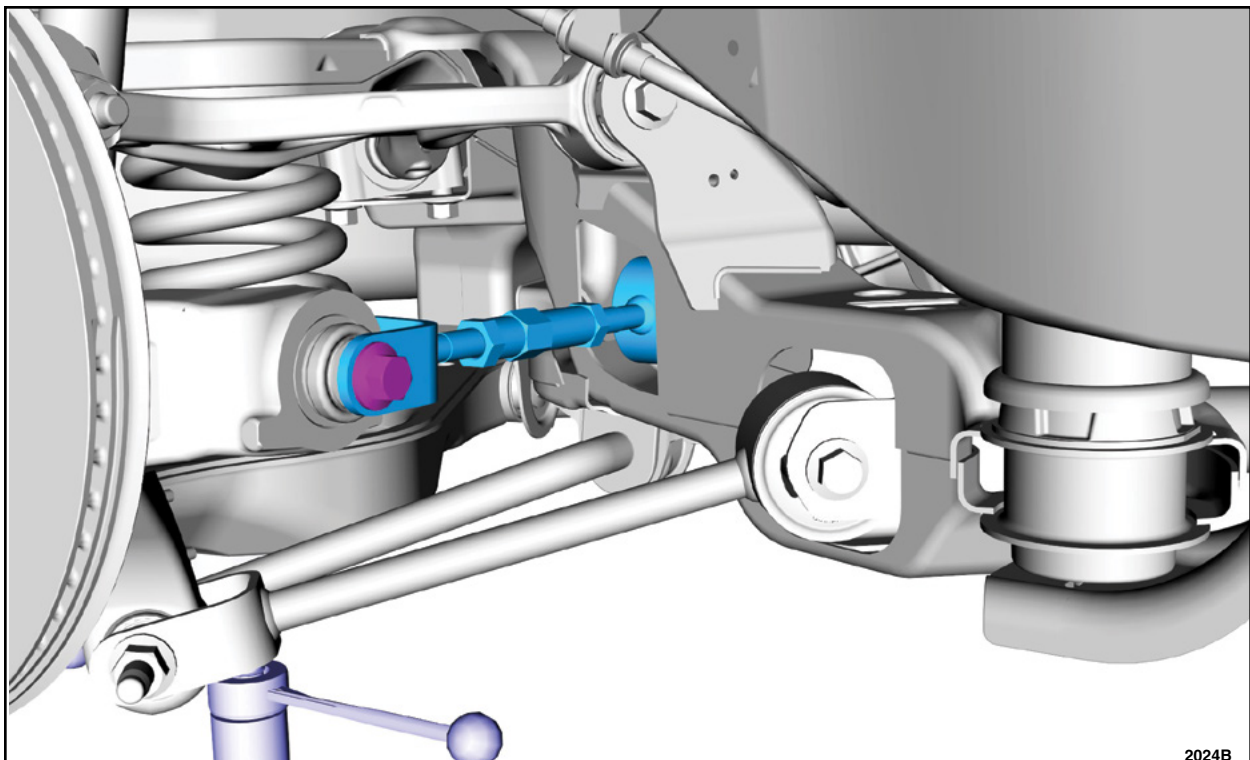
FIGURE 3

5. Remove the toe link-to-wheel knuckle bolt and nut. See Figure 3.

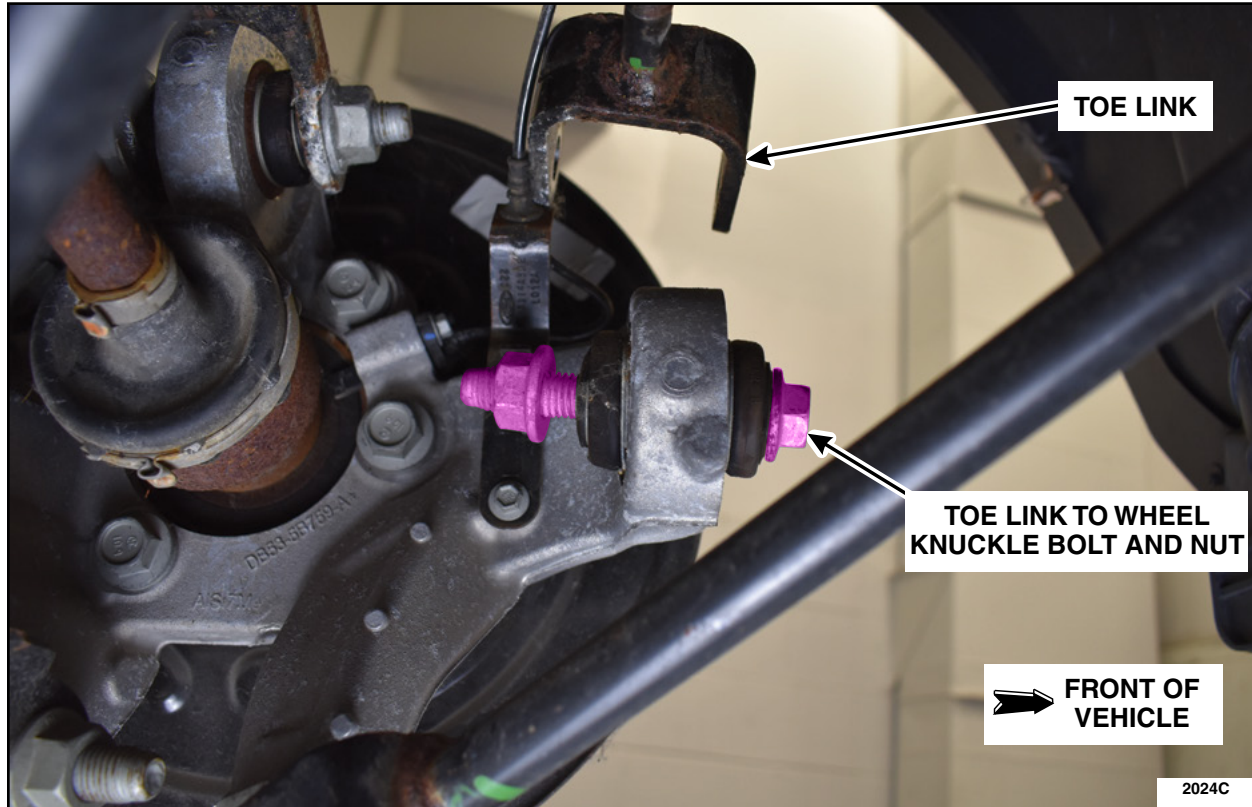
FIGURE 4

6. Install the toe link to knuckle bolt and nut. Tighten the nut while holding the bolt still with a wrench.
See Figure 4.

- Torque: 111 lb.ft (150 Nm).

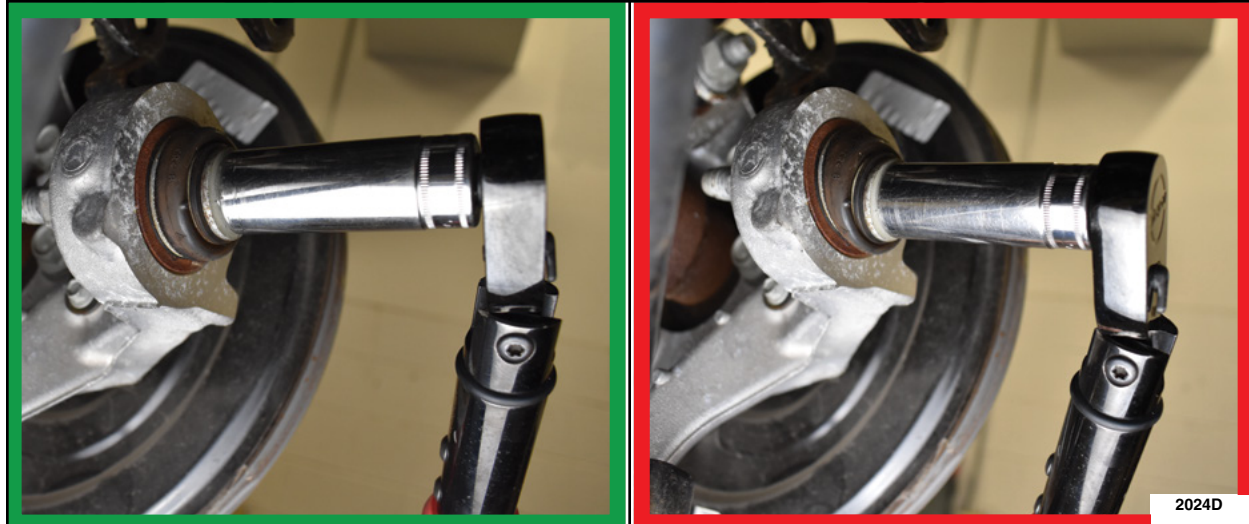
FIGURE 5

7. Using a digital or dial type torque wrench, rotate the toe link to wheel knuckle bolt while keeping the ball joint straight. Do not allow the ball joint to twist as shown in the red picture below. Note the reading off of the torque wrench when the ball joint begins to rotate. See Figure 5.

9. Are the readings over 11 lb. ft (15 Nm)?

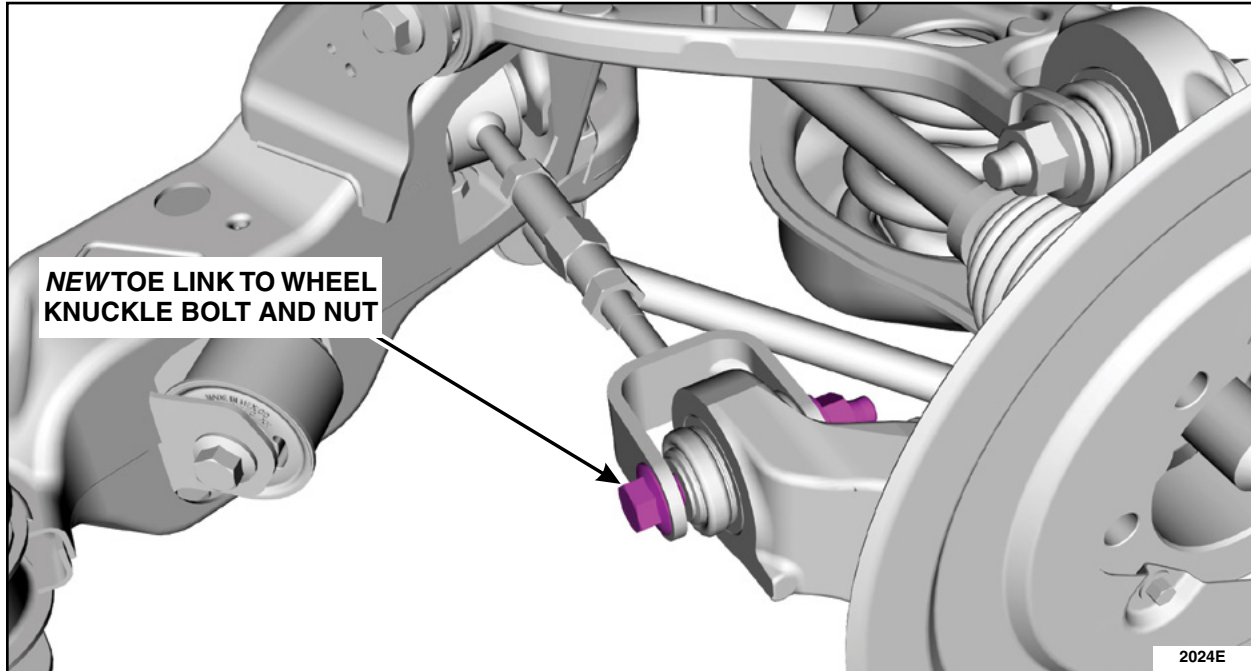
FIGURE 6

10. Install the *new* toe link to wheel knuckle bolt and nut with the vehicle suspension at ride height.
See Figure 6.

- Torque: 111 lb.ft (150 Nm).

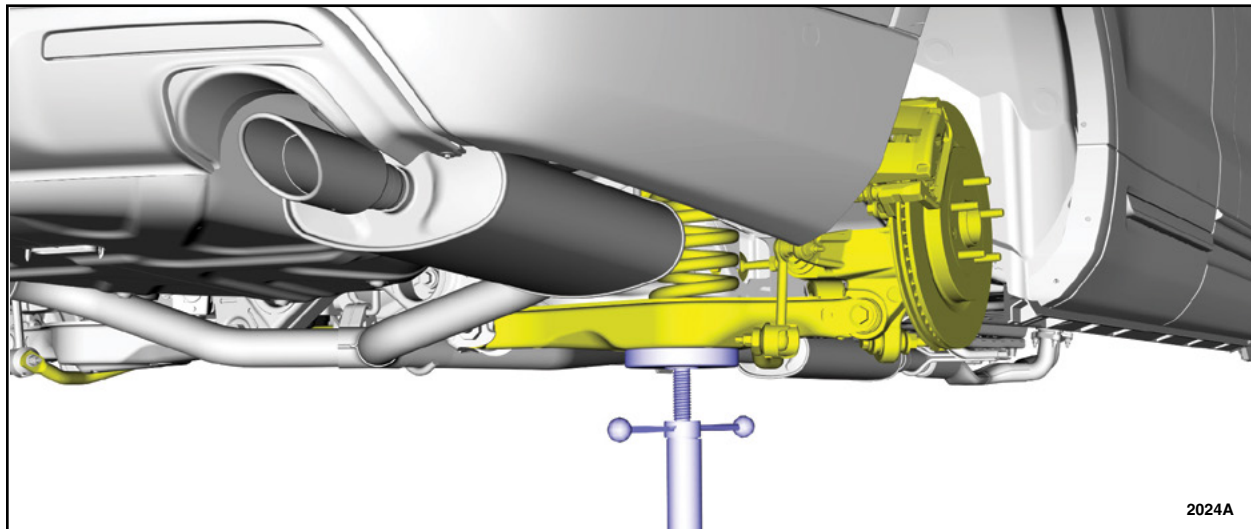
FIGURE 7

11. Remove the jack stand. See Figure 7.

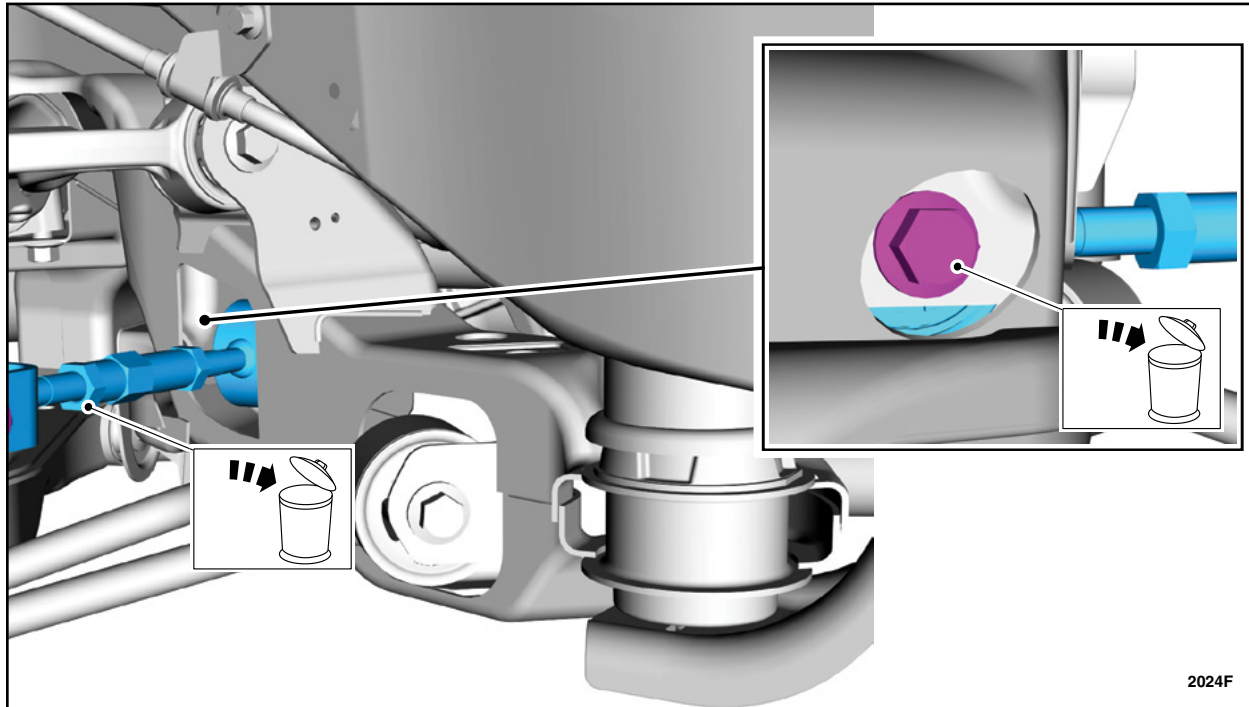
FIGURE 8

13. Remove and discard the toe link to subframe bolt and the toe link. See Figure 8.
