N202319030 Tires Overcured

Release Date: August 2021 Revision: 03

Condition	General Motors has decided that a defect which relates to motor vehicle safety exists in certain Continental tires installed as original equipment on certain 2020 model year Buick Enclave, Cadillac XT5, Chevrolet Traverse, and GMC Acadia, and 2020-2021 model year Chevrolet Silverado and GMC Sierra vehicles. According to the tire manufacturer, Continental Tires the Americas (CTA), the affected tires may have an overcure condition and CTA has initiated a safety recall for these tires. According to CTA, overcured tires may experience a carcass break in the sidewall with sudden air loss or could develop a belt edge separation which could lead to partial or full tread/belt loss. These conditions may increase the risk of a crash.
Correction	Dealers will inspect vehicles and replace tires that have DOT number and production mold number combinations identified by Continental.

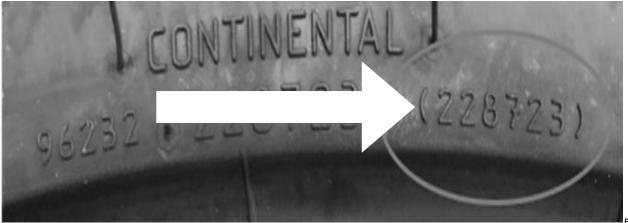
5672012

This procedure involves inspecting the tire sidewall for manufacturing information. The mold number, in parenthesis along with the last four numbers in the DOT stamp (Date Code) indicate if the tire is involved in this recall. See the examples in the photographs below.

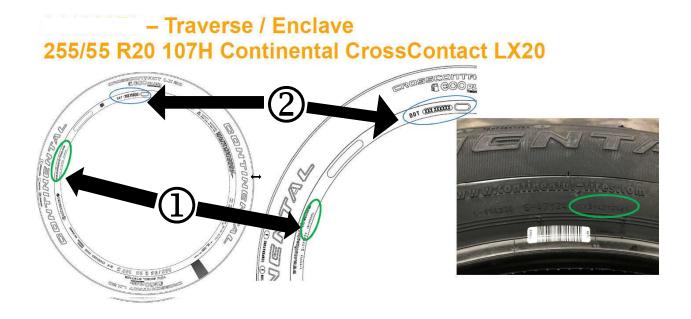
5668968

- 1. Inspect the tire sidewall as shown and verify the mold number (1) and DOT week (2).
- If the mold number and DOT date match the Affected DOT wk(s) Mold # combination in the tire information chart, replace the tire.

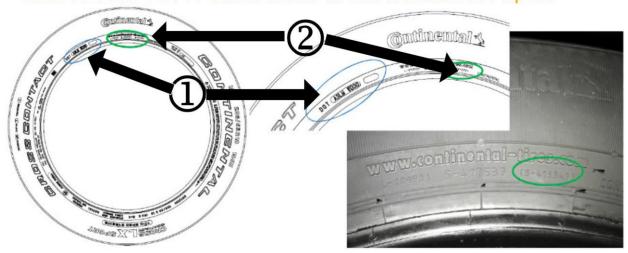
5669524

- 1. Inspect the tire sidewall as shown and verify the mold number (2) and DOT week (1).
- 2. If the mold number and DOT date match the *Affected DOT wk(s) Mold # combination* in the tire information chart, replace the tire.

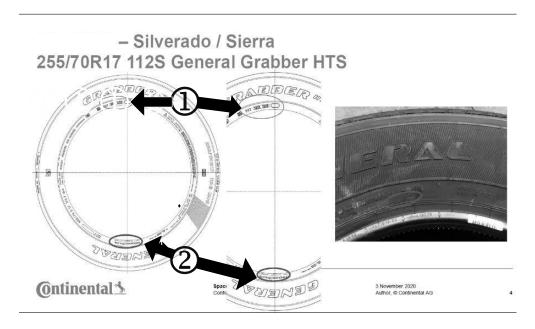
5668974

- 1. Inspect the tire sidewall as shown and verify the mold number (2) and DOT week (1).
- 2. If the mold number and DOT date match the *Affected DOT wk(s) Mold # combination* in the tire information chart, replace the tire.
