N202319030 Tires Overcured

Release Date: December 2020 Revision: 01

Condition	General Motors has decided that a defect which relates to motor vehicle safety exists in certain Continental tires installed as original equipment on certain 2020 model year Buick Enclave, Cadillac XT5, Chevrolet Traverse, and GMC Acadia, and 2020-2021 model year Chevrolet Silverado and GMC Sierra vehicles. According to the tire manufacturer, Continental Tires the Americas (CTA), the affected tires may have an overcure condition and CTA has initiated a safety recall for these tires. According to CTA, overcured tires may experience a carcass break in the sidewall with sudden air loss or could develop a belt edge separation which could lead to partial or full tread/belt loss. These conditions may increase the risk of a crash.
Correction	Dealers will inspect vehicles and replace tires that have DOT number and production mold number combinations identified by Continental.

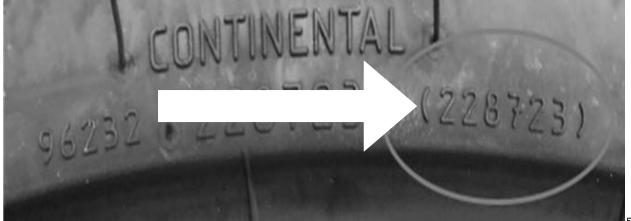
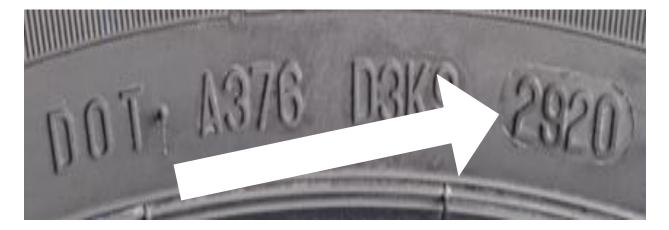
5672012

This procedure involves inspecting the tire sidewall for manufacturing information. The mold number, in parenthesis along with the last four numbers in the DOT stamp (Date Code) indicate if the tire is involved in this recall. See the examples in the photographs below.

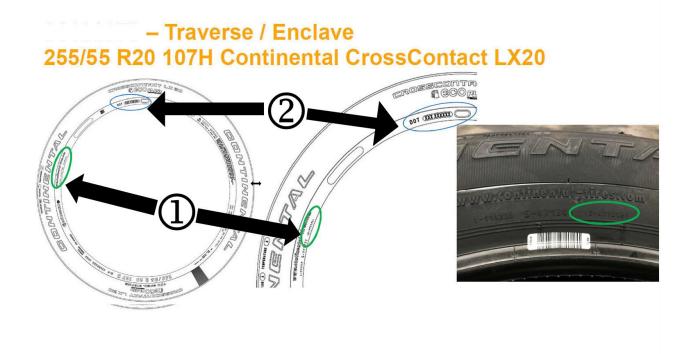
Traverse and Enclave

- 1. Inspect the tire sidewall as shown and verify the mold number (1) and DOT week (2).
- 2. If the mold number and DOT date fall within the *Affected DOT wk(s) Mold # combination* in the tire information chart, replace the tire.

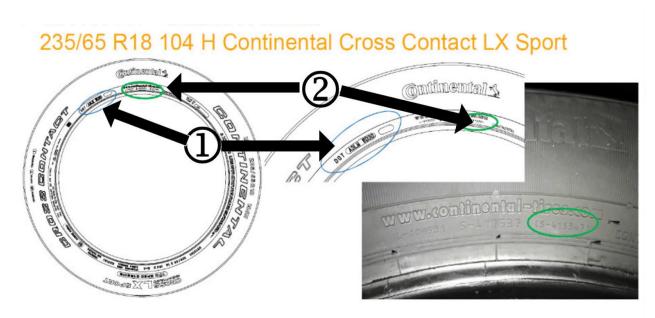
Acadia, XT5

- 1. Inspect the tire sidewall as shown and verify the mold number (2) and DOT week (1).
- If the mold number and DOT date fall within the Affected DOT wk(s) Mold # combination in the tire information chart, replace the tire.

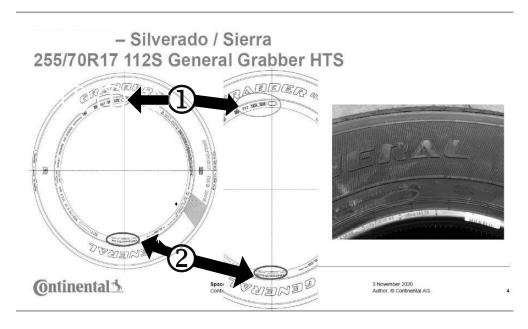
Silverado and Sierra

- 1. Inspect the tire sidewall as shown and verify the mold number (2) and DOT week (1).
- 2. If the mold number and DOT date fall within the **Affected DOT** wk(s) **Mold # combination** in the tire information chart, replace the tire.

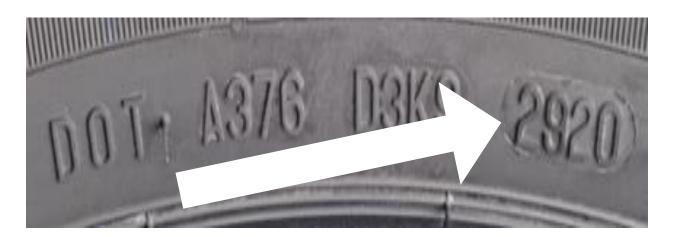
1. Take a picture of the DOT stamp (Date Code).

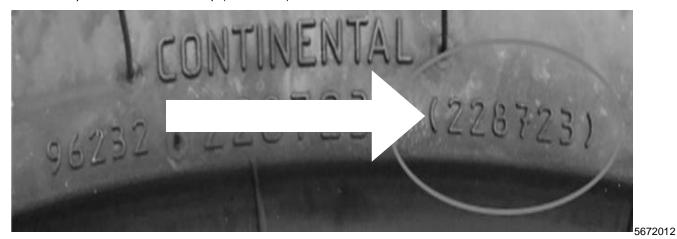
2. Take a picture of the mold number, in parenthesis.
