RECALL 20V688 REMEDY INSTRUCTIONS

Make(s): ROCKPORT
Model(s): RP5A2410290 & RP5A2610290
Model Year(s): 2019

Concern:
The battery box may not be welded adequately to the vehicle and may detach.

Repair Code: 10-20V688
Allotted Time: 1.50 HRS.
Inspection Code: N/A
Allotted Time: N/A
Photo(s) Required: YES
Prior Authorization Required: NO
Part(s) Kit Number: F0200020 (20V688)
Part(s) Return: NO

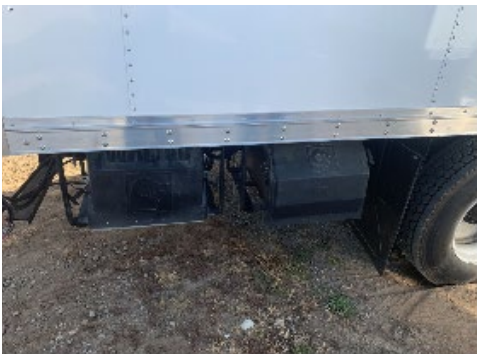
STEP 1: LOCATE THE BATTERY AND PUMP BOX LOCATED ON THE REAR CURBSIDE OF THE TRUCK;
