David J. Johnson  
Director  
Service Engineering Operations  
Ford Customer Service Division

**SUBJECT: Safety Recall 20S63**

Certain Front Wheel Drive 2014-2015 Model Year Taurus, 2014-2016 Model Year Explorer, and 2014 Model Year Edge Vehicles Equipped with a 2.0L or 2.3L Engine Front Halfshaft Bracket Replacement

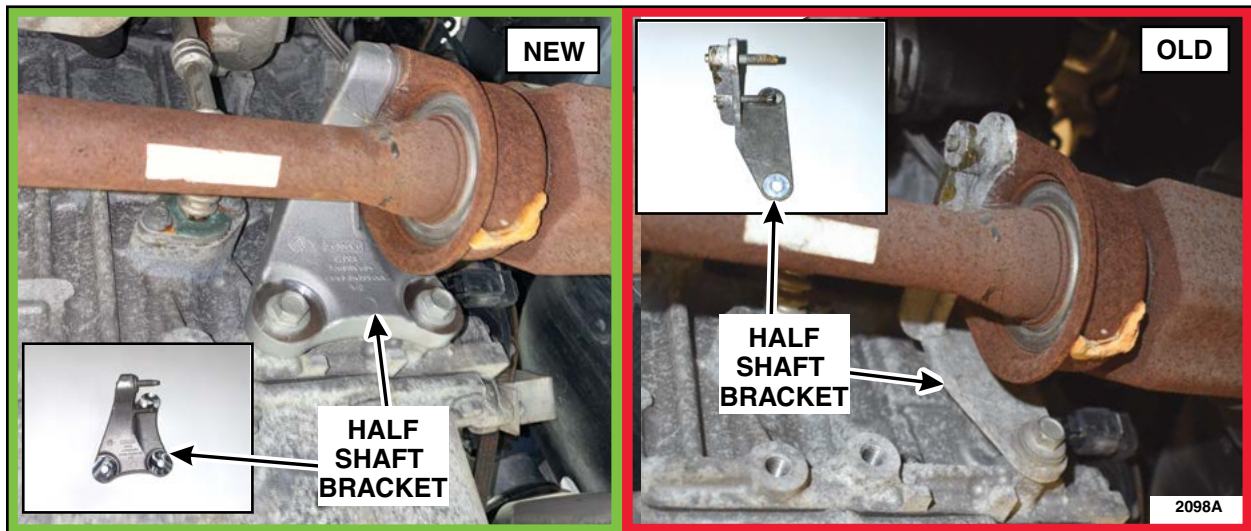
FIGURE 1

**NOTE:** To see the old and *new* half shaft bracket. See Figure 1.

7. Install two (2) *new* half shaft bearing studs into the *new* bracket.

8. Install the *new* RH half shaft bearing bracket and three (3) bolts.
