Keystone RV Company SAFETY ADVISORY # 20-391

Updated: 2/24/21

Outback 335CG and 340BH Frame

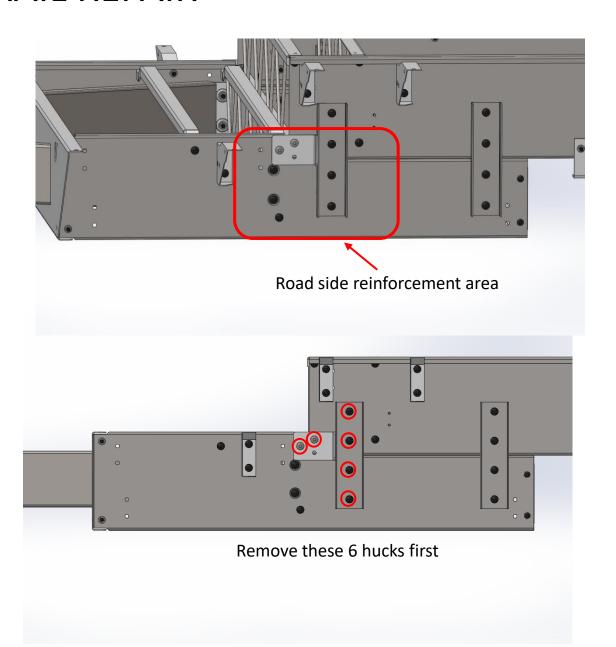
- Identify repair area road side of the frame is shown
- If the area is deformed, a reinforcement plate should be installed.
- If the area is deformed and cracked, the drop rail should be replaced, and reinforcement plates installed.
- Using jack stands, support the unit rearward of the repair area to remove load from the tongue jack and a-frame.

The heads of the first 6 hucks can be cut off with a torch, plasma, or grinder from the outside of the frame. The u-channel and L-bracket will be discarded, it is ok if these parts are gouged during removal since they won't be reused. Do not gouge or cut the frame rail behind these parts.

• Carefully remove the last huck without gouging or cutting the frame rail. Torching or plasma cutting in this area is not recommended. Either grind the head off or use a 3/8" drill bit to drill the center of the head until it comes off.

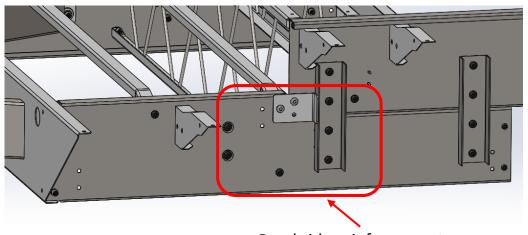
Road side reinforcement area

- Identify repair area road side of the frame is shown
- Support the front of the frame on the tongue jack and front leveling legs or jack stands rearward of the repair area.

• The heads of the first 6 hucks can be cut off with a torch, plasma, or grinder from the outside of the frame. The u-channel and L-bracket will be discarded, it is ok if these parts are gouged during removal since they won't be reused. Do not gouge or cut the frame rail behind these parts.

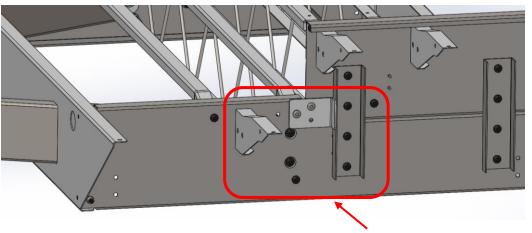
Road side reinforcement area

- Identify repair area road side of the frame is shown
- If the area is deformed, a reinforcement plate should be installed.
- If the area is deformed and cracked, the drop rail should be replaced, and reinforcement plates installed.
- Using jack stands, support the unit rearward of the repair area to remove load from the tongue jack and a-frame.

- Repair one side of the frame at a time so the a-frame doesn't need to be removed.
- The heads of the circled hucks can be cut off with a torch, plasma, or grinder from the outside of the frame. The front u-channel and L-bracket will be discarded, it is ok if these parts are gouged during removal since they won't be reused.
