Keystone RV Company

11/25/20

SAFETY ADVISORY # 20-391

Outback 335CG and 340BH Frame

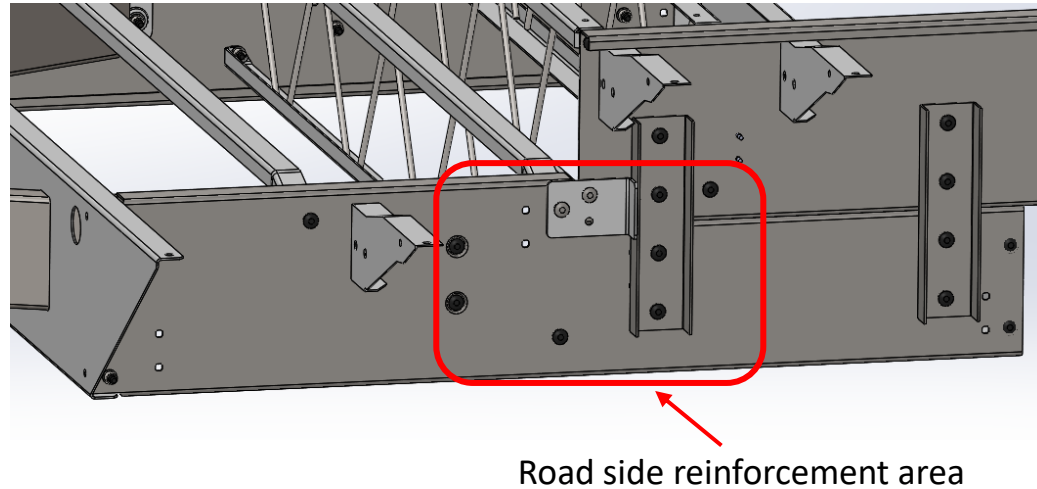
Road side reinforcement area

- Identify repair area – road side of the frame is shown
- Support the front of the frame on the tongue jack and front leveling legs or jack stands rearward of the repair area.

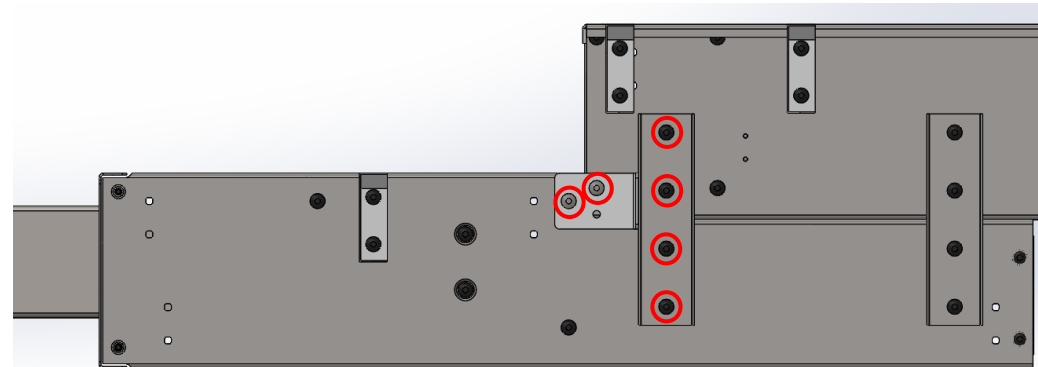
Remove these 6 hucks first

- The heads of the first 6 hucks can be cut off with a torch, plasma, or grinder from the outside of the frame. The u-channel and L-bracket will be discarded, it is ok if these parts are gouged during removal since they won't be reused. Do not gouge or cut the frame rail behind these parts.

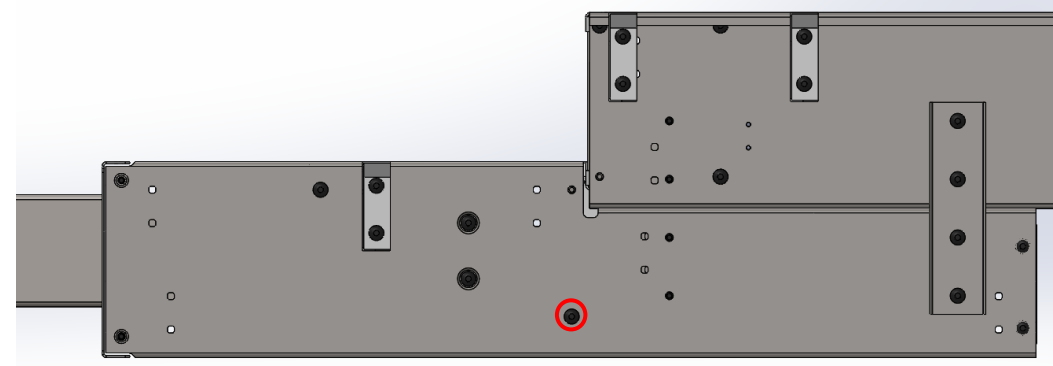
Carefully remove this huck without causing damage to frame rail

- Carefully remove the last huck without gouging or cutting the frame rail. Torching or plasma cutting in this area is not recommended. Either grind the head off or use a 3/8" drill bit to drill the center of the head until it comes off.
