David J. Johnson
 Director
 Service Engineering Operations
 Ford Customer Service Division

January 20, 2021

SUBJECT: **NEW VEHICLE DEMONSTRATION / DELIVERY HOLD**
Safety Recall 20S69 – Supplement #1
 Certain 2021 Model Year Aviator Vehicles
 Front Wheel Knuckle Inspection

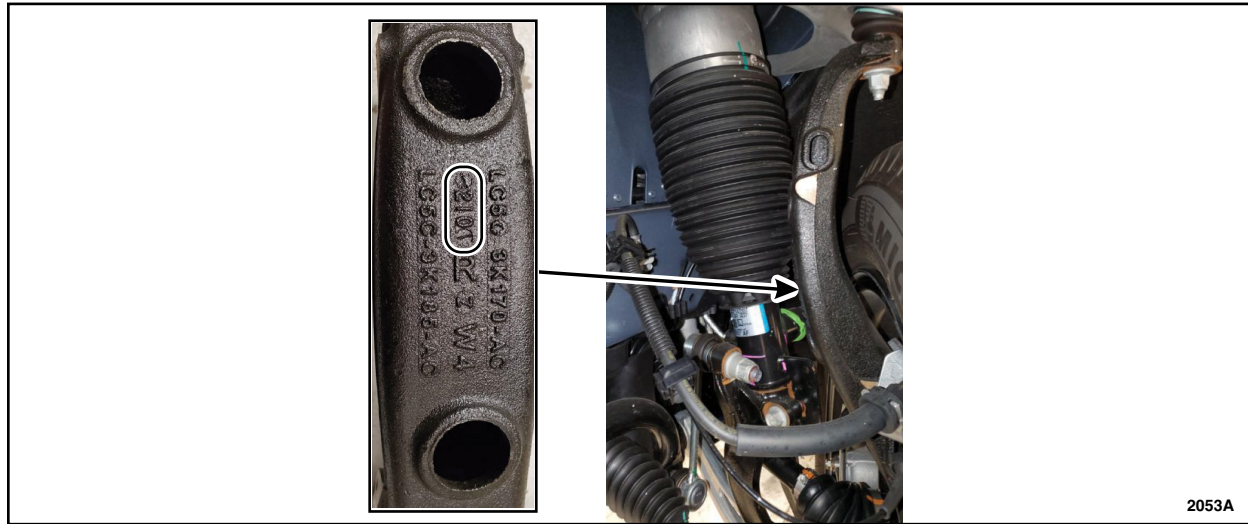
FIGURE 1

1. Turn the steering wheel to the full left position. Inspect and record the left hand wheel knuckle manufacturing date code. See Figure 1.

3. Is the date code for the LH side knuckle 298?

4. Is the date code for the RH side knuckle 296 **OR** 297?

Yes – Does not pass inspection, replace the wheel knuckle. Proceed to steps 4 and 5.
No – Passes inspection, replacement not required. Proceed to step 4.

Yes – Does not pass inspection, replace the wheel knuckle. Proceed to step 5.
No – Passes inspection, replacement not required. This recall is complete.

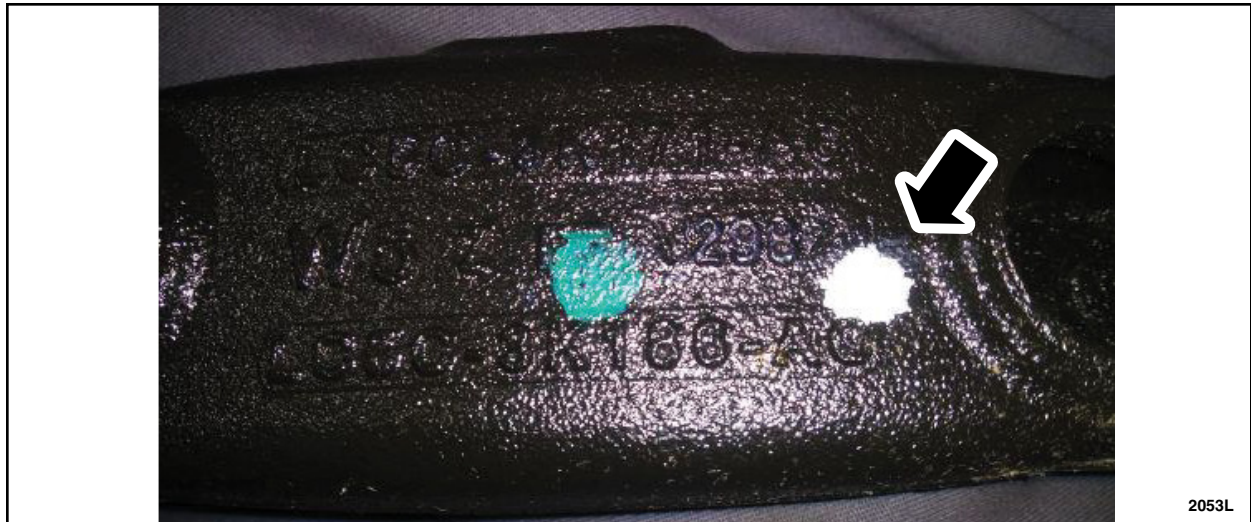
FIGURE 2

Note: There are several wheel knuckles in the parts distribution system with a suspect date code. Parts with the suspect date code AND a white paint dot near the date code are approved for installation. See Part Inspection procedure in the Service Instructions.

6. *Does the new replacement knuckle(s) have a white dot on it? See Figure 2.*

*Yes – Passes inspection, replace the wheel knuckle. Proceed to step 7.
No – Does not pass inspection. Contact SSSC for a new replacement knuckle.*
