**SUBJECT: NEW VEHICLE DEMONSTRATION / DELIVERY HOLD  
Safety Recall 20S69  
Certain 2021 Model Year Aviator Vehicles  
Front Wheel Knuckle Inspection**

**NEW VEHICLE DEMONSTRATION / DELIVERY HOLD**  
**Safety Recall 20S69**  
Certain 2021 Model Year Aviator Vehicles  
Front Wheel Knuckle Inspection

## CERTAIN 2021 MODEL YEAR AVIATOR VEHICLES — FRONT KNUCKLE INSPECTION

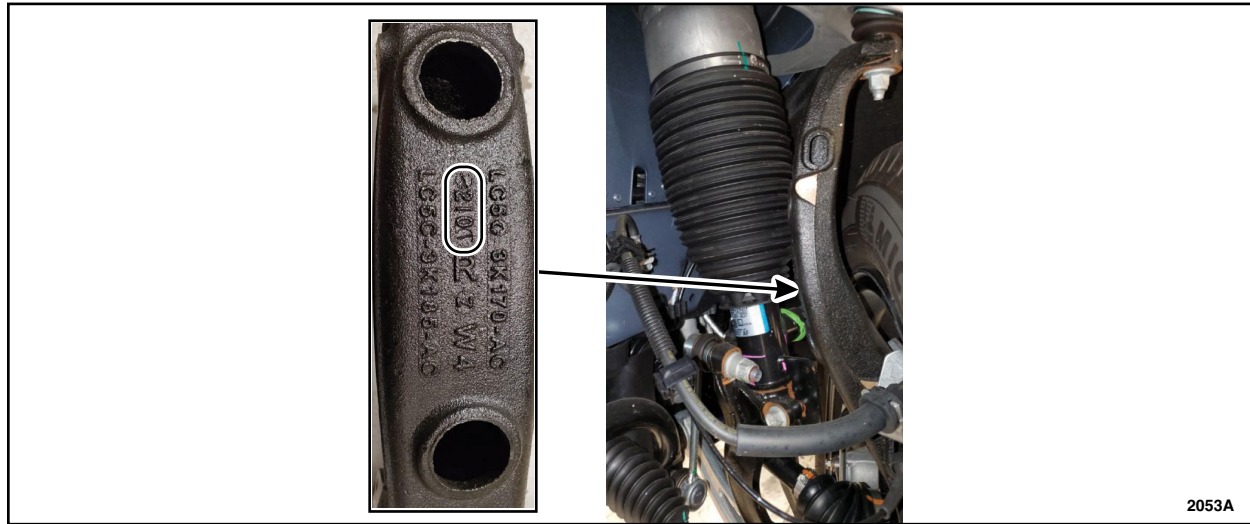
FIGURE 1

1. Turn the steering wheel to the full left position. Inspect and record the left hand wheel knuckle manufacturing date code. See Figure 1.

2. Turn the steering wheel to the full right position. Inspect and record the right hand wheel knuckle manufacturing date code.
3. Is the date code for the LH side knuckle 298?

Yes – Does not pass inspection, replace the wheel knuckle. Proceed to steps 4 and 5.  
No – Passes inspection, replacement not required. Proceed to step 4.
4. Is the date code for the RH side knuckle 296 **OR** 297?

Yes – Does not pass inspection, replace the wheel knuckle. Proceed to step 5.  
No – Passes inspection, replacement not required. This recall is complete.
5. Remove the front wheel bearing and wheel hub. Please follow the Workshop Manual (WSM) procedures in Section 204-01A for RWD vehicles and Section 204-01B for AWD vehicles.
6. Separate the outer tie-rod end from the wheel knuckle. See Figure 2.
  1. Remove and discard the tie rod end nut.  
Torque: 52 lb.ft (70 Nm)
  2. Separate the tie rod end from the wheel knuckle.  
Use the General Equipment: Tie Rod End Remover
