SAFETY RECALL BULLETIN

| SUBJECT: | | | No: | SR-20-005REV2 |
| PARKING BRAKE CALIPER – SAFETY RECALL | | | DATE: | May 2021 |

Certain 2016 Outlander vehicles
Certain 2016 Outlander Sport/RVR vehicles

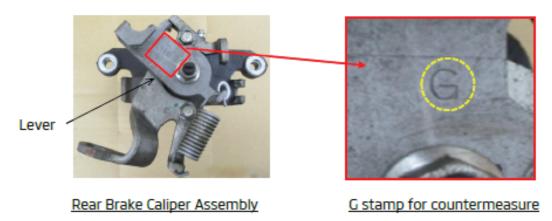
Inspect whether 'G" letter for countermeasure identification is stamped near the caliper lever nut at both left and right sides. If no 'G" letter is stamped as indicated below, go to item 3 for part replacement.
