GROUP
Safety Recall Campaign

NUMBER
SC200** (Rev 1, 04/16/2021)

**SUBJECT: ENGINE BCT / OIL & FUEL LEAK INSPECTION
AND SOFTWARE INSPECTION (SC200**)**

This bulletin provides the procedure to 1) perform the Bearing Clearance Test (BCT) and 2) inspect the engine compartment for engine oil and/or fuel leaks and 3) make any necessary repairs, including engine replacement, if necessary, on the vehicles listed in the table below. Carefully follow the flowchart on page 2 for detailed instructions of the inspection procedures. In addition, check to confirm the vehicle has the latest KSDS software installed in the ECU and if necessary, apply the improved logic described in this bulletin on page 2. Before conducting the procedure, verify that the vehicle is included in the list of affected VINs.

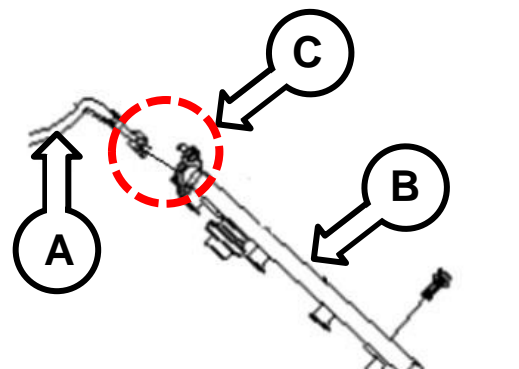
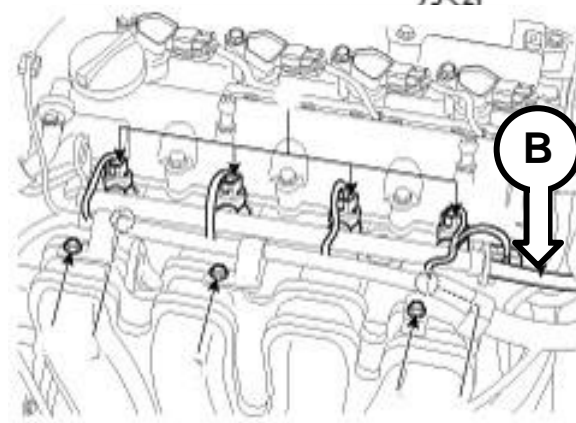
NG: Fuel Leakage	OK: No Leakage

1. Open the hood and remove the engine cover.
2. Inspect for fuel leakage according to the steps below.
 - 2a. Start the engine 'ON'.
 - 2b. Press gas pedal to the floor for 5 seconds, repeat 3 times. Then follow the steps below (2c, 2d) maintaining a steady idling condition.
 - 2c. **Theta 2.4L MPI Engine**
(XMa, SL, TD, TF HEV):
 - Inspect the fuel feed line (A) and delivery pipe (B) connection (C) for fuel leaks using one sheet of test paper (see diagram below).
 - If fuel leakage is found, refer to KGIS for the fuel line connector torque specification to retighten.
 - If fuel is still leaking, open a Techline case online.
 - If no leak is found, proceed to oil pan leak inspection, step 3.

Never release a vehicle to a customer with a fuel leak. If any leak(s) are found that cannot be corrected, as outlined in this bulletin, please open a Techline Case Online.

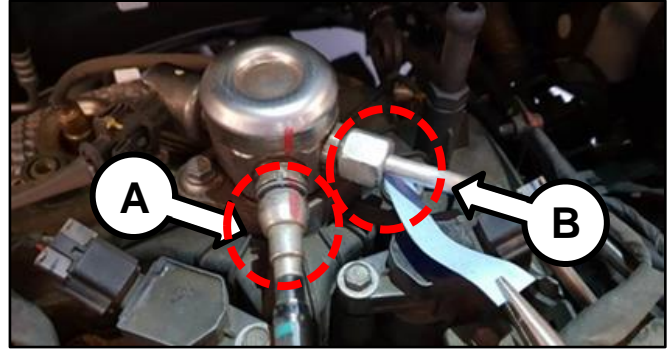
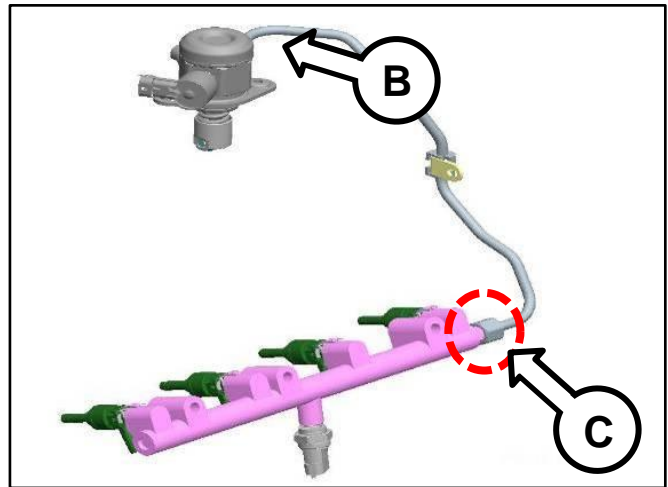
NG: Fuel Leakage	OK: No Leakage

- Inspect the low pressure line (A) and the two (2) high pressure fuel line connections (B) & (C) for fuel leak(s) using an oil test paper (see diagram below).
- If a fuel leak is found, **replace** the affected fuel line and/or pipe by referring to the “Engine Control/Fuel System → Fuel Delivery System → Delivery Pipe → Repair procedures” chapter in the applicable shop manual. Ensure the removed part cannot be reused.
- If **no leak** is found, proceed to oil pan leak inspection, step 3.

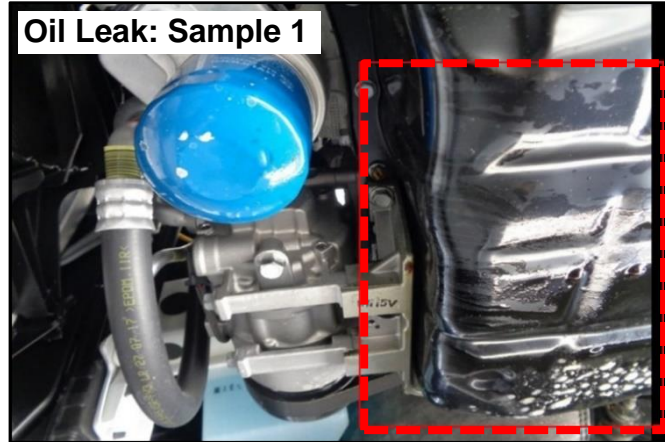
- 4a. Visually inspect for oil leaking from the oil pan seal area.
- 4b. **If oil leakage is found**, (refer to sample images shown), replace the oil pan by referring to the “Engine Mechanical System → Lubrication System → Oil Pan → Repair procedures” chapter in the applicable Shop Manual on KGIS.
- 4c. Open a Techline case and submit PWA.

For this Oil Leak Inspection, replace Oil Pan **ONLY** with a PWA's confirmation of an apparent visible oil pan leak.

- Be sure to tighten bolts to specifications found on KGIS **within 5 minutes** of sealant application.
- Wait at least 30 minutes after assembling the oil pan, to allow sealant to dry completely and refill engine oil.
