# RECALL CAMPAIGN BULLETIN

Classification: EC20-029	Reference: NTB20-089	Date: December 8, 2020
-----------------------------	-------------------------	---------------------------

## VOLUNTARY SAFETY RECALL CAMPAIGN 2020 TITAN AND TITAN XD; EGI HARNESS

**CAMPAIGN ID #:** PC773  
**APPLIED VEHICLES:** 2020 Titan and Titan XD (A61)  
**APPLIED ENGINE:** VK56VD (Gasoline V8)

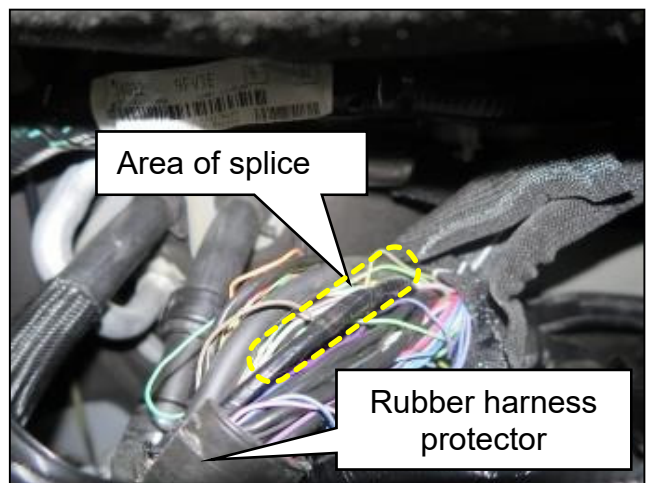
Figure 17

- Locate the affected splice within the transmission power supply wire.

- The splice will be located near the large harness retaining clip.
- The splice can be located by feeling for a raised section on the wire.

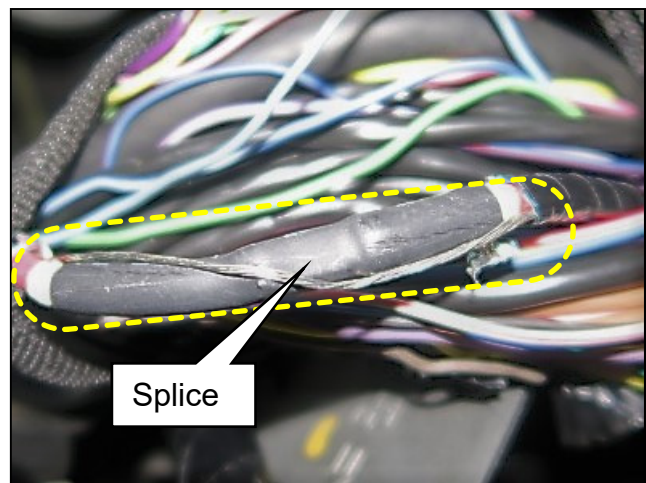
Figure 19

18. Carefully remove the blue aluminum-shielding tape from the harness to expose the splice.
  - The entire splice and part of the red wire insulation MUST be exposed.
