SIB 12 12 20

RECALL 20V-761: CHECK 48 V CABLE CONNECTIONS TO THE STARTER GENERATOR (SGR)

This Service Information Bulletin (Revision 2) replaces SI B12 12 20 **dated December 2020**.

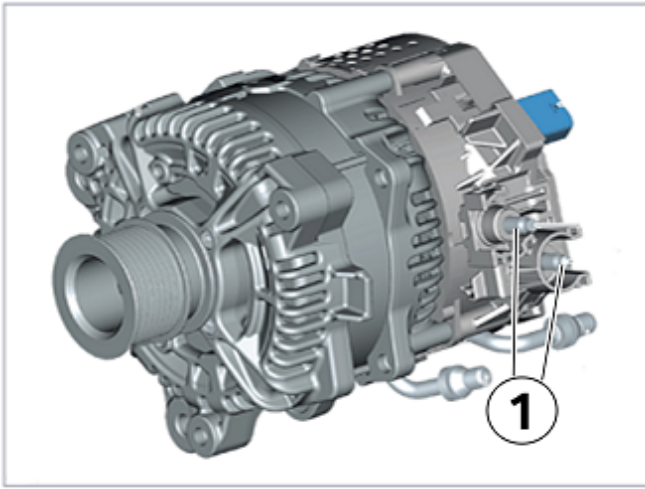
The 48-Volt battery cable connections to the starter / generator (SGR) may not have been assembled to specifications. Over time, this could lead to increased resistance at the connection(s) and, in rare cases, a thermal event.

Check the positive (1) and negative (2) cables for play at the mounting lugs on the SGR.

- Deactivate the 48 V electrical system (Repair instruction REP-TAT-P-6124-18-B47_48V)
- Remove and discard the flange nut on the B+ or B- cable.
- Install a new flange nut so that it’s carefully started by hand to avoid cross-threading
- Torque to 19 Nm
