Subarunet Announcement

DATE: January 5, 2021

SUBJECT: Recall WRH-20 / WRI-20 Denso Gen 4 CP1 software update. Critical points to avoiding unnecessary hardware replacement

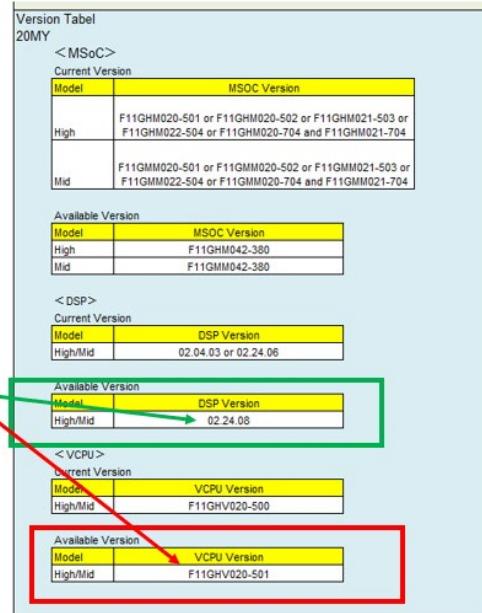
3. Software corrupted following the update

In some rare cases, there may be a loss of the audio output or CID malfunction following the software update. This condition may or may not be accompanied with an error message(s) other than the "Software update setup is initializing..." or "Software update Incomplete". Should this occur, go to the "Version Information" screen following **WRH-20, WRI-20** and **TSB 15-261-20R** and confirm "MSOC" version, "V-CPU" version, "RAD_SW" version and "DSP_FW" version. See below for an example of failed software update showing incorrect data for "V-CPU" version and "DSP_FW" version.

If the version displayed for MSoC is incorrect or there is no "RAD_SW" version and "DSP_FW" version displayed or asterisk symbols (****) are shown, the software was corrupted during the software update. Should this occur, **NEVER use the same USB drive for another update without reformatting it and loading a new set of the update files as outlined in the related service bulletin.**

Please note it is still possible to recover CCU state by performing another software update, if "V-CPU" version is wrong and "DSP_FW" version doesn't show as "****". CCU recovery is successful, as long as you get "Software update setup is initializing..." message during next attempt to update the software. Otherwise the condition is not recoverable and will require Cockpit Control Unit (CCU) replacement.
