Service Bulletin

20-122

December 11, 2020 Version 1

Safety Recall: 2002-06 CR-V Driver's Power Window Switch (Only VINs that start with SHS)

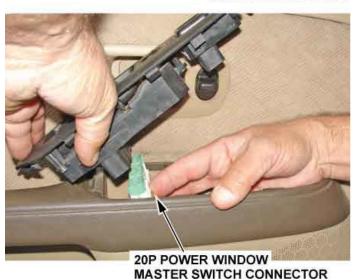
- 3. Disconnect the two connectors from the driver's power window master switch. Inspect the 20-pin power window master switch connector for any damage.
 - If no damage is found on the harness connector, go to REPAIR PROCEDURE A on page 4.
 - If there is damage found on the harness connector, go to REPAIR PROCEDURE B on page 5.

- REPAIR PROCEDURE A: Replace the driver's power window master switch.
- REPAIR PROCEDURE B: Replace the driver's power window master switch and the driver's door wire harness.
