RE: **Recall Campaign Launch Notification**
Check Starter Harness
MY18-20 253 (AMG GLC-Class)

Campaign No. 2021010006, March 2021

SUBJECT: **Model GLC-Class (253 platform)**
Model Year 2018
Check Starter Harness

Order No. P-RC-2021010006

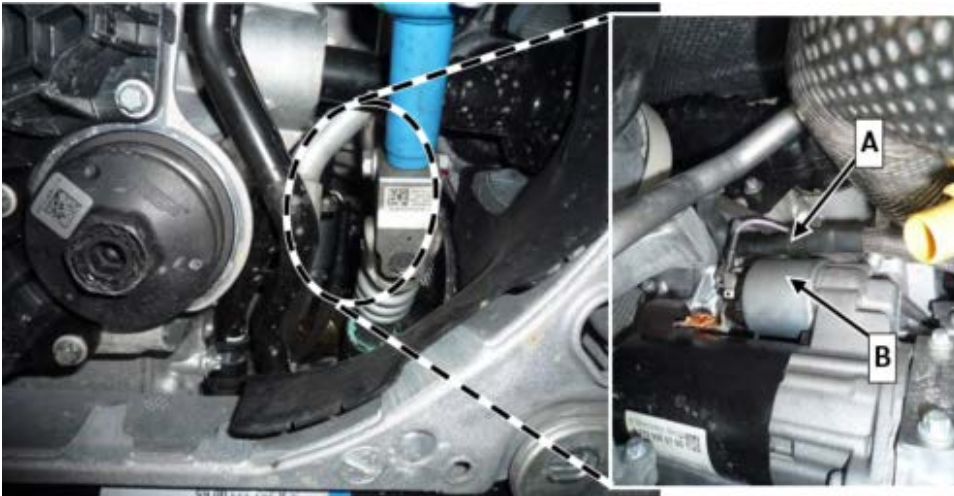
Figure 1

1. Remove lower engine compartment lining (**AR61.20-P-1105LW**).
2. Check circuit 30 starter wiring harness (**A, Figure 1**) at starter.

i The circuit 30 starter wiring harness must **not** be in contact with the solenoid switch (B) of the starter as in Figure 1.

- a. Circuit 30 starter wiring harness is in contact with starter: Carry out **check/test procedure B**.
- b. Circuit 30 starter wiring harness is **not** in contact with starter: **End measure**.

1. Disconnect ground line of battery (**AR54.10-P-0003LW**).
2. Unscrew circuit 30 starter wiring harness at starter and check for damage in area of insulation.

i The insulation must **not** be damaged (any sign of chafing is considered damage). To improve accessibility, remove the quick-release fastener of the steering shaft if necessary.

- a. Insulation of circuit 30 starter wiring harness damaged: Carry out **work procedure**.
 - b. Insulation of circuit 30 starter wiring harness **not** damaged: **End measure**.

i If the insulation is **not** damaged, the circuit 30 starter wiring harness **must** be reinstalled correctly and in such a way that it does not make contact with any surface that may result in chafing, taking the anti-twist lock at the solenoid switch into account.
