SAFETY RECALL

VOLVO Trucks North America

Number RVXX2006 Page 1 (12)

Norgren Collet Inspection/Replacement VAH, VHD, VN

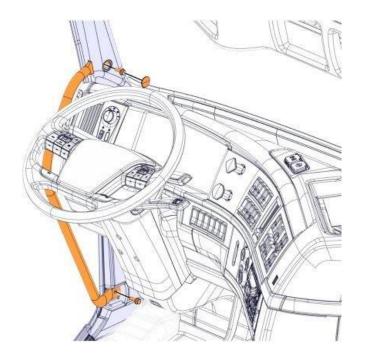
- 1. Remove the screw cover.
- 2. Remove the screws.
- 3. Remove the handle.

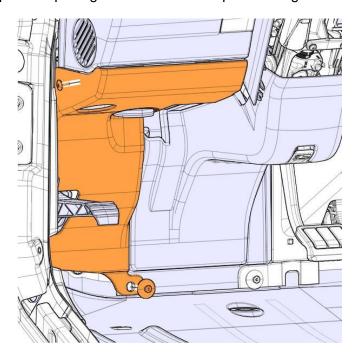
4. Remove the screws.

Note: Pull floor mat back to expose the screw on the lower end.

5. Remove the panel exposing the interior side of pass through.

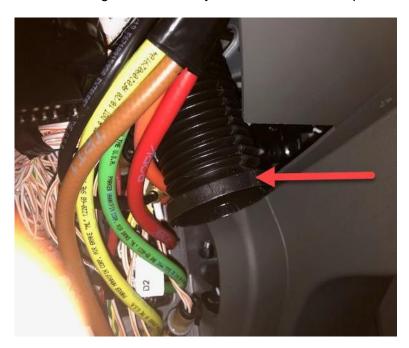
6. Pull the air vent down, moving it out of the way to allow for air line inspection.
