N523NAS1

TECHNICAL BULLETIN

SAFETY RECALL: Aftermarket Seatbelts Incorrect Service Part Number

MODEL:	MODEL YEAR:	VIN:
New Range Rover Evoque (LZ)	2020	001474-075808

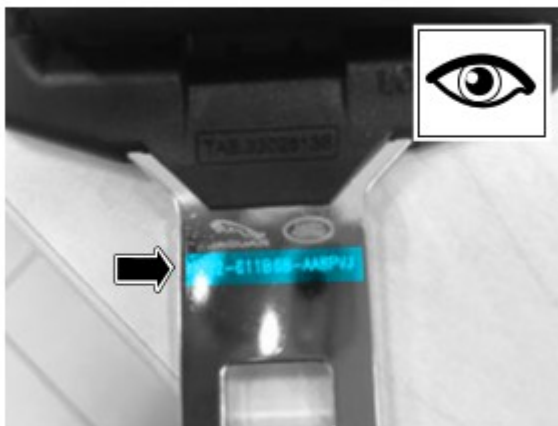
E278393

Inspect the left and right (outboard) second row seatbelts. Inspect, and record on the repair order, the part number shown in the area highlighted in the illustration.

- If both left and right seatbelts **DO** show part number **K8D2 611B68 AA 8PVJ**, no further action is required. Close the door and release the vehicle.
- Any second row seatbelt, left or right, that **DOES NOT** show part number **K8D2 611B68 AA 8PVJ** will require a new seatbelt retractor; go to the Service Instruction.

Renew the second row seatbelt retractor (see TOPIx Workshop Manual section 501-20A: Removal and Installation - Second Row Seatbelt Retractor).
