David J. Johnson
Director
Service Engineering Operations
Ford Customer Service Division

SUBJECT: NEW VEHICLE DEMONSTRATION / DELIVERY HOLD – *Supplement #3*
Safety Recall 20S73

Certain 2021 Model Year Econoline Equipped with 7.3L Engine
Engine Cover Thermal Management

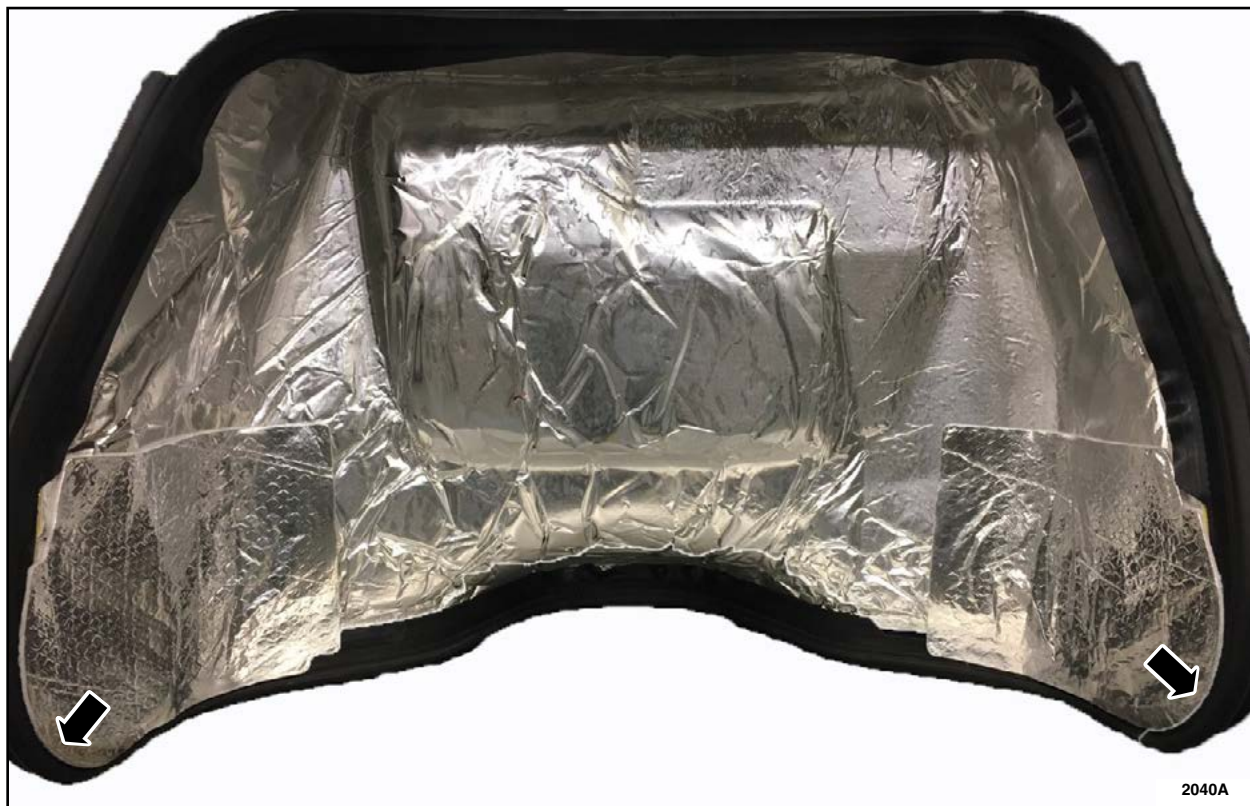
FIGURE 1

1. Reprogram the Powertrain Control Module (PCM) with the latest calibration. Please follow the Module Reprogramming on Page 5. Then, proceed to Step 2, if a Cutaway Chassis.
2. Remove the engine cover. Please follow the Workshop Manual (WSM) procedures in Section 501-05.
3. Inspect the thermal cover positioning on the interior of the engine cover, on the right and left side lower corners, as shown in Figure 1.

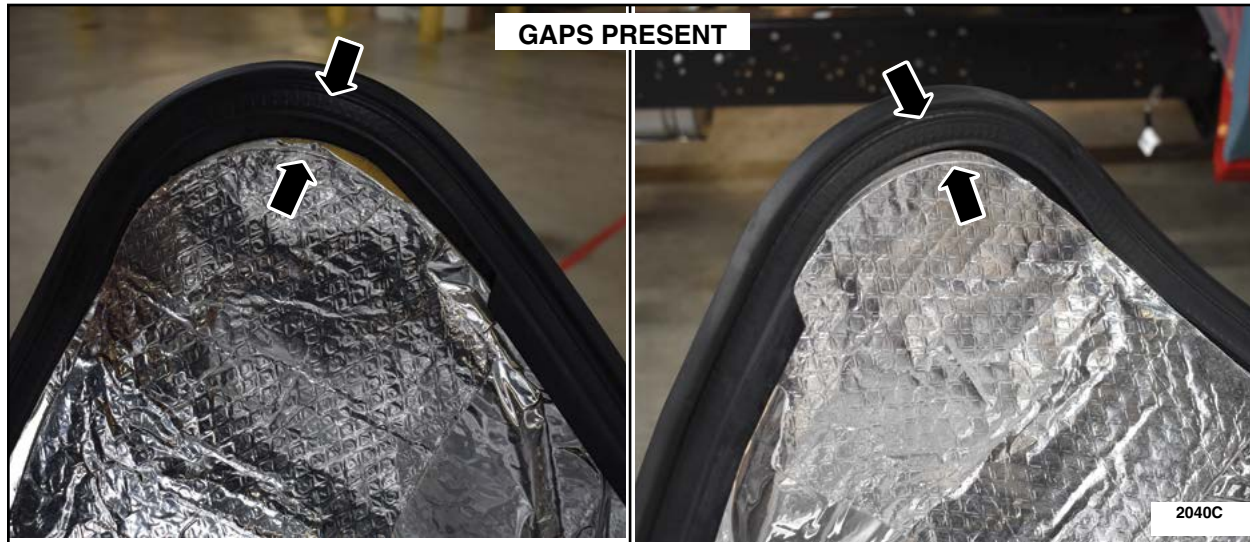
FIGURE 2

4. Are there any gaps present between the thermal shield and the engine covers weatherstrip on either side of the engine cover as shown in Figure 2?

YES - Proceed to the Thermal Patch Kit Installation Procedure.
NO - No further action is required.
