ReplaceRear Axle Brake Calipers

Campaign No. 2021030006, April 2021

SUBJECT: Model 907 Sprinter, Model Year 2019-2020 Electric Parking Brake Rear Brake Calipers

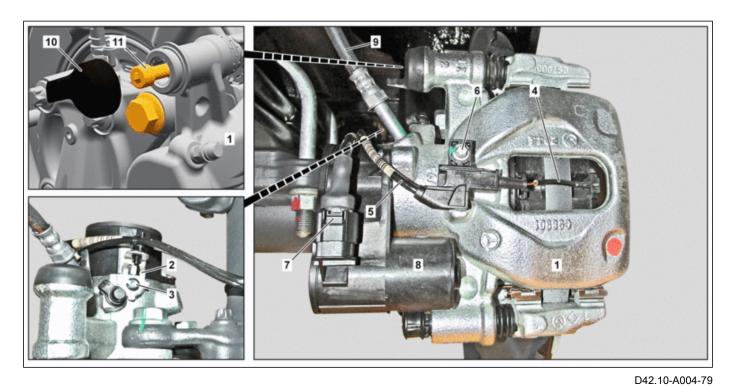
- Brake caliper 1
- 2 Bracket
- 3 Screw
- 4 Electrical wiring harness
- 5 Electrical wiring harness

Actuator motor

6 7 Electrical connector

8

- Screw
- 9 Brake hose 10 Dust cap
- 11 Screw

Replace both rear-axle brake calipers, along with actuator motors of electric parking brake.
