Product Safety Recall

N202322235 Seat Belt May Not Be Properly Attached

Release Date: January 2021

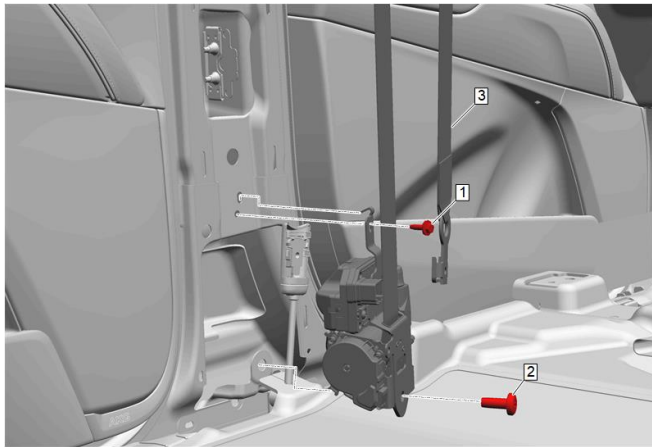
5618244

Service Procedure for First Row Outer Seatbelt Retractor Mounting Bolt (Crew Cab Models)

2. Remove and discard the lower retractor bolt (2).
3. Install the new retractor mounting bolt. Refer to the note above for installation details. Tighten the new service bolt to 45 N.m (33 lb. ft).
4. Reinstall the center pillar lower trim panel. Refer to *Center Pillar Lower Trim Panel Replacement* in SI.

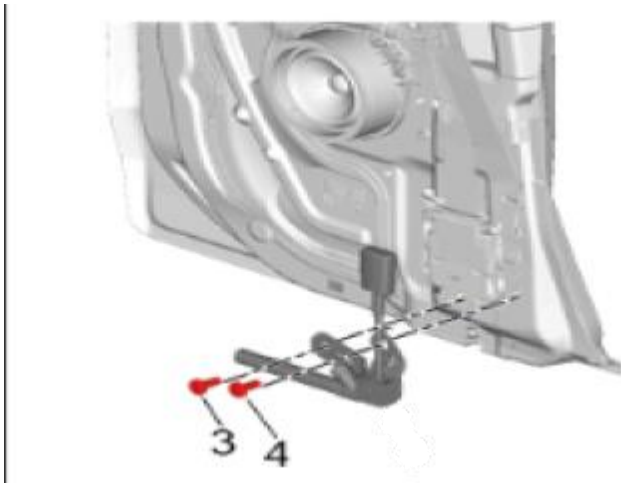
5697062

Service Procedure for First Row Outer Seatbelt Retractor and Pretensioner Mounting Bolt (Extended Cab Models)

2. Remove the seat belt retractor (3) and the seat belt anchor plate (4) mounting bolts. Discard the bolts.
3. Install **TWO** new mounting bolts at the seat belt retractor (3) and the seat belt anchor plate (4) locations. Refer to the note above for installation details. Tighten the new service bolts to 45 N.m (33 lb. ft).

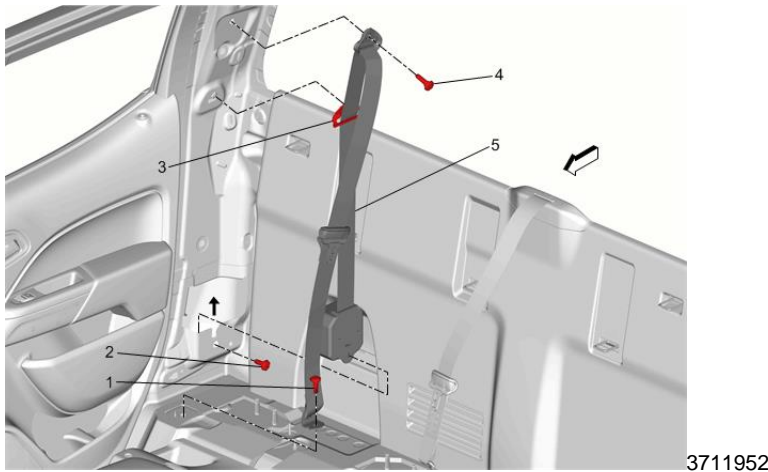
Service Procedure for Second Row Outer Seatbelt Retractor and Seat Belt Anchor Bolt Replacement (Crew Cab Models)

2. Remove the second-row retractor mounting (2) and seat belt anchor (1) bolt. Discard the bolts.
3. Install **TWO** new mounting bolts at the seat belt retractor (2) and the seat belt anchor plate (1) locations. Refer to the note above for installation details. Tighten the new service bolts to 45 N.m (33 lb. ft).
4. Reinstall the body lock pillar garnish molding. Refer to *Body Lock Pillar Garnish Molding Replacement* in SI.

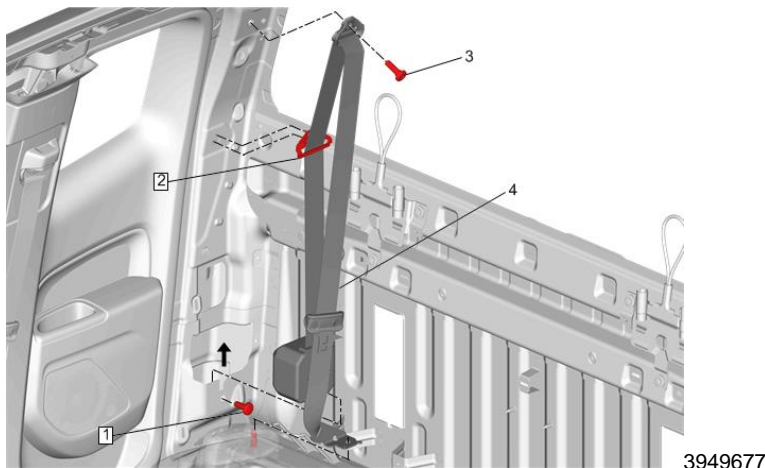
Service Procedure for Second Row Outer Seatbelt Retractor Mounting Bolt Replacement (Extended Cab Models)

2. Remove the second-row retractor mounting (1) bolt. Discard the bolt.
3. Install the new retractor mounting bolt (1). Refer to the note above for installation details. Tighten the new service bolt to 45 N.m (33 lb. ft).
