Product Safety Recall

N202322231 Seat Belt May Not Be Properly Attached

Release Date: January 2021

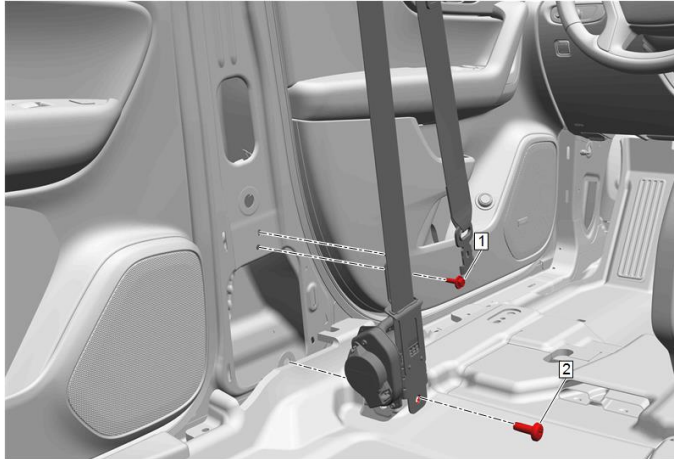
5148395

NOTE: Driver side shown. Passenger side similar.

2. Remove and discard the lower retractor bolt (2).
3. Install the new retractor mounting bolt. Refer to the note above for installation details. Tighten the new service bolt to 45 N.m (33 lb. ft).
4. Reinstall the center pillar lower trim panel. Refer to *Center Pillar Lower Trim Panel Replacement* in SI.
