Product Safety Recall

N202322234 Seat Belt May Not Be Properly Attached

Release Date: January 2021

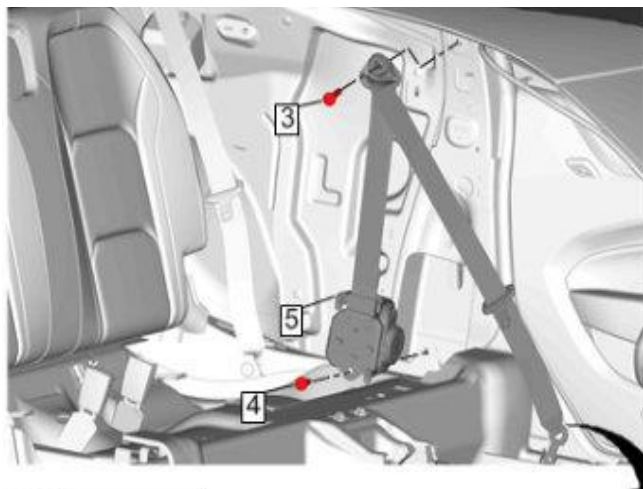
5699168

NOTE: Driver Side Shown, Passenger Side Similar

2. Remove the front seat belt retractor mounting bolt (4). Discard the bolt.
3. Install the new seat belt retractor mounting bolt (4). Refer to the note above for installation details. Tighten the new service bolt to 45 N.m (33 lb. ft).
4. Reinstall the left quarter lower rear trim panel. Refer to *Quarter Lower Rear Trim Panel Replacement* in SI. If the rear seat belt anchor mounting bolt requires replacement, perform that procedure before reinstalling the trim panel.
5. Repeat steps 1-4 on the right-side seat belt retractor mounting location.

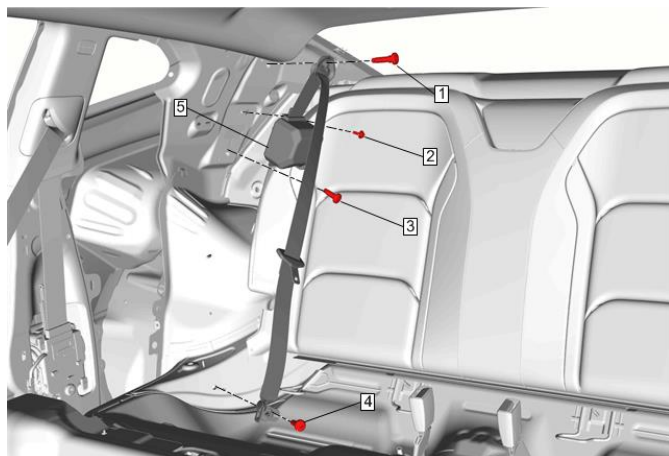
4140498

NOTE: Passenger Side Shown, Driver Side Similar

1. Remove and discard the seat belt anchor bolt (4).
2. Install the new seat belt anchor mounting bolt (4). Refer to the note above for installation details. Tighten the new service bolt to 45 N.m (33 lb. ft).
3. Reinstall the quarter lower rear trim panel. Refer to *Quarter Lower Rear Trim Panel Replacement* in SI.

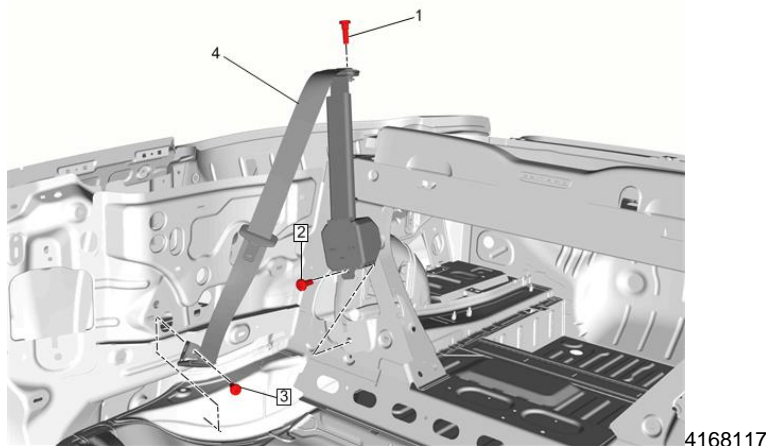
NOTE: Passenger Side Shown, Drive Side Similar

2. Remove and discard the seat belt anchor bolt (3).
3. Install the new seat belt anchor mounting bolt (3). Refer to the note above for installation details. Tighten the new service bolt to 45 N.m (33 lb. ft).
4. Reinstall the quarter lower rear trim panel. Refer to *Lower Rear Trim Panel Replacement* in SI.
