Product Safety Recall

N202322232 Seat Belt May Not Be Properly Attached

Release Date: December 2020

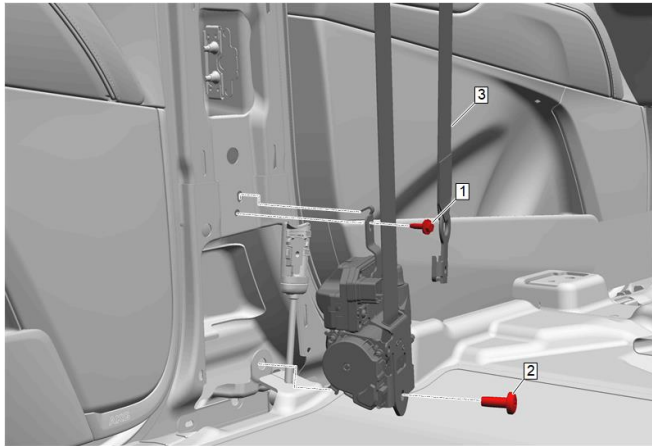
5618244

NOTE: The bolt being removed from the vehicle may not have cut the proper threads in the nut when the vehicle was manufactured. If this occurred, expect to feel resistance for the complete bolt length when removing the bolt. When the new bolt is being installed in an unthreaded nut, there will be resistance as the self-threading bolt threads the nut. There will be an initial resistance while the thread is being cut, followed by a reduction in resistance. This is an expected condition. Continue tightening the bolt until the retractor or belt bracket is secured. To complete the installation, tighten the bolt to the proper torque specification.

1. Remove the center pillar lower trim panel. It is not necessary to disconnect the seat belt from the seat belt anchor plate tensioner. Refer to *Center Pillar Lower Trim Panel Replacement* in SI.

2. Remove and discard the lower retractor bolt (2).
3. Install the new retractor mounting bolt. Refer to the note above for installation details. Tighten the new service bolt to 45 N.m (33 lb. ft).
4. Reinstall the center pillar lower trim panel. Refer to *Center Pillar Lower Trim Panel Replacement* in SI.
