## Methane Detection System Will Not Warn the Operator if the System Loses Power

<b>Title (metadata)</b>	21PBN / 21KWH – LNG/CNG Methane Detection System Will Not Warn Operator if System Loses Power – NHTSA ID: 21V00N, TC: 2021-793
<b>Bulletin No.</b>	21PBN / 21KWH
<b>Description</b>	21PBN / 21KWH – LNG/CNG Methane Detection System Will Not Warn Operator if System Loses Power
<b>Supplier</b>	Peterbilt / Kenworth
<b>Section</b>	Fuel - 44
<b>What's New Abstract</b>	<b>Safety Recall</b> – The methane detection system will not warn the operator if the system loses power. The driver could be unaware of an issue with the methane detection system or excessive methane present, increasing the risk of a fire, crash, or injury.
<b>Revision</b>	
<b>Introduction</b>	On certain LNG and CNG vehicles, the methane detection system may not function as designed. The driver may not be alerted by warning lamp and buzzer if the methane detection system loses power.
<b>Situation</b> (Chassis Affected)	PB-244 (241 US / 3 Canada) Model 536, 567 and 579 chassis model year 2016 through 2022 LNG and CNG vehicles built from 06/01/2015 through 11/30/2021 with a methane detection system.

<table><tr> <th colspa

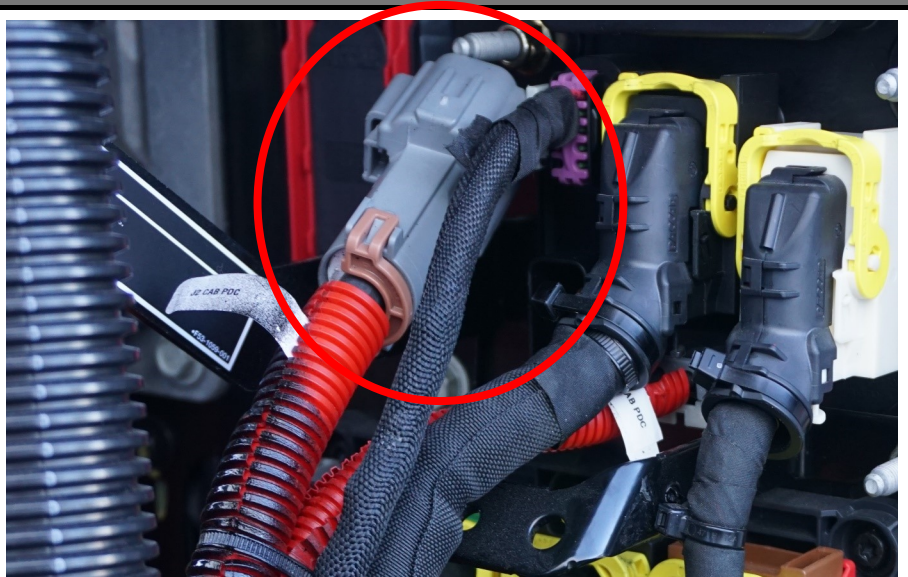
**Step 1:** Disconnect power to cab:

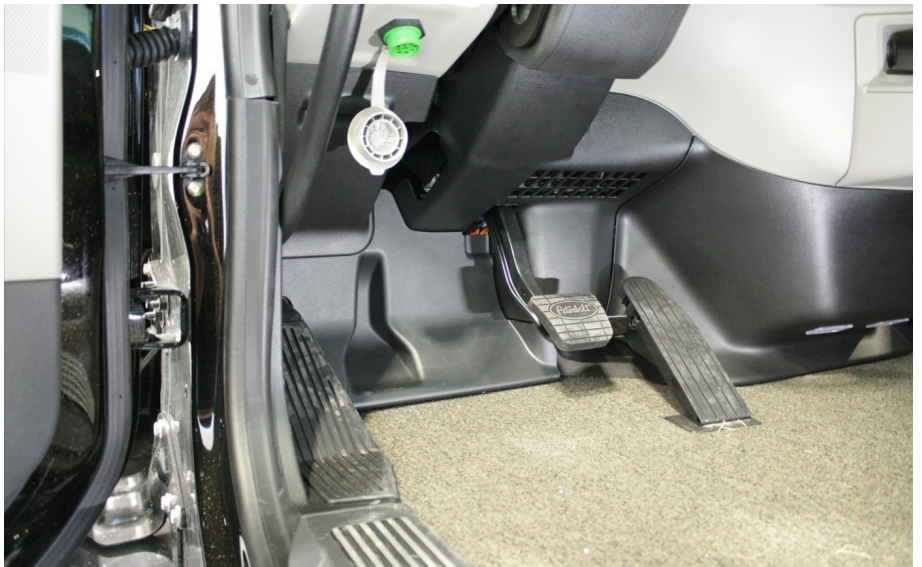
**Step 2:** Remove Lower panels on LH side (5 screws) (2 connectors)

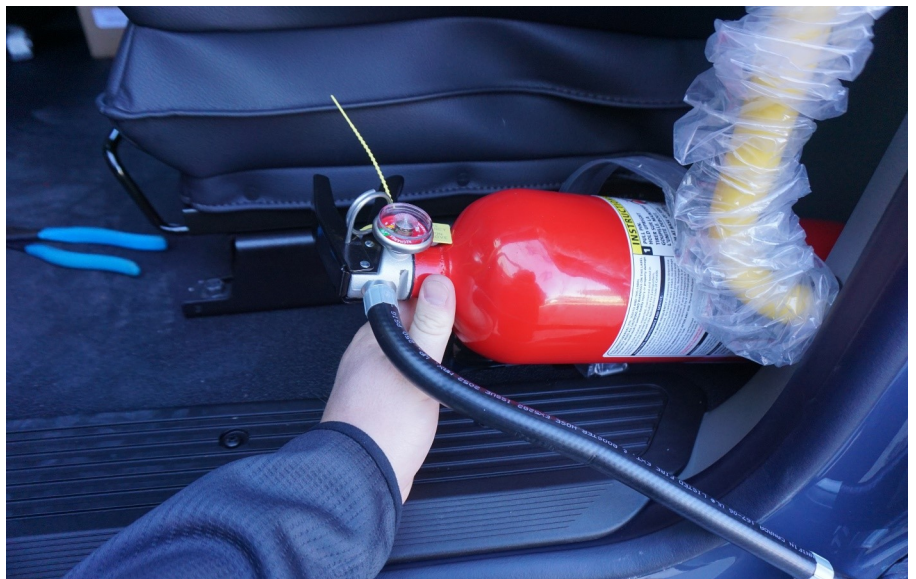
**Step 3:** Remove Fire extinguisher

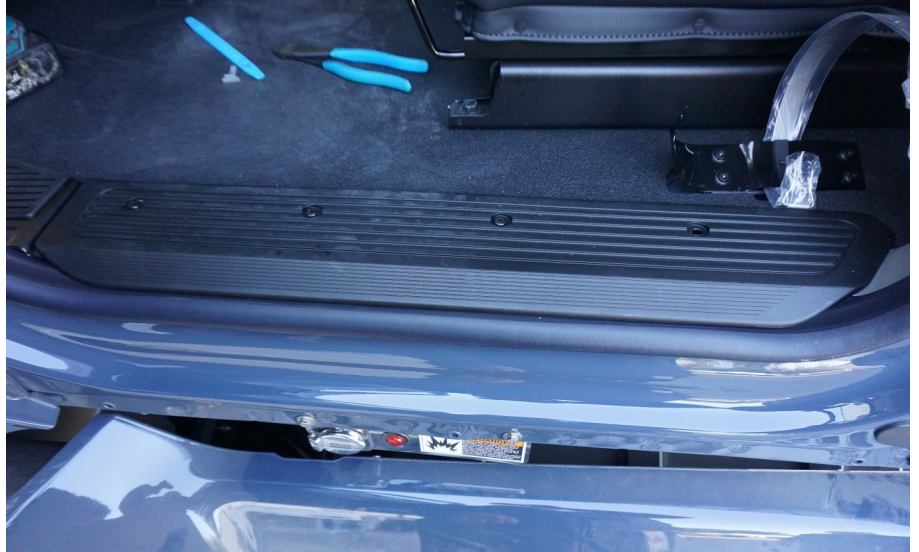
**Step 4:** Remove LH door sill plate (4 screws)

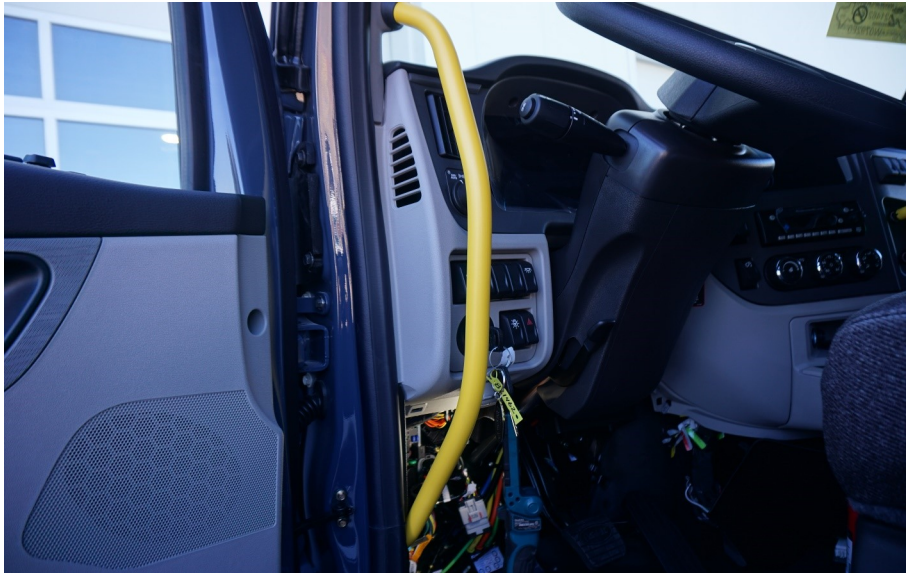
**Step 5:** Remove LH front handle (3 bolts)

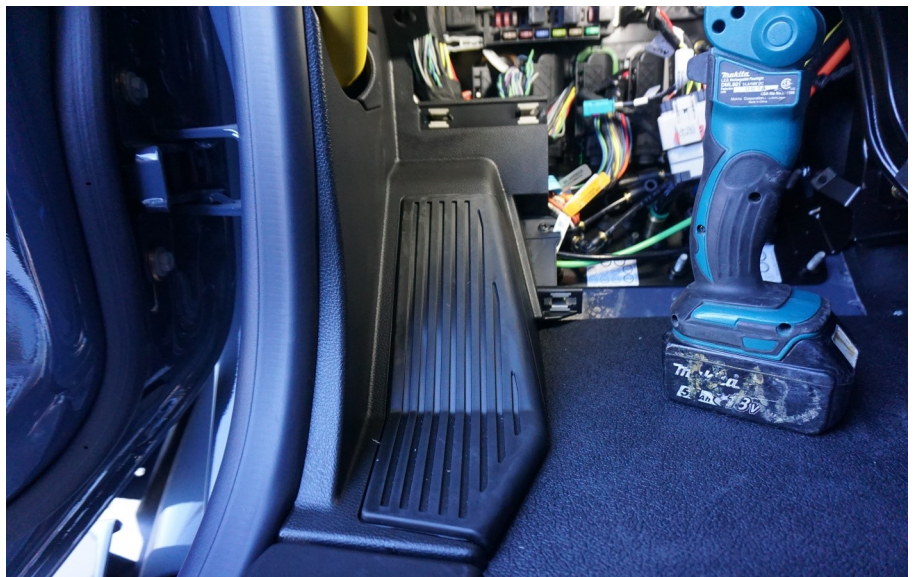
**Step 6:** Remove LH foot rest (2 screws)

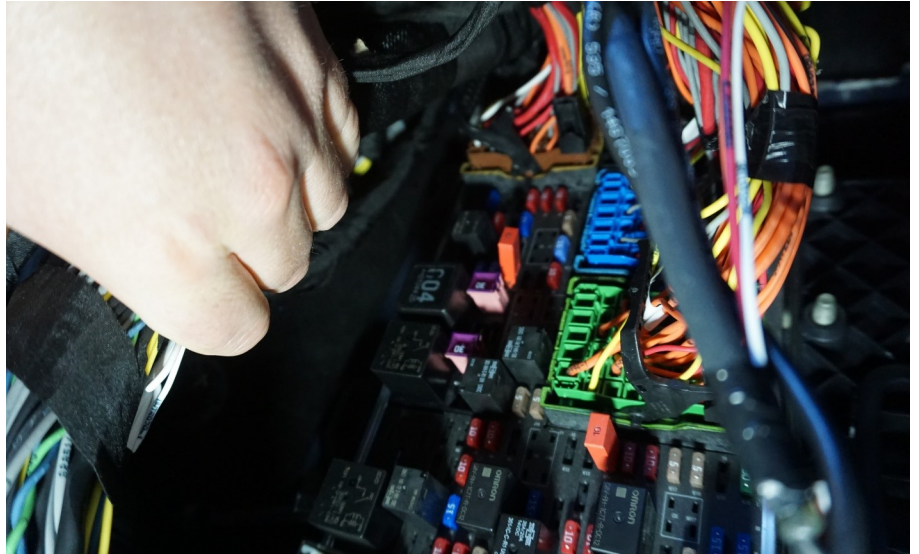
**Step 7:** Remove zip ties securing harness

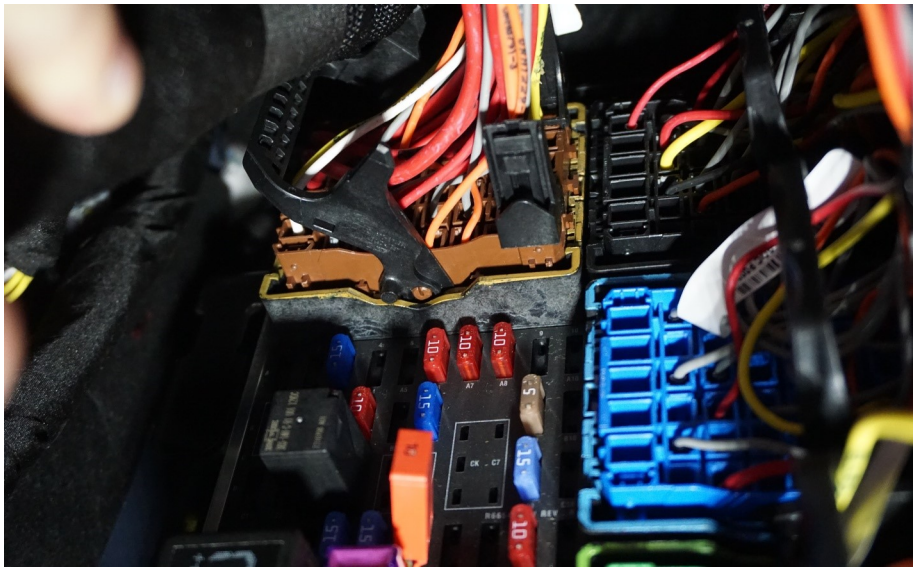
**Step 8:** Gently pull harness out of the wat and remove P004 connector (brown)

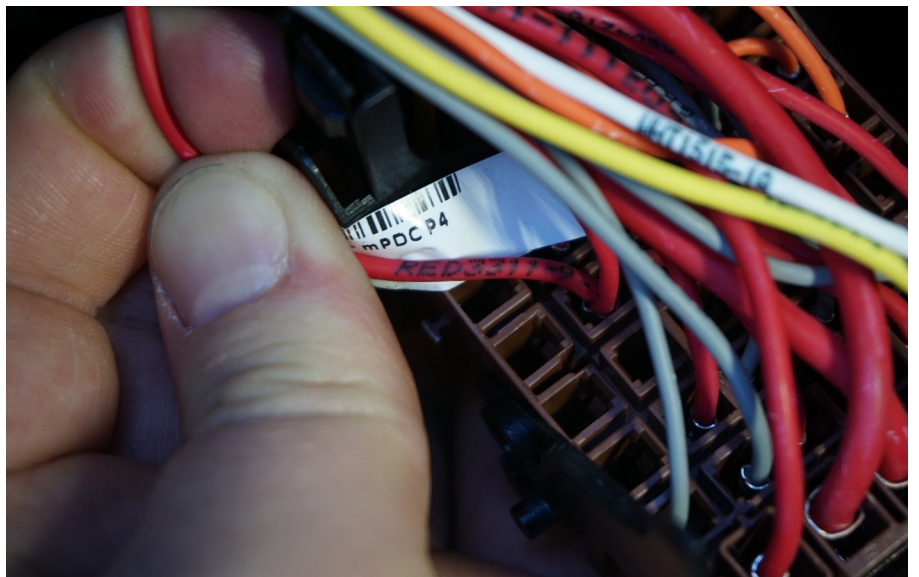
**Step 9:** Locate and cut wire RED 3311-9

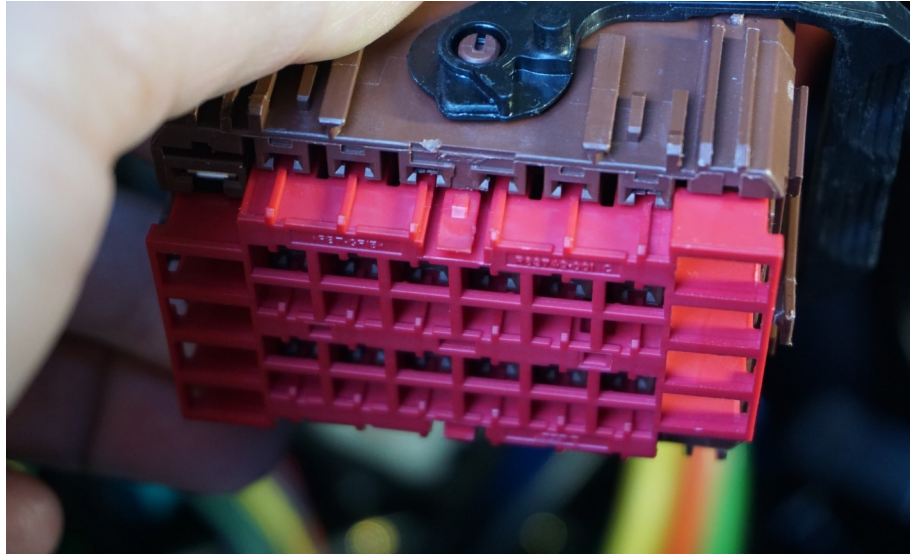
NOTE: The secondary lock must be released in order to add a wire terminal to the connector.

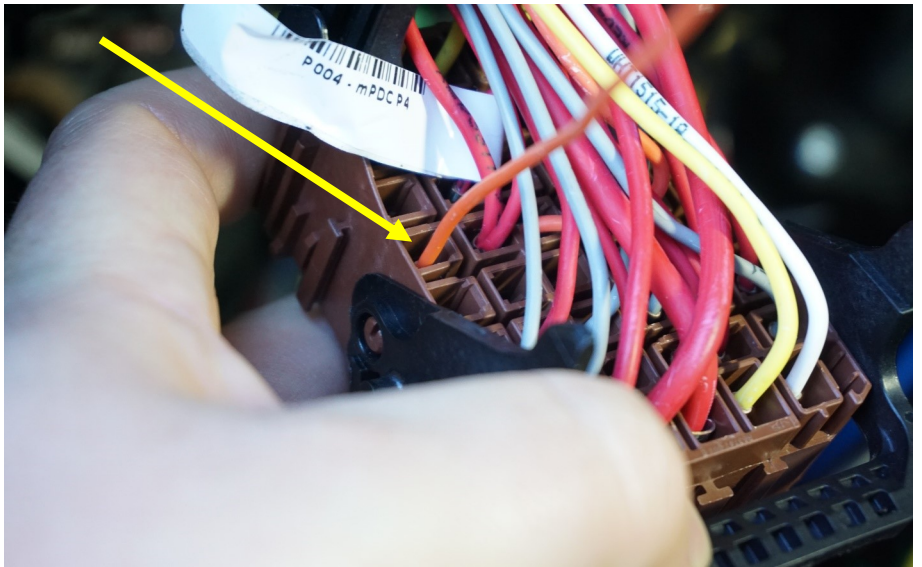
**Step 10:** Add terminal to wire red3311-9 and re-locate to position B4

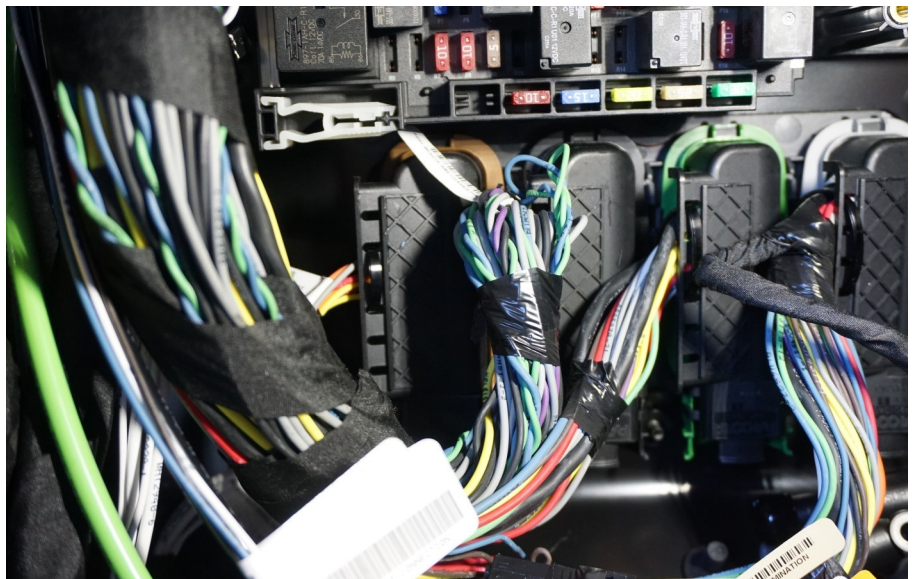
**Step 11:** Remove 4 firewall pass-through connectors:

NOTE: Must be removed from outside.

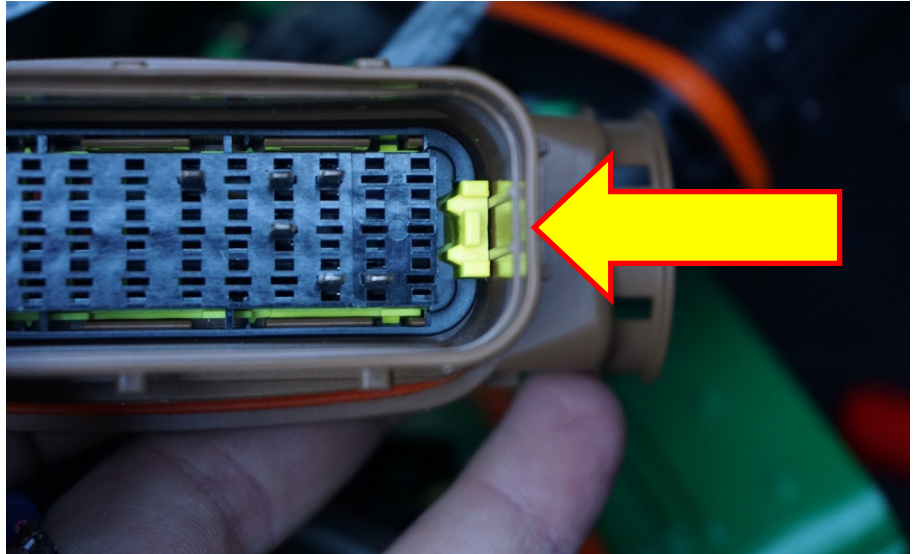
**NOTE:** The secondary lock is released by sliding the yellow tab towards the pins until it clicks.

Be sure to lock the secondary lock after replacing wires.

**The disconnected wires must be cut, then insulated with tape or heat shrink tubing**

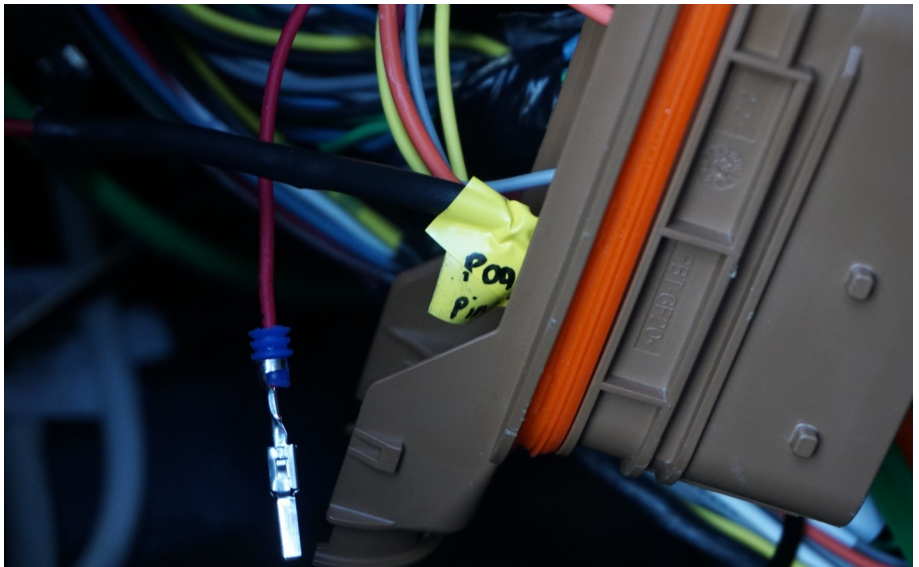
**Step 12:** Replace pin 25 in connector P099 (brown) with RED0731-17 on the rework harness:

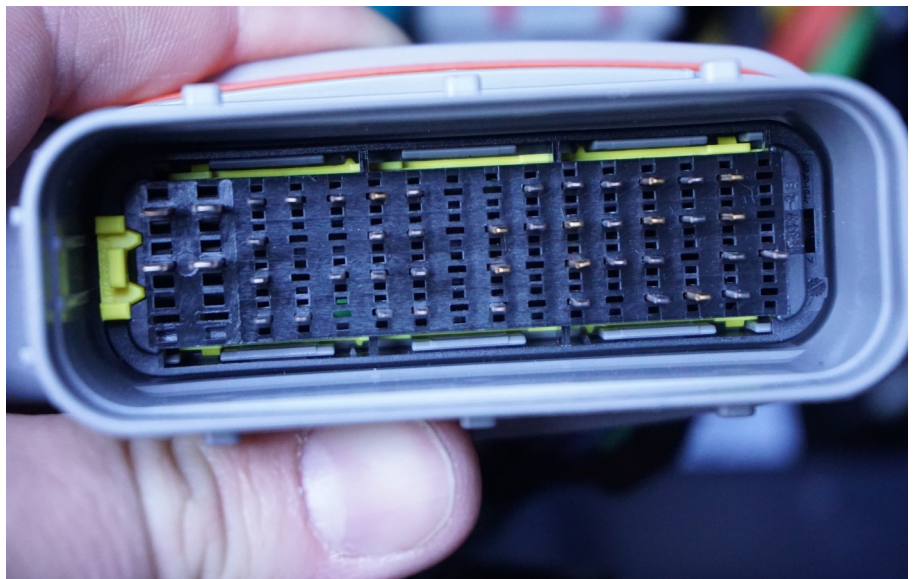
**Step 13:** Replace pin 17 in connector P006 (gray) with RED 0731-10 on the rework harness:

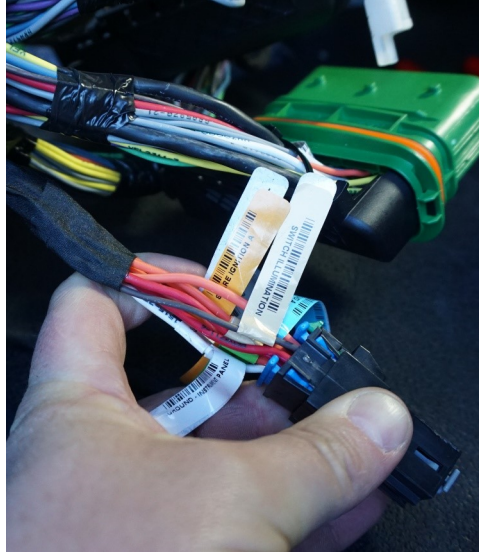
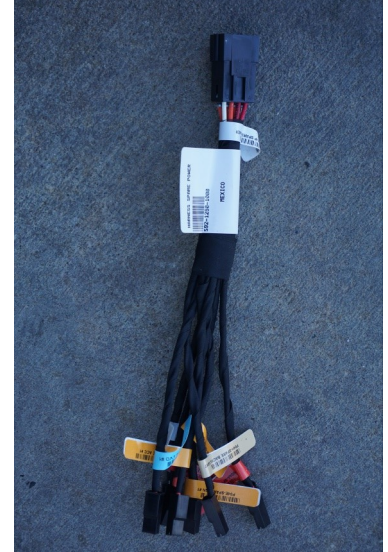
**Step 14:** locate spare power connector (tied back near the firewall pass through connectors) and plug in harness S92-1250-1000

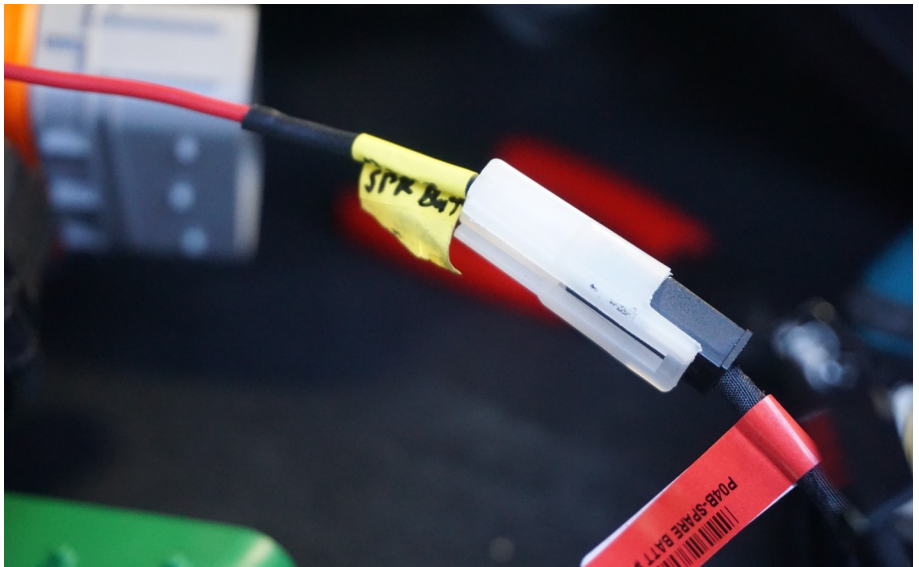
**Step 15:** Plug the rework harness into terminal P04B Spare batt 1

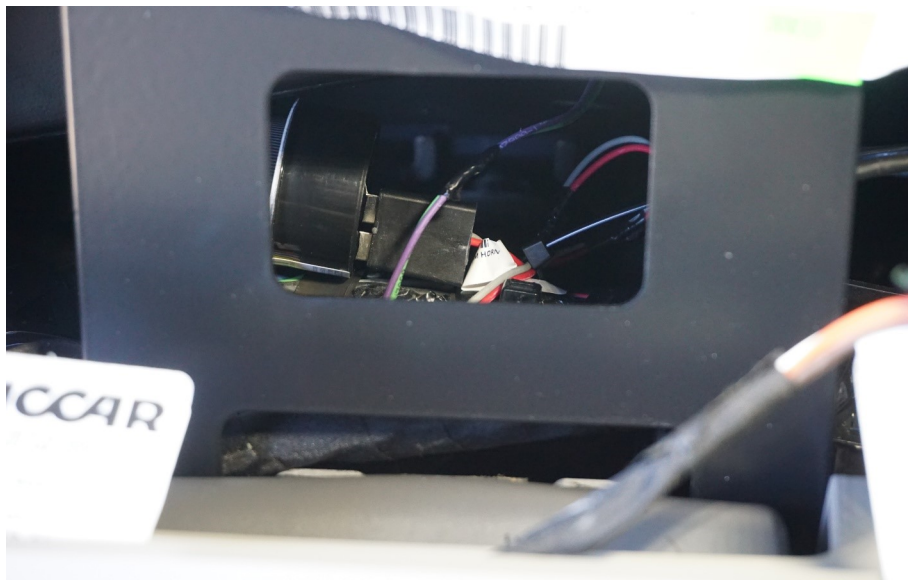
**Step 16:** Remove the C,B panels and dash cluster, then locate the methane detection alarm (located behind the dash cluster)

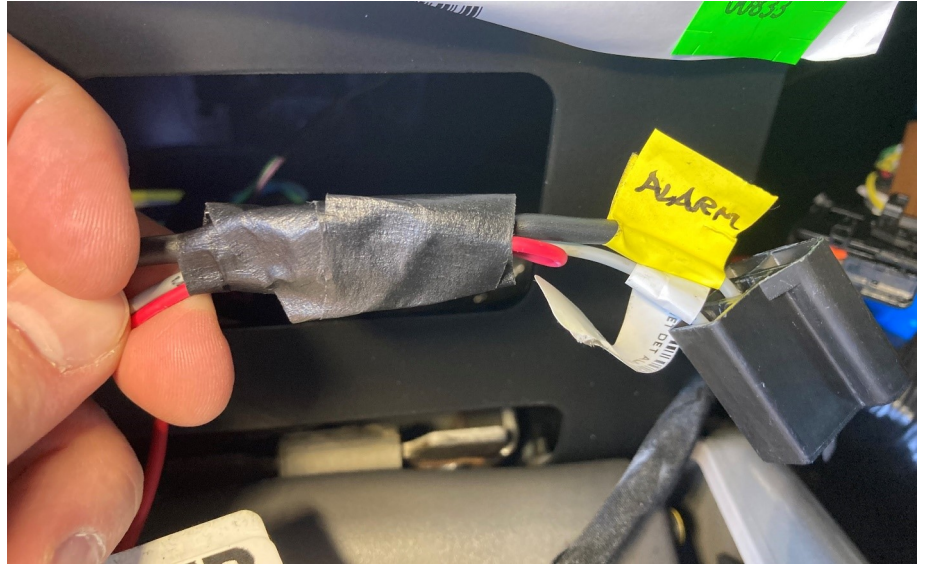
**Step 17:** Re-pin alarm connector power wire with the rework harness, then insulate the unused cable and secure the alarm in its original position.

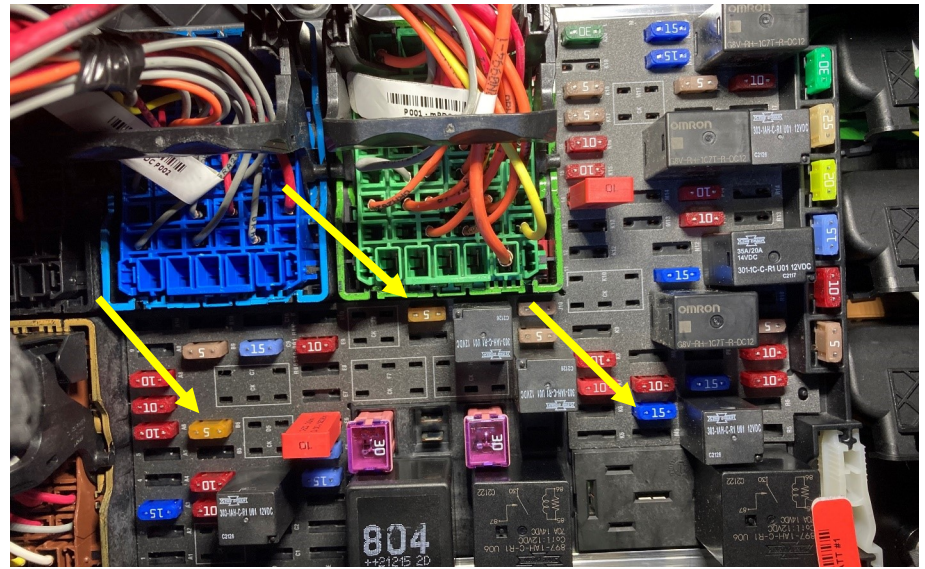
**Step 18:** Move the 15 Amp fuse in location B6 to M6, then insert 5Amp fuses in locations B6 and G10

Note: location G10 may be populated with a 20Amp fuse from the factory, replace it with the 5Amp fuse
