PRODUCT CAMPAIGN BULLETIN

APPLICABILITY: 2021MY Outback 2.5L
 2021MY Impreza
SUBJECT: CVT Select Lever Cable Nut- Low Torque

NUMBER: WRA-21R
DATE: 01/21/21
REVISED: 02/01/21
NHTSA ID: 21V-024

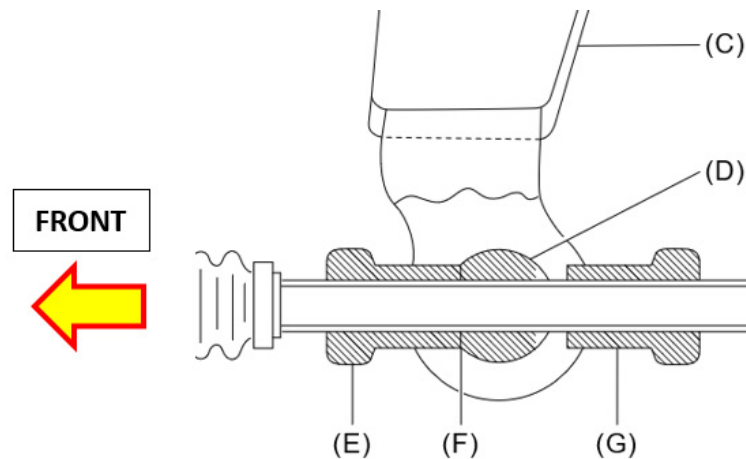
Subaru of America, Inc. (Subaru) is recalling certain 2021 model year Outback and Impreza vehicles in which the CVT select lever cable nut may have been under-torqued during vehicle assembly.

If the CVT select lever cable nut was not properly torqued and loses retention, the gear select may not function properly. If the gear select does not function properly, there is an increased risk of a crash.

Step 5: Using the illustration below as a guide, confirm the select cable adjustment and proper torque of adjustment nut (G):

5a) Loosen the rear adjusting nut (G) while holding the front adjusting nut (E) with a wrench.

5b) With (G) loosened, turn the front adjusting nut (E) until it lightly touches the contact point (F) on the connector pin (D).

5c) Tighten the rear adjusting nut (G) against the connector pin (D).

5d) While holding the front adjusting nut (E) with a wrench, torque the rear adjusting nut to **7.5 Nm (5.5 ft. lbs. / 66 inch-lbs.)**.

Step 6: IMPORTANT: After adjustment is complete, confirm the select lever operates normally in all ranges.
