Safety Recall Y03 / NHTSA 21V-028

Software Update

2018 – 2020(JL) Jeep® Wrangler

2020 (JT) Jeep® Gladiator

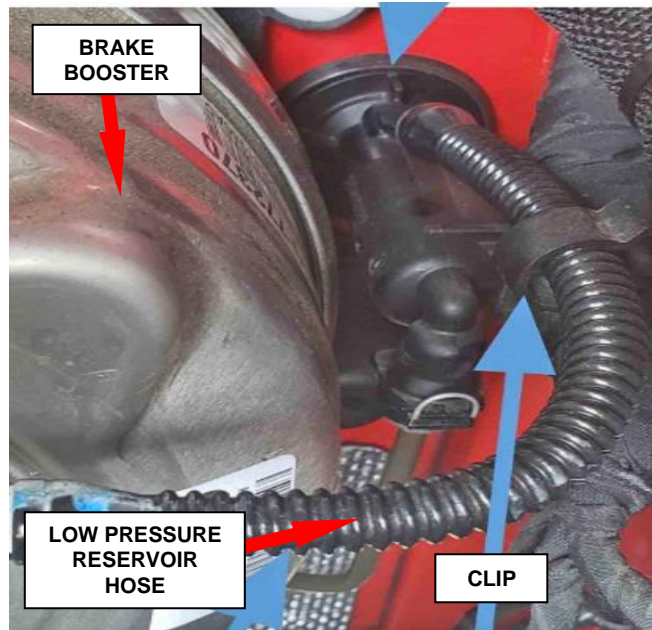
Figure 1 – Low Pressure Reservoir Hose

1. Locate and cut the clip holding the wire harness to the low pressure reservoir hose and **Discard** the clip (Figure 1).
2. Visually inspect the low pressure reservoir hose for any leaks/seepage (See Sample Pictures Below), if leak or seepage, deformation, or wear is found replace the reservoir hose (Figure 1).

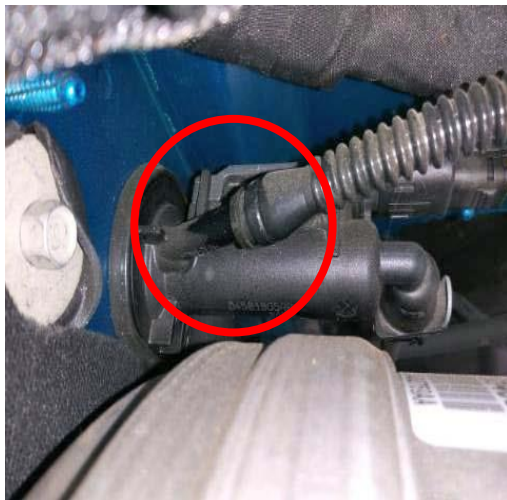
SAMPLE of Leak/Seepage

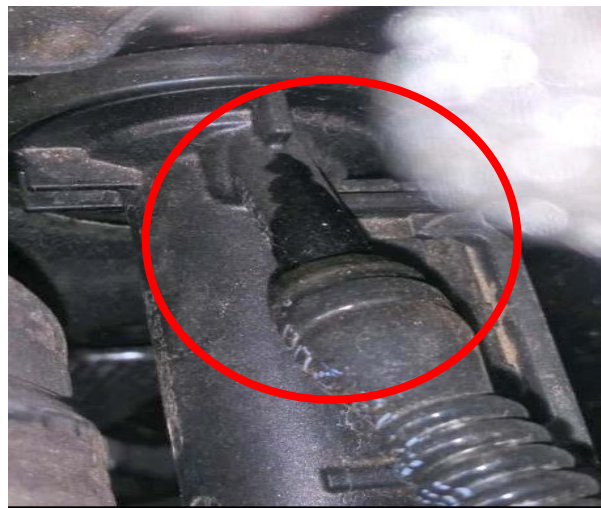
SAMPLE of Leak/Seepage
