Recall Campaign Bulletin

Campaign No. 2022050004, May 2022

SUBJECT: **Model GLE-Class (167 platform)**
Model Year 2020

Check and Replace Lighting Control Unit

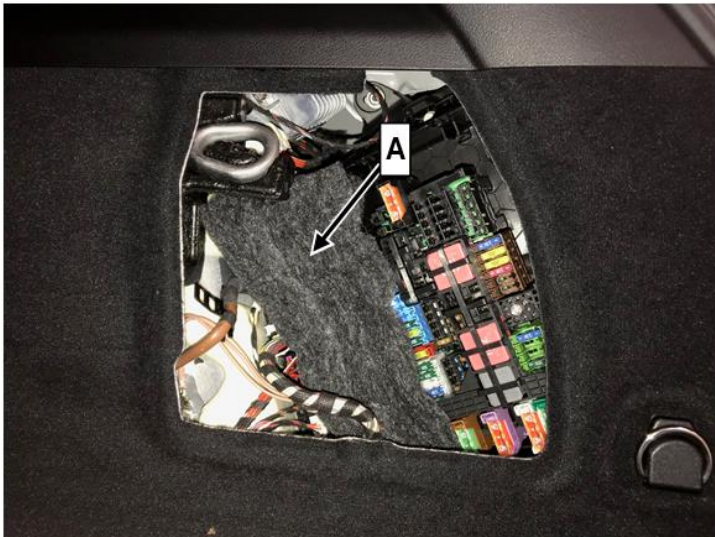
Figure 1

1. Connect XENTRY Diagnosis.
2. Update software of signal acquisition and actuation module.
 - i** The software with the part number **A1679027813** **must** be updated.
 - i** To do this, select menu item "Quick test view – N10/8 rear signal acquisition and actuation module (rear Sam) – Adaptations – Control unit update – Updating of control unit software".
 - i** Then follow the user guidance in XENTRY Diagnosis.
3. Disconnect ground line of battery (AR54.10-P-0003ME).
4. Remove service flap in right rear trunk.
5. Remove insulation (**A, figure 1**) and unscrew screw (**B, figure 2**).

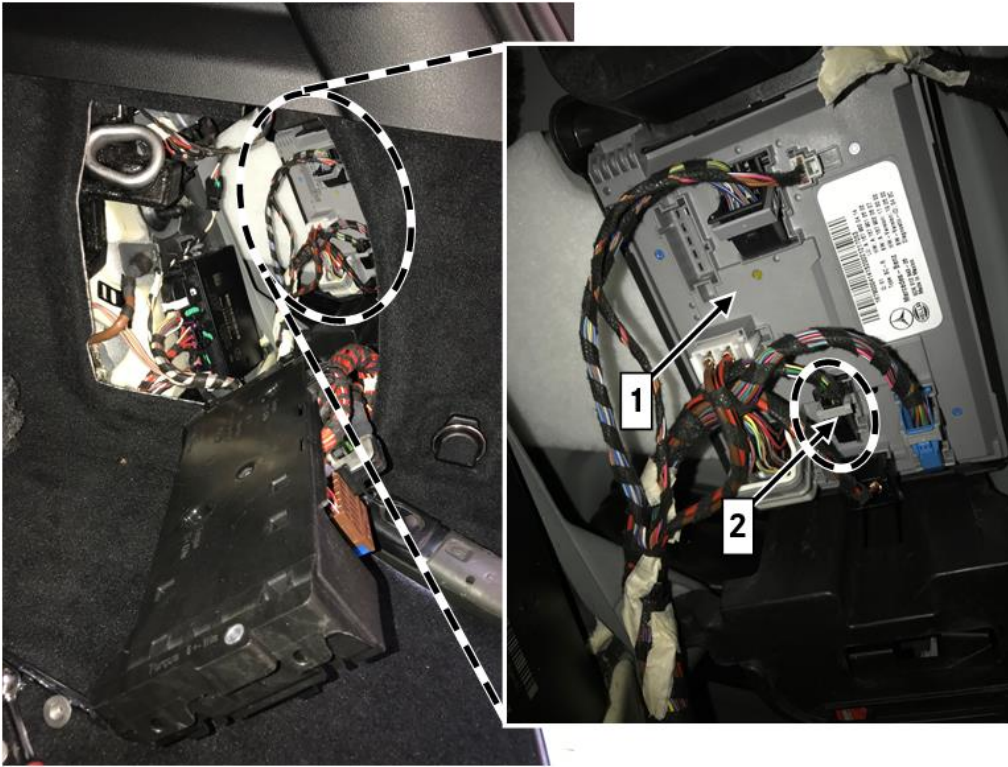
Figure 3

6. Release fuse and relay module and set down with connected lines through service flap in trunk (**figure 3**).

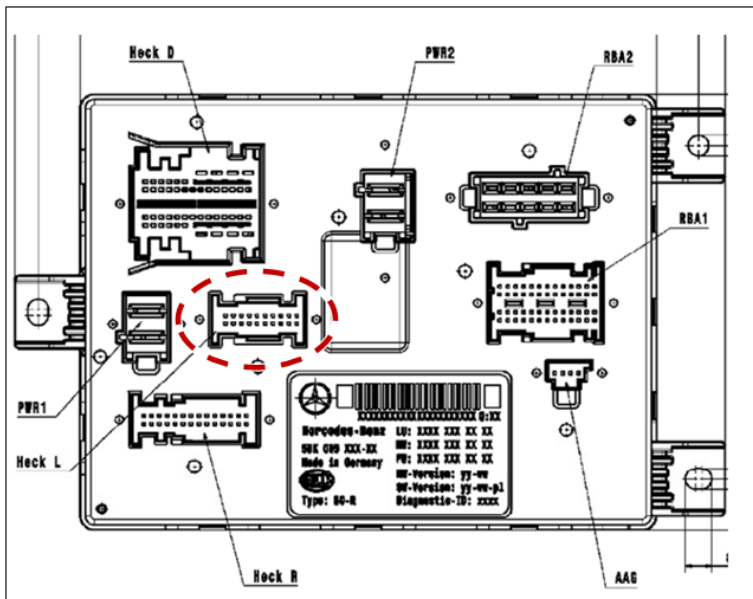
Figure 4

7. Move/wiggle Heck L plug (**2, figure 3 and figure 4**) as well as disconnect the contacts and connect the contacts again.
i Ground line of battery shall **not** be connected.
