SIB 34 02 21

## RECALL 21V-062: INTEGRATED BRAKE SYSTEM

This Service Information Bulletin (Revision 2) replaces SI B34 02 21 **dated March 2021**.

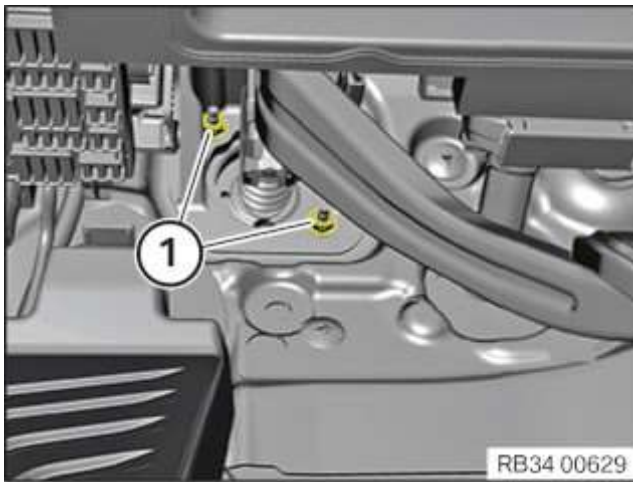
- Remove the hydraulic unit (1).
