Subject: Battery Compartment Cable Routing Inspection & Correction			
Field Change Program: Field Campaign	FCP Number: 491	Revision: A	Date: 02/22/2021
Coach Section: 07-Electrical	P/N: N/A		Type: Safety Recall

Ref. NHTSA Recall No.: 21V-063	Ref. Transport Canada Recall No.: 2021-058
--	--

1.0 Description

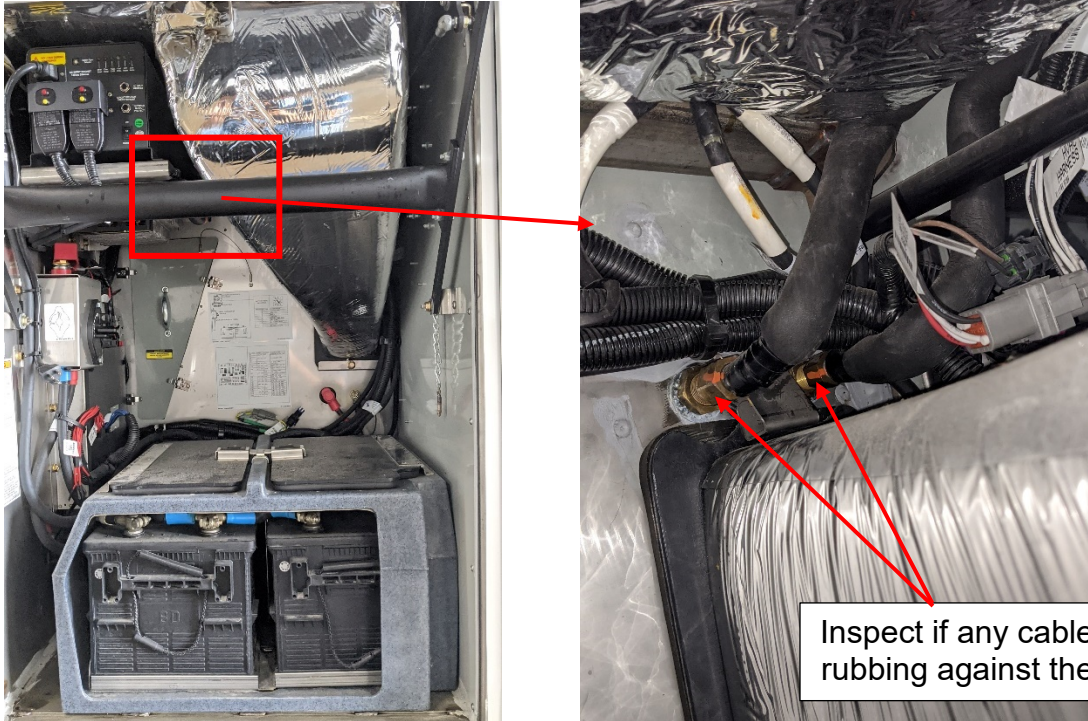
Open battery compartment door and verify if any of the power cables are in contact with or are rubbing against the parcel rack A/C line copper fittings.

If cables are found to be touching or rubbing on the copper lines, refer to Section 5.1 for routing correction.

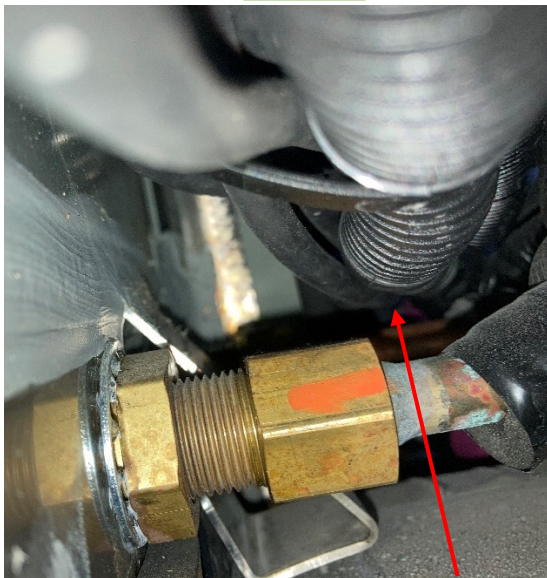
Good

Gap between cables and fitting.
Continue with next steps of inspection

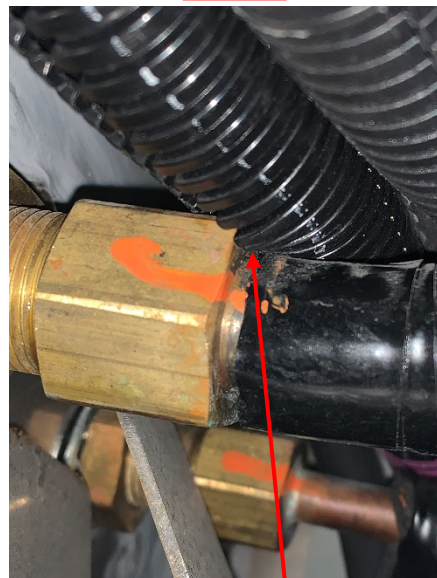
Bad

Cable touching copper fitting. Refer to Section 5.1 for routing correction

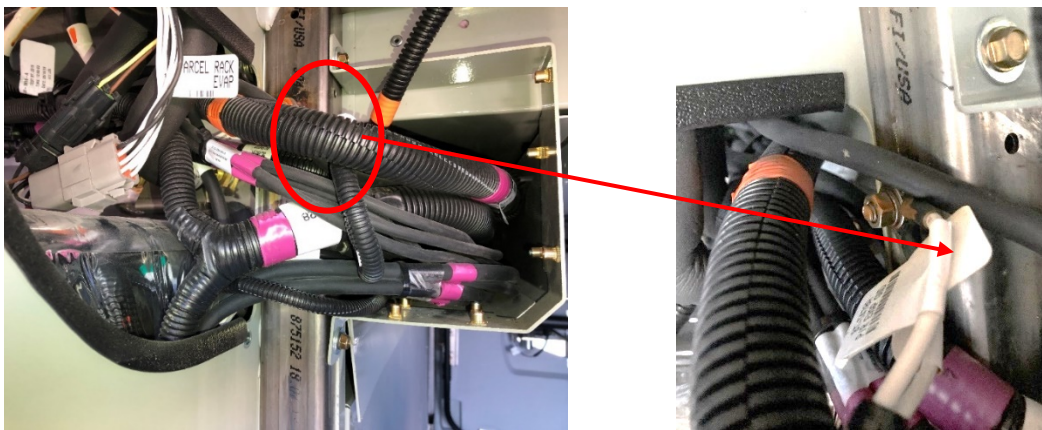
Inspect to see if cables are unsecured and close to the ground stud on the coach frame.

If the cables are unsecured, refer to Section 5.2 for routing correction.

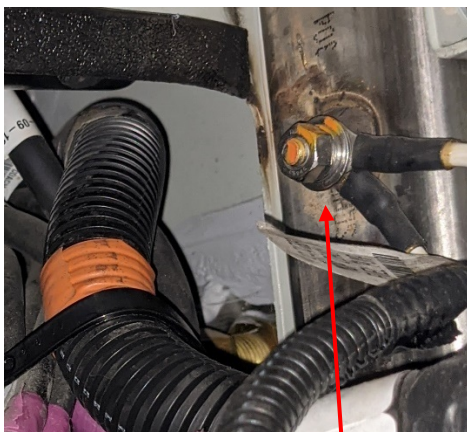
Good

Gap between cables and ground stud. Continue with next steps of inspection

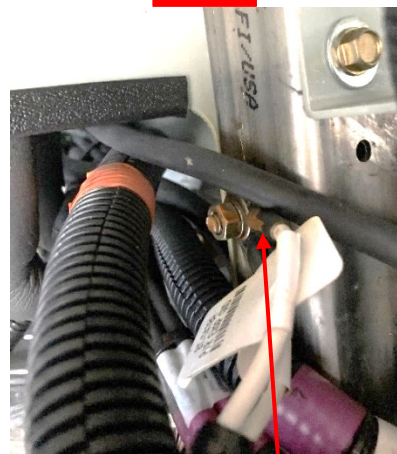
Bad

Cable close to ground stud. Refer to Section 5.2 for routing correction

Pull all the cables coming out of battery compartment away from ground stud and secure them with a zip tie, MCI P/N: 19-11-259.

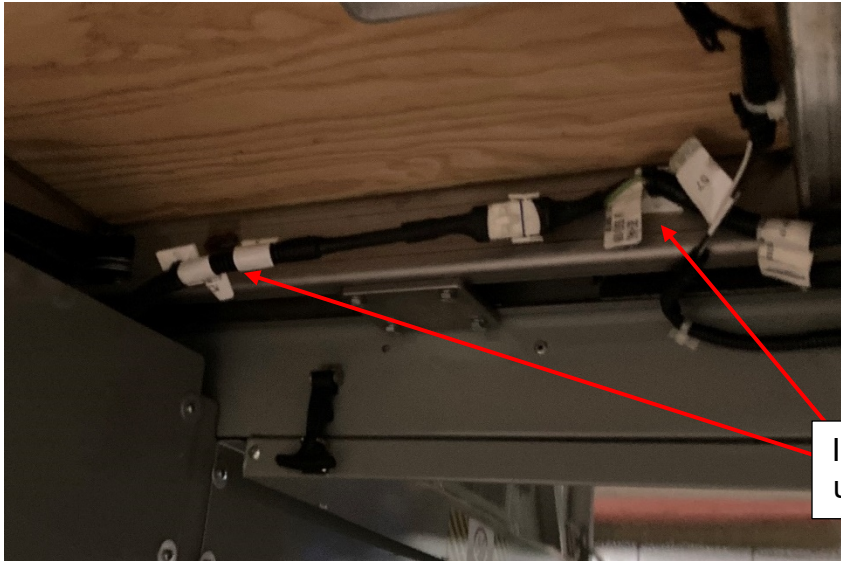
Inspect adhesive tie bases used to secure 110V harness

If the adhesive tie base are failed, refer to Section 5.3 for routing correction. Otherwise, inspection is completed.

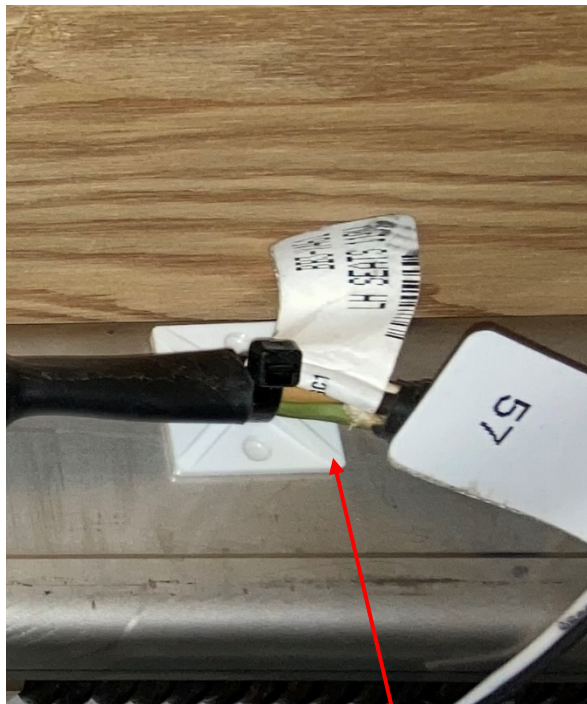
Good

Adhesive base intact. Inspection completed.

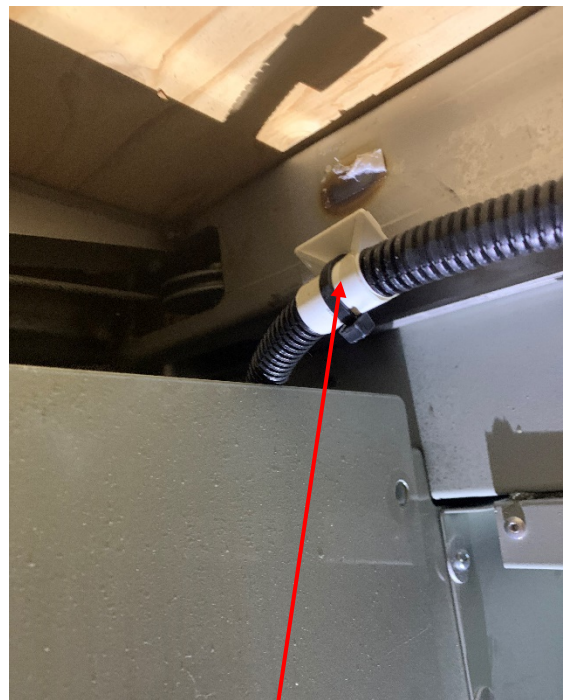
Bad

Adhesive base failed. Refer to section 5.3 for rework

Cut the cable ties securing the 110V harness. Discard the tie base.

Clean the frame with isopropyl alcohol and install new adhesive tie bases, MCI P/N: 19-04-0283 and secure the cable with cable ties, MCI P/N: 19-11-259
