April 2021
FL874A
NHTSA #21V-067
Transport Canada #2021-060

Subject: M2 Transmission Oil Cooler Line

Models Affected: Specific Model Year 2014-2019 Freightliner Business Class M2 vehicles manufactured October 17, 2013, through September 25, 2018, and equipped with a Mahle-Bahr radiator.

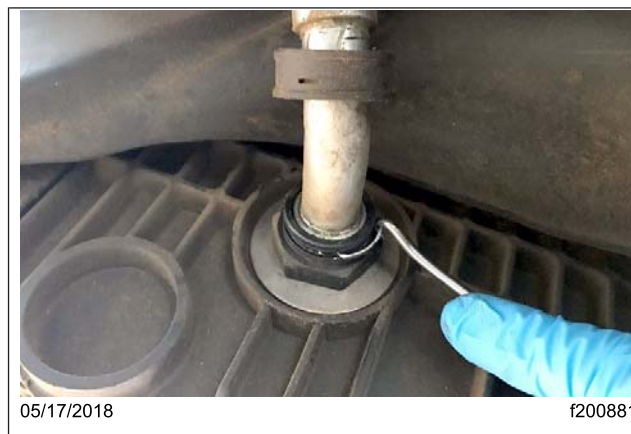
Fig. 3, Removing the Retaining Clip

On specific vehicles, the retaining clip that engages the transmission oil cooler line connection to the in tank oil cooler may fail and allow the transmission fluid cooler hose to disengage which may allow fluid to leak. If a rapid loss of transmission fluid occurred, it could lead to fluid on the road which may present a risk of a motor vehicle hitting the fluid and causing loss of control.

1. Remove the plastic lock ring by evenly prying it away from the fitting, and sliding it back onto the metal portion of the transmission cooler line.
2. Using a pick or a small screwdriver, remove the tube retaining clip. See [Fig. 3](#).
