SIB 66 02 21

## RECALL 21V-096: REARVIEW CAMERA

This Service Information bulletin (Revision 3) replaces SI B66 02 21 **dated March 2021**

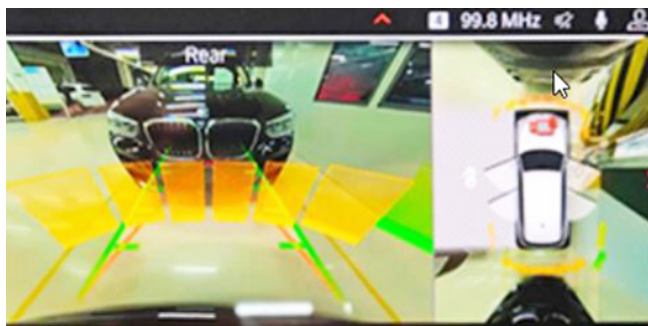
#### **Picture 1.**

The images are displayed in the **correct image position** on the CID for vehicles equipped with option code 6U3.

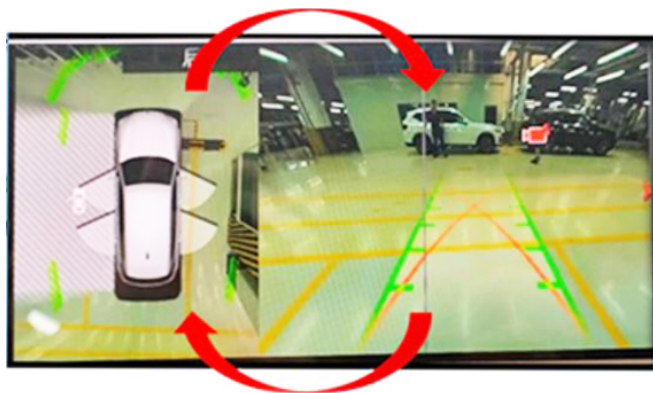
**Picture 2.**

Shows a possible failure in vehicles equipped with option 6U3.

The top view and rearview images are **incorrectly displayed** in the wrong position (swapped) on the CID.

Note: The camera icon is in the correct location, however it seems out of place due to wrong image location.

Software coding error in the ICAM control unit with Integration Level-

- S15A-19-11-555 to S15A-20-07-565
- S18A-19-11-565 to S18A-20-07-565

Encode the ICAM using ISTA 4.27.1x or higher (released December 2020).

- S15A-20-11-542 or higher
- S18A-20-11-542 or higher

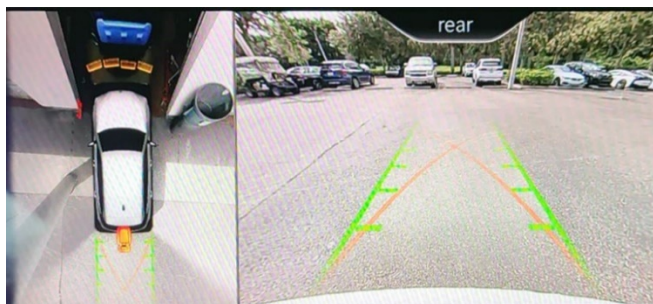
**Picture 3.**

Shows the **correct image display** for vehicles without option code 6U3.

Note: The correct image layout for vehicles without option code 6U3 is opposite to the layout for vehicles with option code 6U3 (seen in Picture 1 above).
