RECALL: THIS MODIFICATION HAS TOP PRIORITY AND MUST BE PERFORMED IMMEDIATELY TO ENSURE CUSTOMER SAFETY

INSPECTION AND REPAIR OF THE MAIN WIRING HARNESS AND MODIFICATION OF THE TAIL END LOWER PART

**AFFECTED MODEL:
2020 1290 SUPER DUKE R**

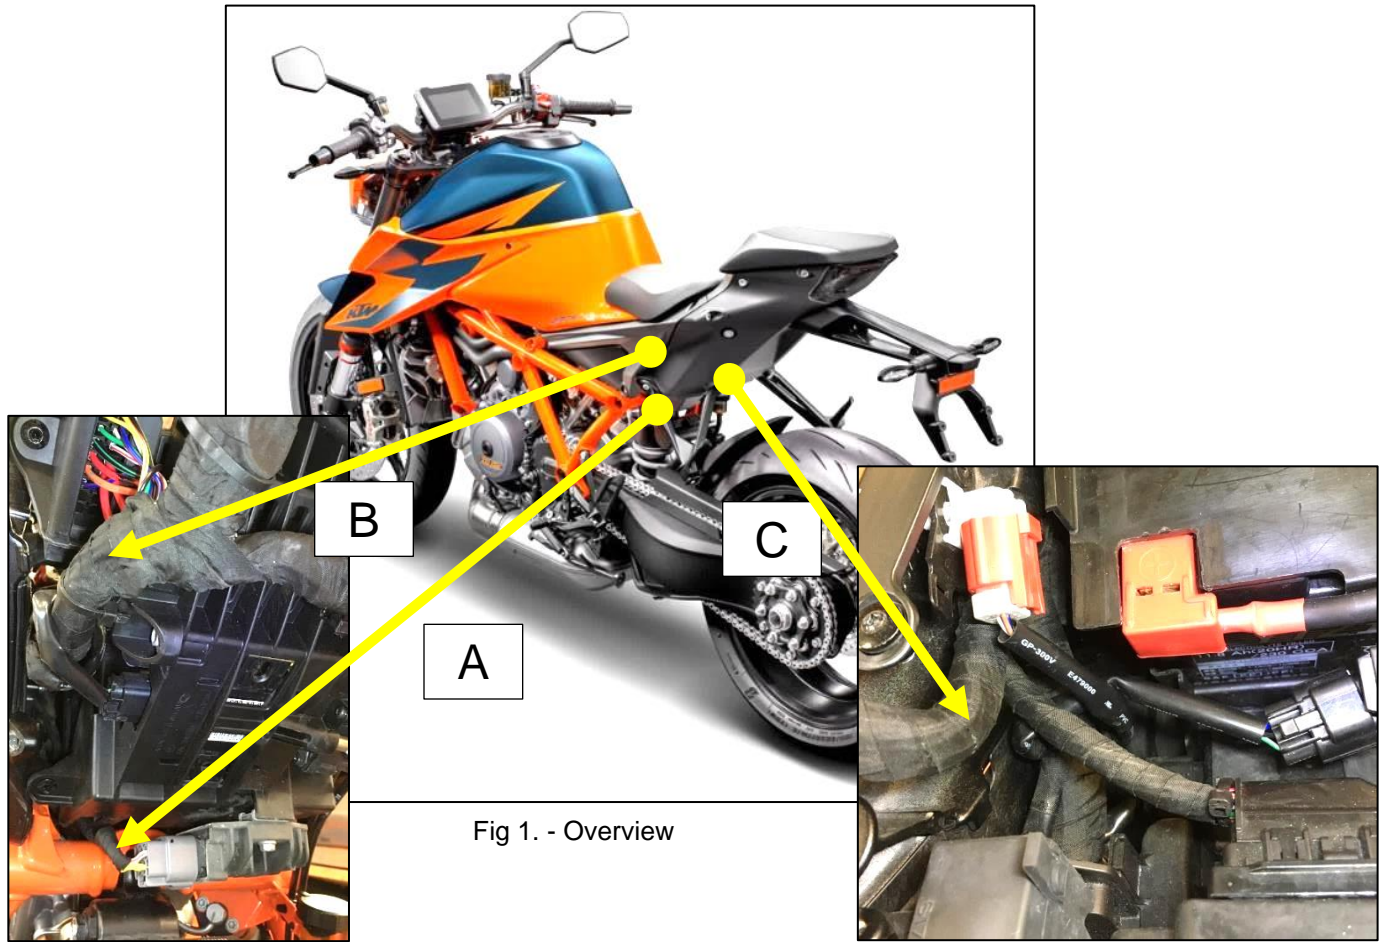
Fig 1. - Overview

Fig 2. - Zoom of Area A and B

Fig 3. - Zoom of Area C

Table 1 - Wiring locations to inspect and repair. Decide what action to take depending on the wires condition.

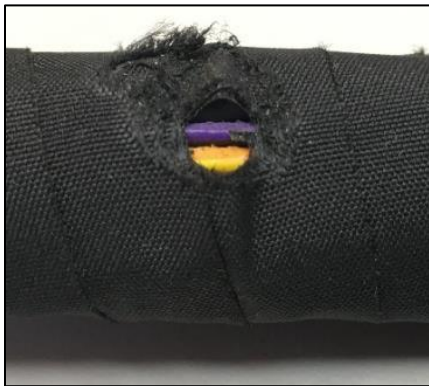
Fig. 4 - Mild or no Damage (follow code 00)

1. **Wiring repair possibility #1:** If there is no damage or mild damage (Fig. 4) to the wiring insulation tape as explained on page 9 then you must perform the steps shown on page 9. Use the Action code ending in 00 when submitting the claim.

1. Check the main wiring harness for signs of rubbing, damaged or melted wires in the locations Area A, B and C. See Figures 1 to 6 and Table 1 and Table 2 for further details.
2. If the wiring has no damage or mild damage as shown in Figure 4 repair the mildly worn insulation on the main wiring harness using black wiring harness insulation tape.
3. Also check the main wiring harness behind the side panel (Fig. 10 - page 7) for contact points and secure with cable ties if necessary.
4. As shown in Fig. 11 (Page 8), secure the wiring harness of the voltage regulator on the battery carrier, using two cable ties.

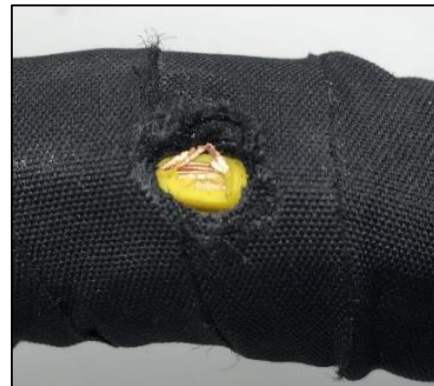
2. **Wiring repair possibility #2:** If there is damage to the wiring for the voltage regulator (Fig. 5.) which is located in **Area A** (Fig. 2) then the wire can be replaced. If the voltage regulator wire is damaged and needs replaced you will need to follow the instructions on page 10 and Annex 2 from the repair manual which is attached to the Dealer.net notification. Use the Action code ending in 01 when submitting the claim.

Fig. 5 - Copper visible (follow code 01)

1. Check the main wiring harness for signs of rubbing, damaged or melted wires. See Figures 1 to 6 and Table 1 and Table 2 for further details.
2. **If the wiring has damage to the wire and has copper visible as shown in Figure 5 repair the wire as explained in the following steps.**

3. Disconnect the 12-V battery and remove the left cover on the rear frame.
4. Remove the connector housing as per Annex 2. Laterally guide the wiring harness out of the rear frame to ensure sufficient space for the subsequent wire repairs.
Note: Annex 2 is an additional attachment that is available for download in the Dealer.net notification.

5. Perform wire repairs as per Annex 2.
6. Guide the wiring harness to the voltage regulator again and mount the connector housing as per Annex 2.
7. As in Fig. 11 - Page 8, secure the wiring harness of the voltage regulator on the battery carrier, using two cable ties.
Note: The wiring harness must not protrude over the connector housing and the course to the main frame must be checked for contact points (Fig. 12 - Page 8).

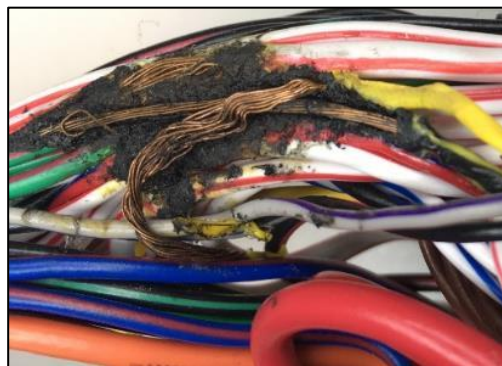
3. **Wiring repair possibility #3:** If the wiring insulation on the main wiring harness is damaged in **Area B and/or Area C** (Fig. 2, 3 & 6) then you must replace the main wiring harness and perform the steps shown on page 11. Use the Action code ending in 02 when submitting the claim.

Fig. 6 - Severe Damage (follow code 02)

1. Check the main wiring harness for signs of rubbing, damaged or melted wires. See Figures 1 to 6 and Table 1 and Table 2 for further details.
2. **If the damage to the wiring is severe as shown in Figure 6 then the main wiring harness must be replaced.**

3. Disconnect the 12-V battery.
4. Replace the main wiring harness.
5. As in Fig. 11 - Page 8, secure the wiring harness of the voltage regulator on the battery carrier, using two cable ties.
Note: The wiring harness must not protrude over the connector housing and the course to the main frame must be checked for contact points (Fig. 12 - Page 8).

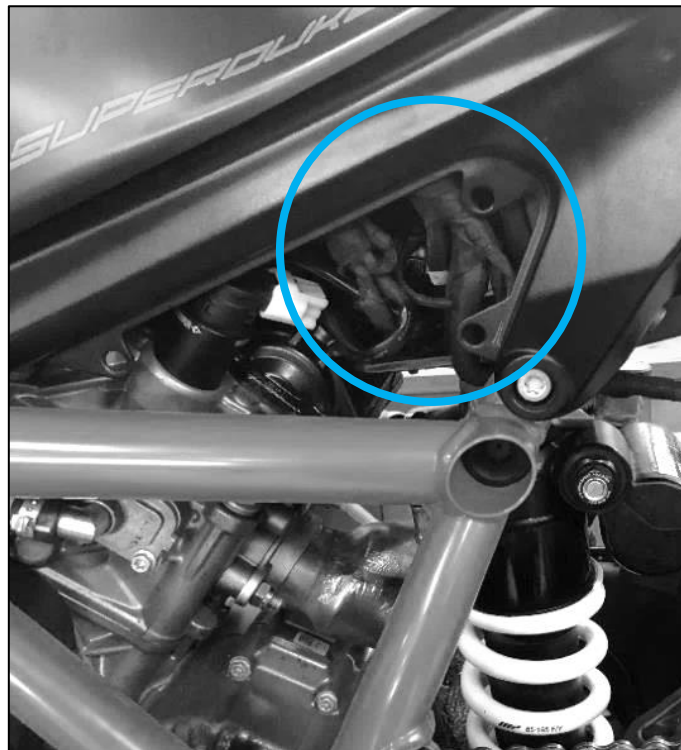
Fig. 10 - Main wiring harness area to be checked

8. Also check the main wiring harness behind the side panel (Fig. 10 - Page 7) for contact points and secure with cable ties if necessary.
9. Install the tail end lower part as per repair manual/Annex 1 and tighten screws as per Table 3.
