GROUP
Safety Recall Campaign

NUMBER
SC206 (Rev 1, 05/04/2021)

SUBJECT: NEW FUSE KIT INSTALLATION IN JUNCTION BOX AND SOFTWARE INSTALLATION (SC206)

This bulletin provides the procedure to install a new fuse kit for the Hydraulic Electronic Control Unit (HECU) in the junction box on some Sportage (QL) and Cadenza (YG) vehicles listed in the table below. Also, affected Sportage (QL) vehicles equipped with the Electronic Parking Brake (EPB) / without Smart Cruise Control (SCC) will also get the HECU software logic update. The affected vehicles may exhibit numerous warnings, including illumination of the tire pressure warning light, ABS warning light, MIL warning light, a burning/melting smell and/or smoke from engine compartment in the area where the HECU is located. It is believed that the electrical circuit within the HECU experiences a short circuit condition that results in excessive current, thereby increasing the risk of an engine compartment fire. Before conducting the procedure, verify that the vehicle is included in the list of affected VINs.

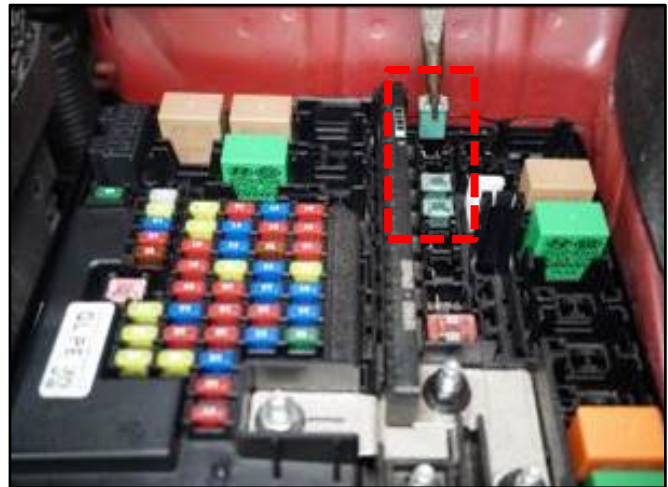
2. Remove the following two (2) fuses from the junction box:

1. ABS1
2. ABS2

Note: Drill a hole through the center of the removed fuse(s). DO NOT reuse.
