David J. Johnson  
Director  
Service Engineering Operations  
Ford Customer Service Division

March 10, 2021

**SUBJECT: NEW VEHICLE DEMONSTRATION / DELIVERY HOLD -  
Safety Recall 21S11**  
Certain 2020 Model Year Aviator and Explorer Vehicles  
Rear Lower Control Arm Bolt and Nut Replacement

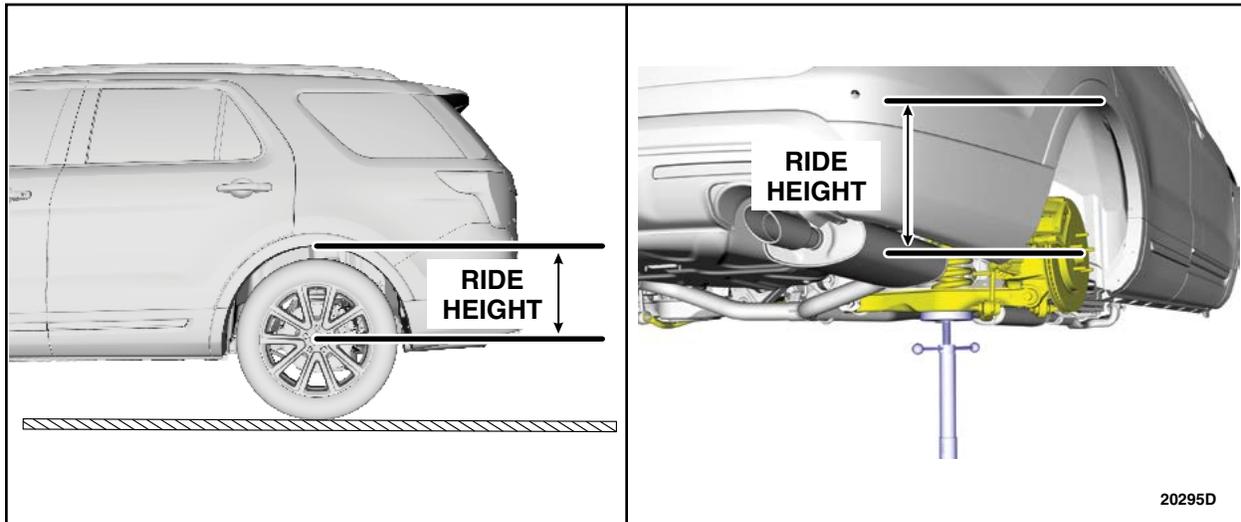
**FIGURE 1a**

1. Measure the distance from the center of the wheel hub to the lip of the fender with the vehicle in a level, static ground position (ride height) before disassembly. See Figure 1a.

6. Adjust the jack stand to achieve the ride height measured in Step 1. See Figure 1b.

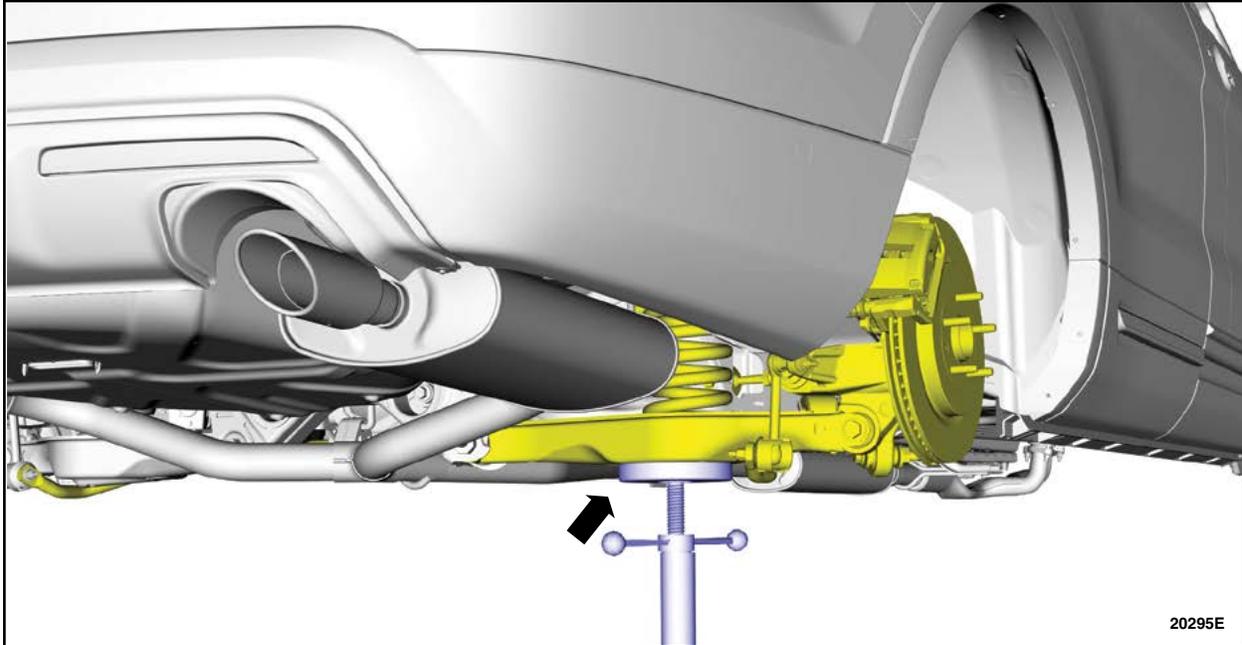
**FIGURE 2**

2. Remove both rear wheel and tire. Please follow the WSM procedures in Section 204-04A.
3. Using a jack stand, support the rear suspension to ride height. See Figure 2.

**NOTICE:** Make sure that the insulator pads are correctly positioned to prevent direct contact with other components.

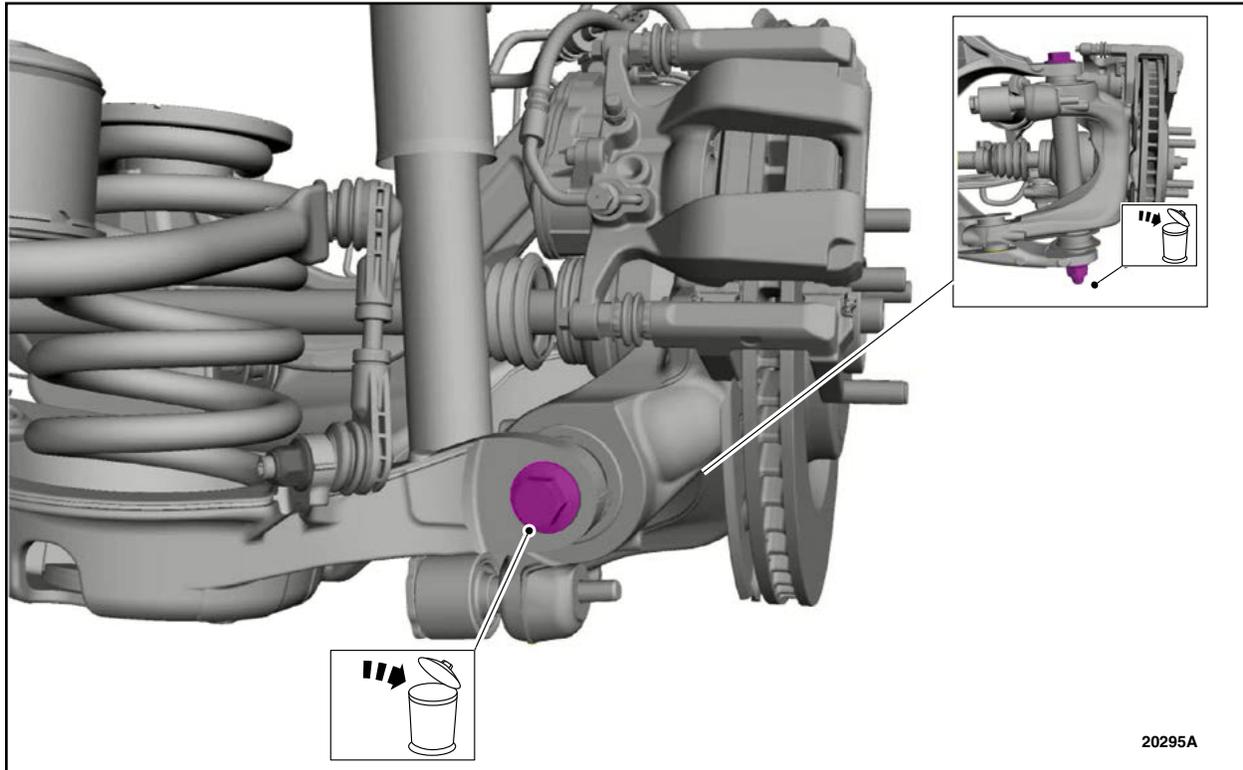
**FIGURE 2**

In some of the affected vehicles, the bolts that attach the rear lower control arms (RLCA) to the wheel knuckles may have missed the heat treatment process during manufacturing. A RLCA attachment bolt with missing heat treatment may fracture while driving. Fracture of a RLCA attachment bolt diminishes steering control, increasing the risk of a crash.

4. Remove and discard the lower arm-to-wheel knuckle bolt and nut. See Figure 2.
