SIB 52 04 21

RECALL 21V-156: OUTER HEADREST SECOND ROW

This Service Information Bulletin (Revision 3) replaces SI B52 04 21 **dated March 9, 2021**.

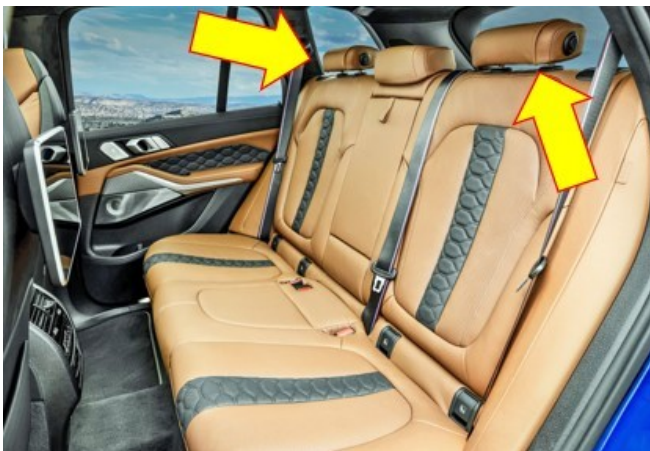
Left and right outer headrests may have been installed which do not have a positive stop movement limiter at their highest position.

During a frontal impact, unsecured items (e.g., luggage) in the rear could move forward and contact the rear seat, which could cause the headrest to detach from the seat.

Check each headrest for the presence of the positive stop. If missing, replace the headrest.

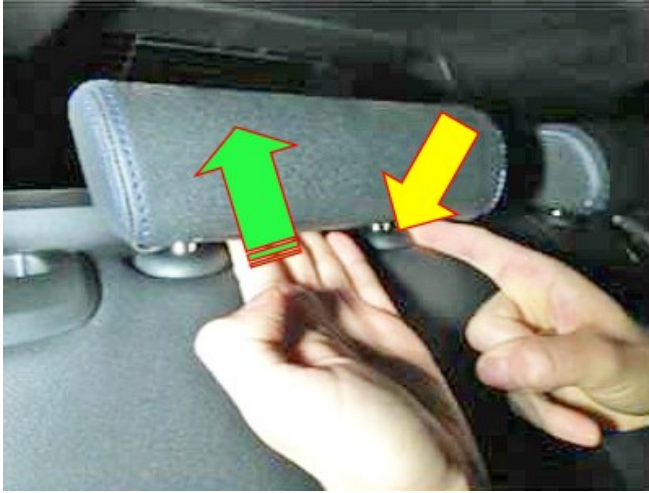
1. On either outer headrest, squeeze the headrest height release button (yellow arrow) at the seatback top retaining collar.

With your other hand, raise the headrest as far as possible with a light effort. Do not use excessive force to attempt raising the headrest. You may only see a maximum of 3 visible notches on the headrest rod.

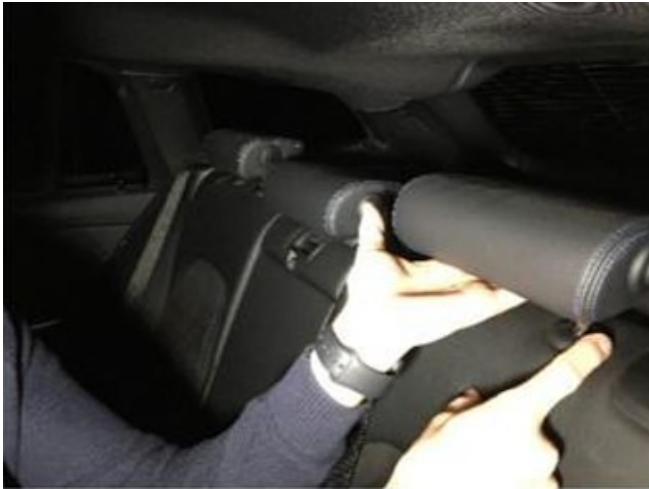
If the headrest cannot be lifted out of the seat, the positive stop is present. This headrest is thereby OK.

Note: The presence of 4 or 5 notches from B52 04 21 Revision 2 on the headrest post does not matter on a headrest which cannot be pulled out of the backrest.

An "OK" headrest cannot be pulled up high enough to view those lower notches. The 4th or 5th notch only pertains to a headrest which can be pulled out, which is Not OK.

Usually only 2 or 3 notches are visible on the post when the headrest is up against its positive stop.

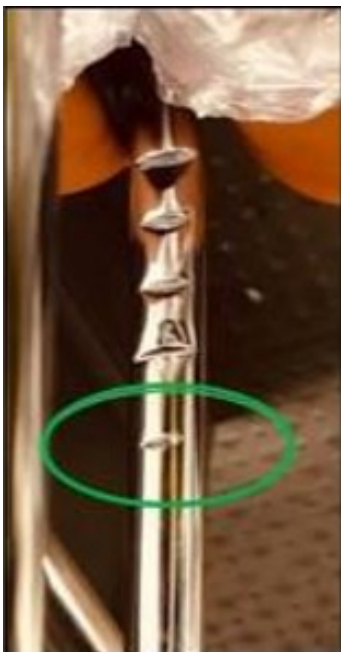
After a headrest has been fully pulled out from the backrest, a supplemental check as to the Not OK status is the presence of only 4 notches on either post.

The photo shows a 5th notch (circled) but this does not matter because the headrest was easily pulled out. That is the main criteria for a Not OK headrest.

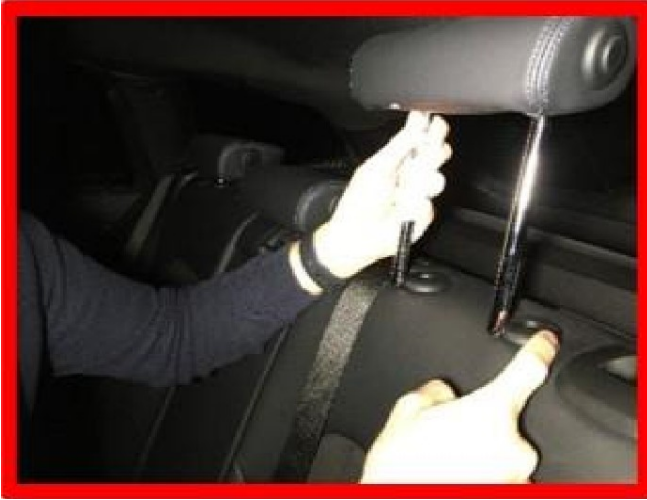
If the headrest can be easily lifted out, continue to Step 2.

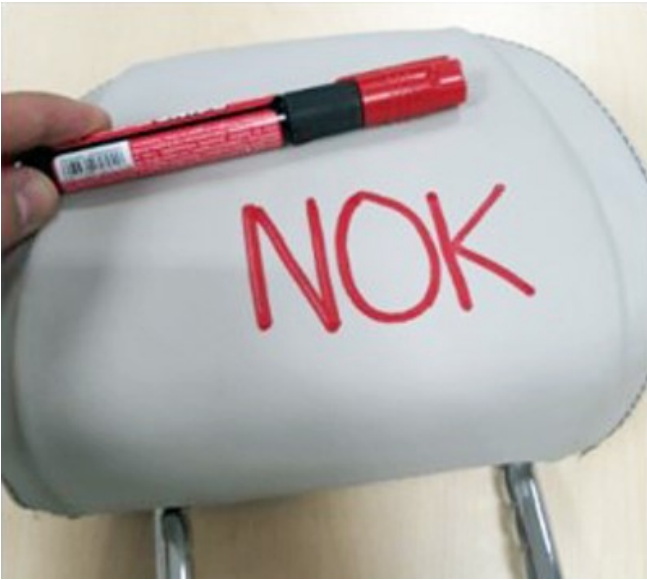
2. Headrests which

- Can be easily pulled completely out of the backrest, AND
- Have either 5 or 4 notches in the posts which are only visible once the headrest is off the vehicle

Mark the headrest "NOK" (not OK) with a permanent marker or paint pen so that it cannot be confused for a good headrest

2. Replace the headrest with a new unit. Confirm that there are **5** notches on the headrest post. **A new replacement headrest with only 4 notches is not correct, because it is for a different model.**

3. Push the new headrest fully down into the backrest so that both posts lock into the seatback internal retainer.

4. Repeat Step 1 to ensure that the new headrest cannot be easily pulled fully out of the backrest.
