Technical Service Bulletin

GROUP RECALL	NUMBER 21-01-033HG
DATE JUNE 2021	MODEL(S) G80 (DH)

SUBJECT: G80 (DH) MULTI FUSE REPLACEMENT KIT INSTALLATION
(RECALL CAMPAIGN 006G)

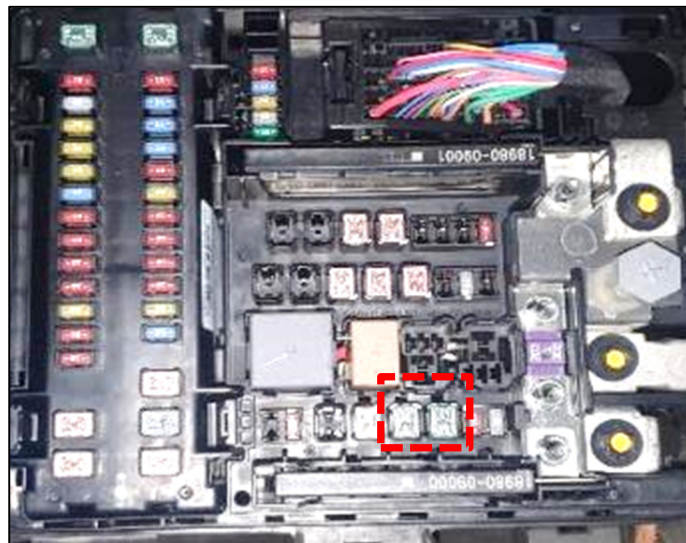
Description: An electrical short in the hydraulic electronic control unit (HECU) may increase the risk of an engine compartment fire. This bulletin describes the procedure to install replacement fuses.
