Keystone RV Company

3/18/21

SAFETY ADVISORY # 21-403

Cougar Inverter Wiring

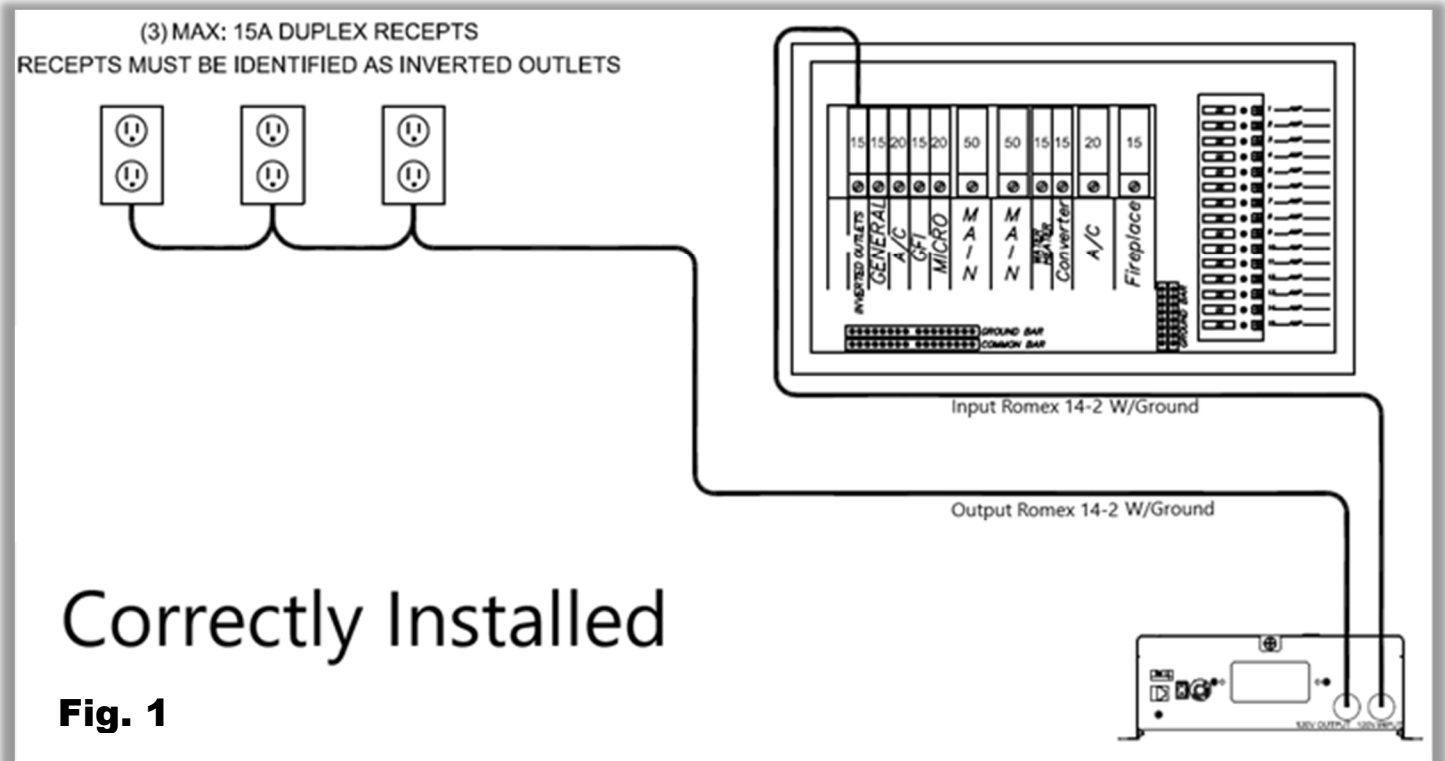
With a fully charged battery connected; disconnect the shore power and turn on the inverter. Inspect outlets labeled "Off the Grid Inverter Circuit". These should be the only 120VAC circuits energized in the unit. See Figure 1. If these are the only circuits energized proceed to Warranty Reimbursement for inspection only, otherwise proceed to Step 3.

If other circuits are energized verify the inverter input and output connections are connected properly. If the connections are reversed, disconnect 120VAC and 12VDC power to the unit, repair the connections and test the function of the inverter.
