Product Safety Recall

N202325161 Battery Cable Short Circuit

Release Date: March 2021

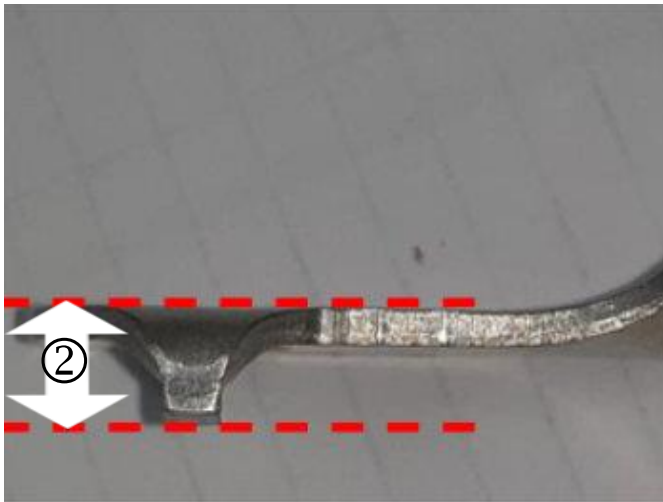
5779103

* If both anti-rotation tabs are trimmed to the correct 6mm length (2), no further action is required. Reinstall the cables following steps 6-9 below.

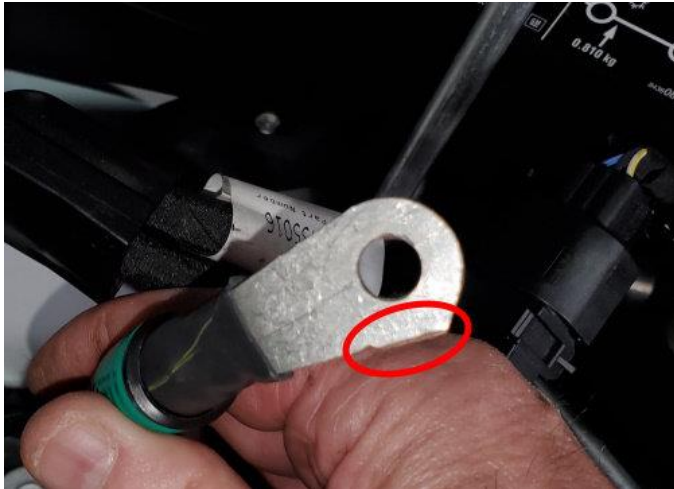
5693961

* If one or both anti-rotation tabs has been cut completely off, or measures less than 6mm as shown in the first graphic in this step, replace the positive battery cable assembly. Refer to Battery Positive Cable Replacement in SI. When installing the new cable assembly, follow steps 6-9 below.
